AAIS Case N°: AIFN/0013/2015

Gyrocopter Loss of Control-Inflight

| Make and Model: | AUTOGYRO / MTOSport |
| Date of Occurrence: | 9 December 2015 |

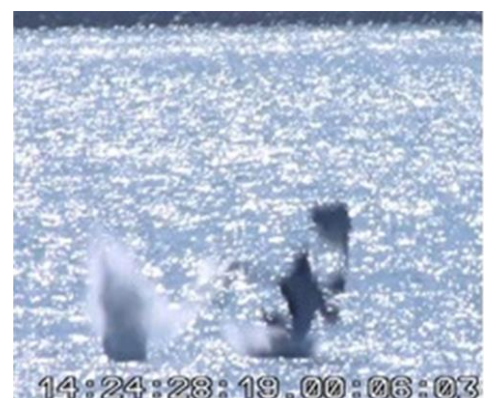
At 1424:28 (figure 4), the Aircraft impacted the water at approximately 90 km per hour in a nose down attitude. Four seconds later, the Aircraft started to sink and submerged within six seconds after the impact. The Pilot was not seen until the search and rescue team recovered him.

Figure 4. Aircraft impacts the water

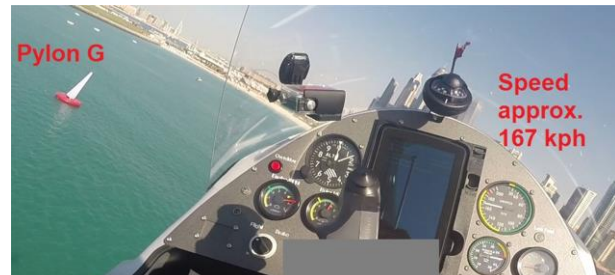
The approach to pylon G, as noted by the GoPro camera, the Aircraft airspeed was in the yellow band with a speed between 160 to 170 km per hour. The normal range, green arc speed, as per the *POH*, is between 30 to 120 km per hour. The WAG event director for the gyrocopter air race had stated that the Pilot had performed satisfactorily during the competition, and was ranked number 11 out of 21 competitors at the start of the Accident flight.

Figure 5. Aircraft approach to pylon G

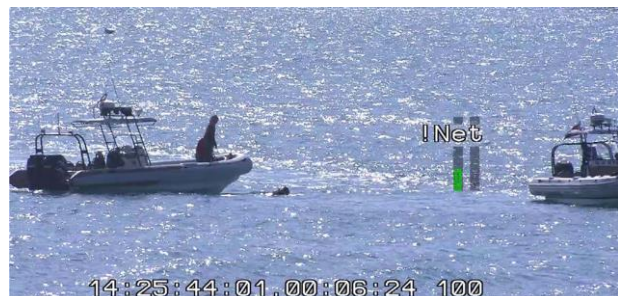
Based on the WAG videos, the Search and Rescue team arrived at the Accident site within 40 seconds, and the first diver was in the water at 1425:44 which was 72 seconds after the impact. The team stated that they faced difficulties due to limited underwater visibility. The Pilot was recovered approximately 10 minutes after the impact. The medical team carried out cardiopulmonary resuscitation (CPR) two minutes after he was placed in the rescue boat.

Figure 10. Diver in the water 72 seconds after impact
