الهيئة العامة للطيران المدني  
GENERAL CIVIL AVIATION AUTHORITY

### - Final Report -

AAIS Case N°: AIFN/0003/2015

# Detachment of Canopy During a Roll Manoeuvre

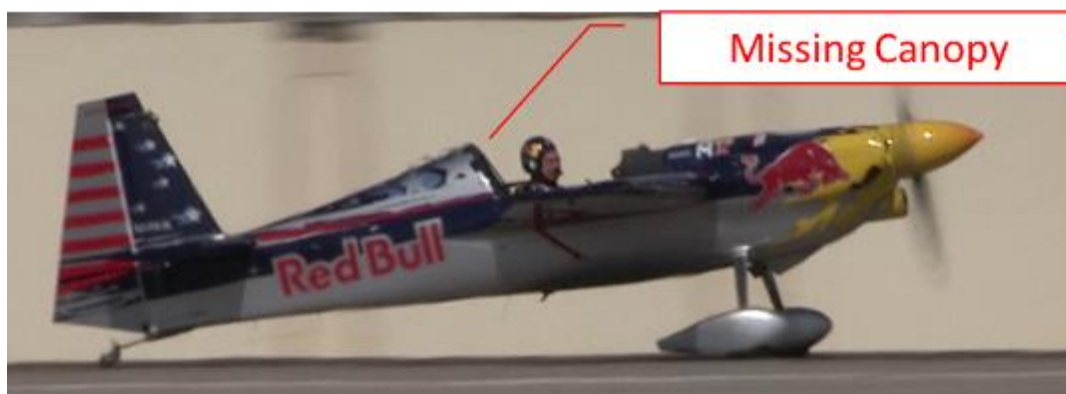
**Figure 1.** Missing canopy

- The canopy was detached and had separated from the airframe
- No damage was found to the flight control systems
- The canopy controls were intact and functional. The emergency release handle was still set to safety with break-away wire intact
- The right front hinge was still attached to the Aircraft
- There was impact damage to the glare shield on the right hand side
- There was minor damage to the right hand wing upper surface and some scuffing of the paint
- The turtle deck had scuffing and a small puncture on the left hand side
- The right hand horizontal stabilizer leading edge had 5 to 6 small chips in the paint
- The underside of the 'D' section (on the leading edge) has a puncture heading fore to aft (front to back)

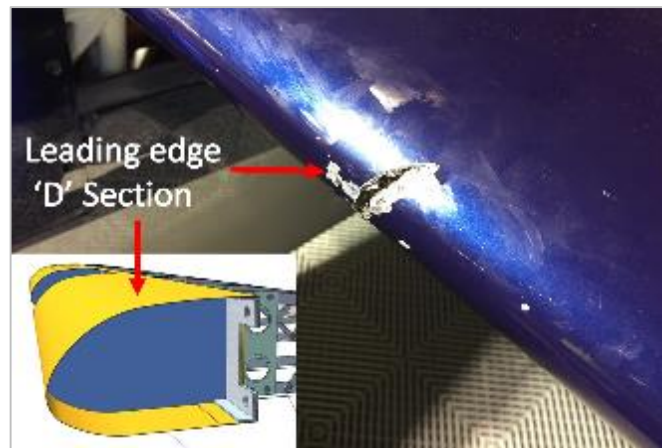
**Figure 2.** Horizontal leading edge damage

- The left hand horizontal stabilizer had scuffs and chips on the upper and lower surfaces.
- The leading edge suffered a deep cut in the inner 1/3rd section. No spar damage seen
- The vertical fin had a deep cut in the lower 1/3rd of the assembly, numerous scuffs and paint chips also were noticed

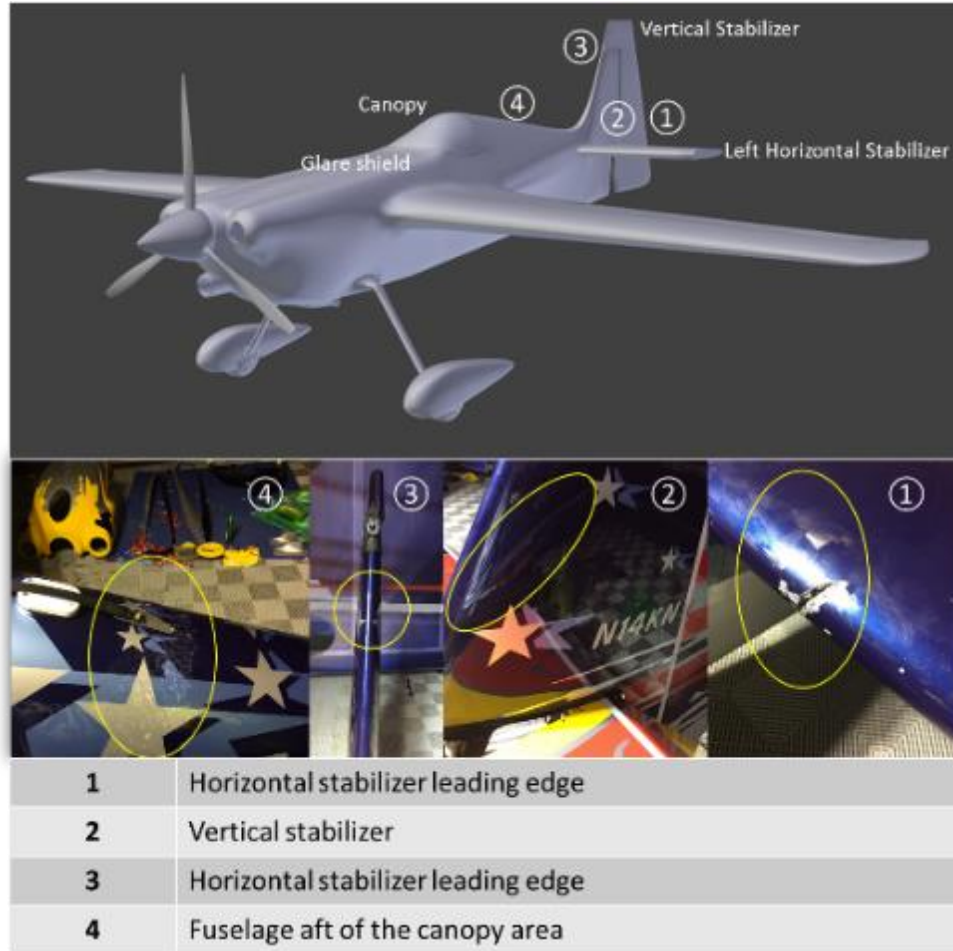
Figure 3. General damage

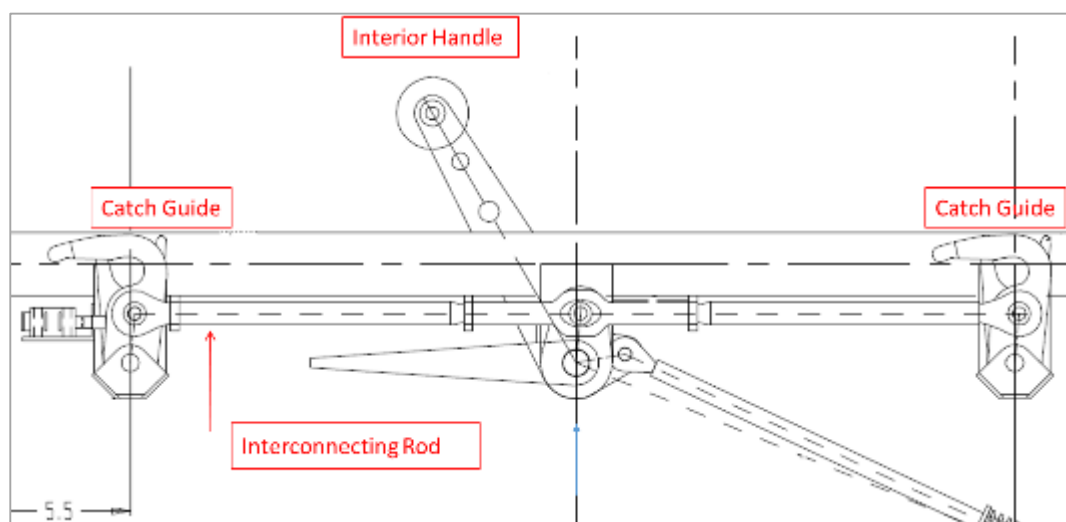
Figure 5. Canopy Latch Mechanism

The canopy latching/locking mechanism is a simple mechanical lever system.

The pilot pushes the lever forward to engage the catch guides, which locate the canopy under tension, securing the canopy in position.

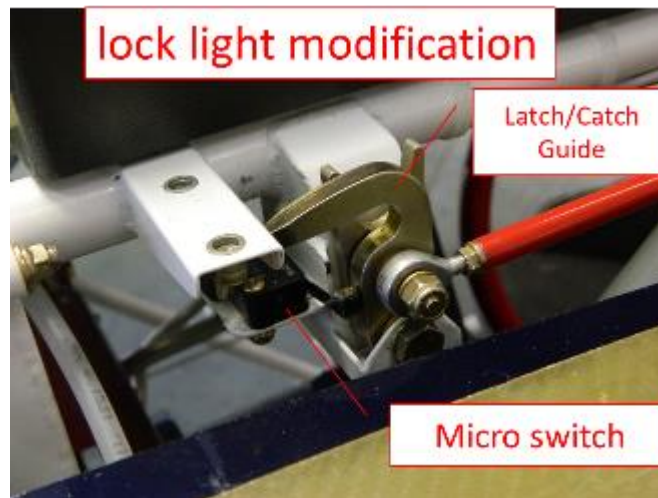
Figure 9. Lock light modification

The instrument panel mounted red LED is wired to the normally-closed terminal of a micro switch. This illuminates the LED when there is no contact (canopy handle open) with the switch. When the canopy handle is in the closed and locked position, the switch is activated, turning off the LED.

Given the challenging race conditions, loads imposed on the airframe and the high ambient temperatures of the UAE, the lock light modification installation and pilot alerting system modification designed to alert pilots via LED light if the canopy is open, should be a mandatory modification for competitive sport aircraft.

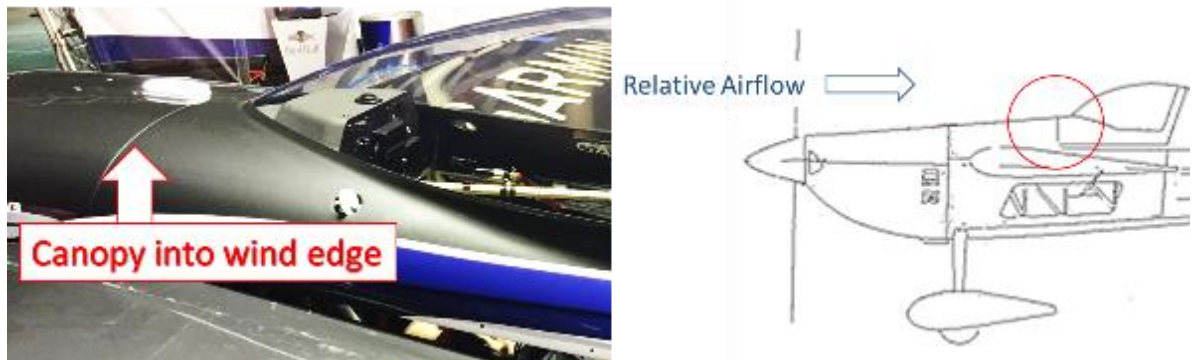
Figure 10. Example the canopy edge on an exemplar airframe

The tolerance for the canopy fit when assembled can be within the assembly tolerance, however, due to the high temperatures in Abu Dhabi and the high airframe demands

imposed on the airframe during the race, this tolerance can be affected and remain undetected.

If a gap allows the airflow to lift the canopy forward edge, there is the possibility that the lifting of the forward edge can cause the mechanical locking device to move the catch guides and the locking lever to move backwards to the unlocked position.

The root cause of the canopy separation was the tolerance on the gap between the canopy leading edge and the fixed installation of the glare shield. If the gap is protruding into wind, the canopy will move, allowing the canopy locking lever move from locked to unlocked.

In conjunction with the manufacturer install an indicating mark on the canopy and glare shield to align with the fully latched position. All Edge 540 crews can then check the latched canopy for looseness by applying positive pushing pressure vertically to the canopy to assure no looseness exists.

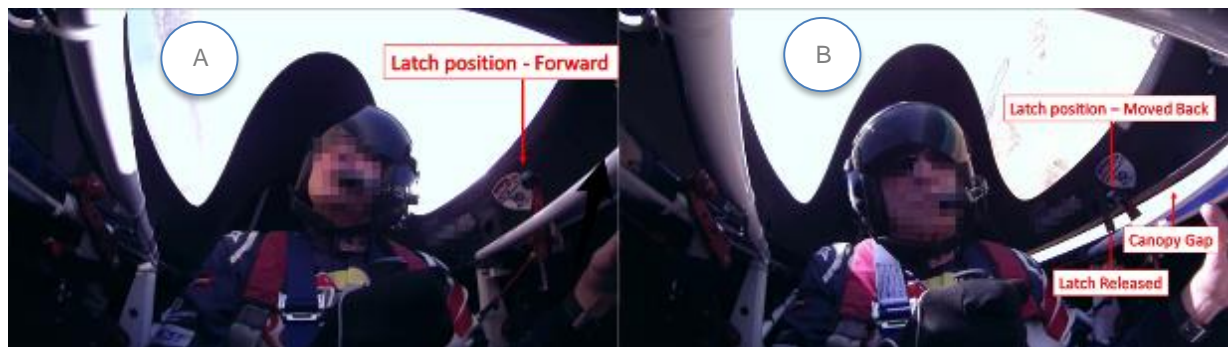
Figure 11. Photo showing the latch position (Source: on-board camera)

In figure 11A, the canopy locking lever can be seen in the forward (locked) position, and in figure 11B above the locking lever can be seen in the aft or unlocked position.

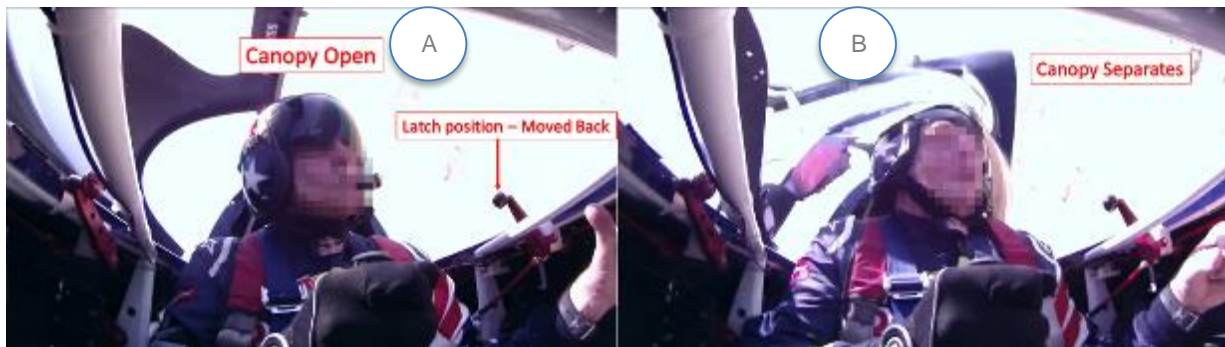
Figure 12. Photo showing canopy opening and separation (Source: on-board camera)

In figure 12A the canopy has opened and rotated around the right hand hinge line. In figure 12B the forward edge of the canopy separates contacting the pilots face and head.

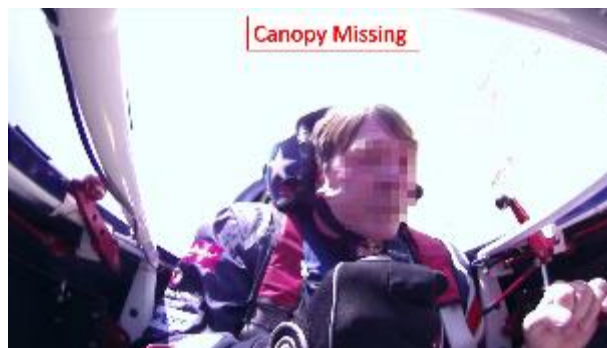
Figure 13. Photo showing canopy detached and helmet and boom microphone pushed back (Source: on-board camera)
