الهيئة العامة للطيران المدني
GENERAL CIVIL AVIATION AUTHORITY

- Final Report -

AAIS Case N°: AIFN/0001/2016

Balloon Hard Landing

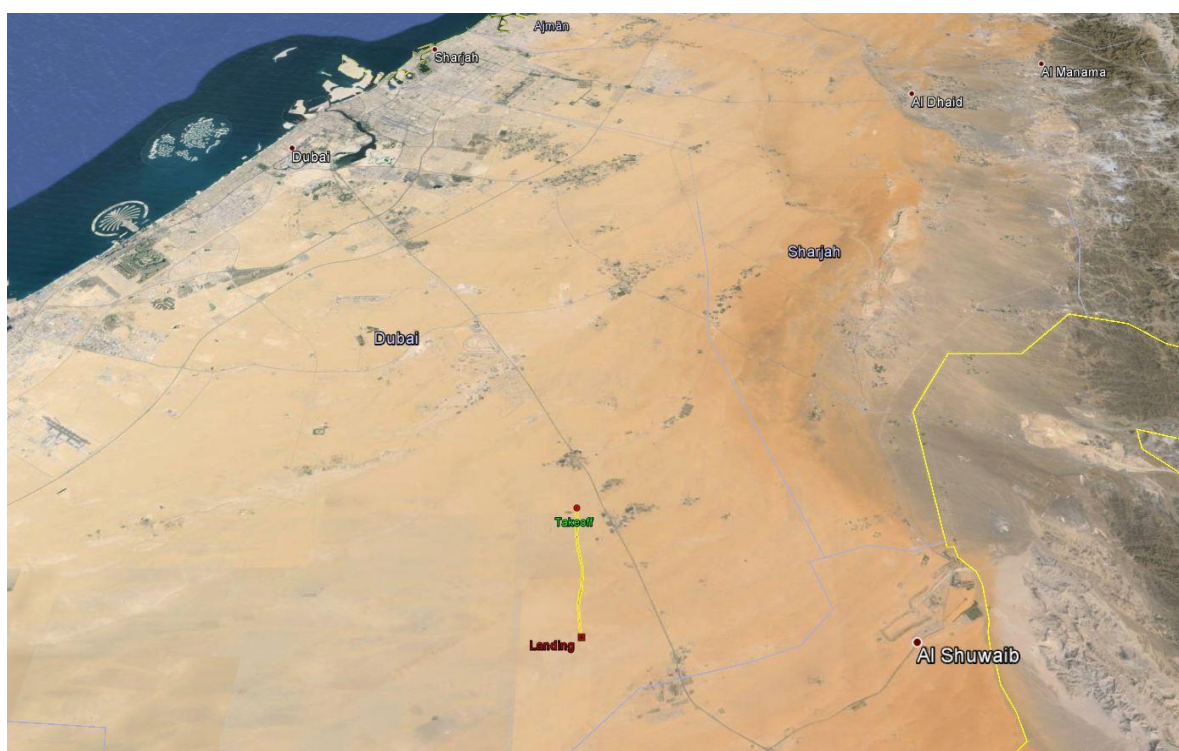
Figure 1. Area of the takeoff and landing

While the Balloon was climbing after the first touchdown, the Pilot closed the burners. When the Balloon reached approximately 54 feet above ground level, it descended continuously until the second touchdown, a hard landing, with a sink rate of 406 ft/min on touchdown. The Balloon was in the air for 34 seconds after the first touchdown. The Balloon speed was approximately 2.5 knots on the hard landing. Figure 1 shows the take-off and landing area of the Balloon.

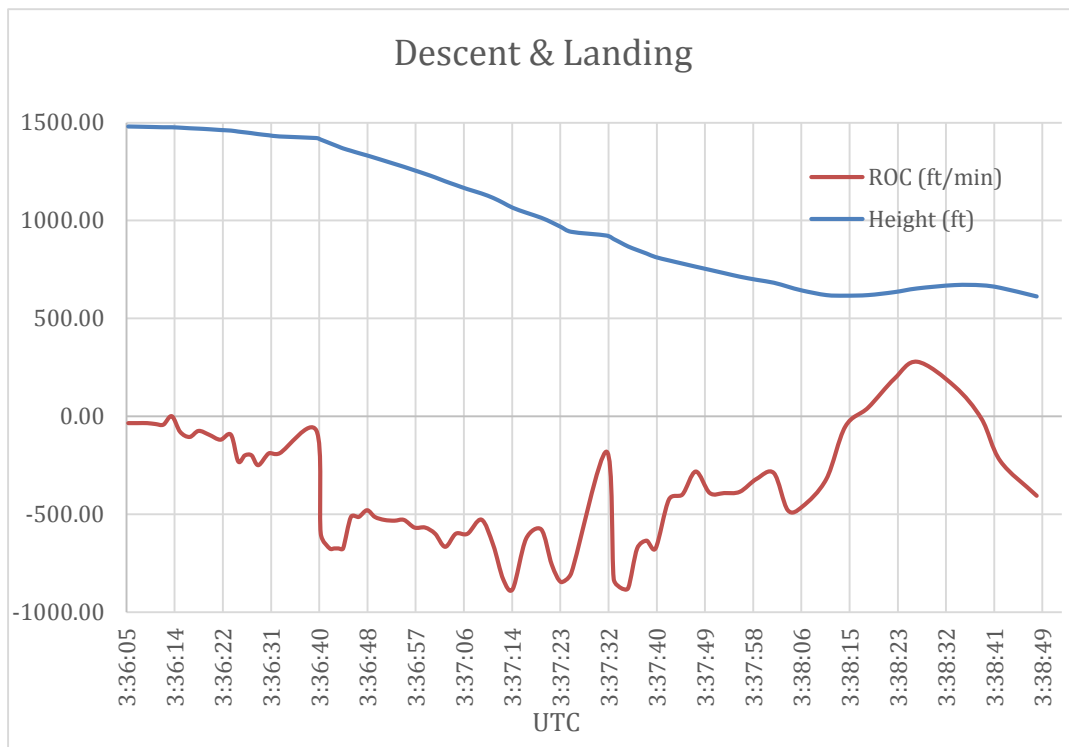
Figure 7a. Vertical speed and height during descent and landing

The downloaded height, rate of climb, and Balloon speed data are given in Figures 7a and 7b. The figures represent the time period from the start of descent, to landing.

The Pilot managed the descent without using the parachute line, and instead relied on the burners to control the rate of descent. From the recorded flight data, shown in Figure 7a, the maximum rate of descent was approximately 877 feet/min (4.45 m/sec), which was below the allowable maximum rate of descent, which is 1,000 ft/min.

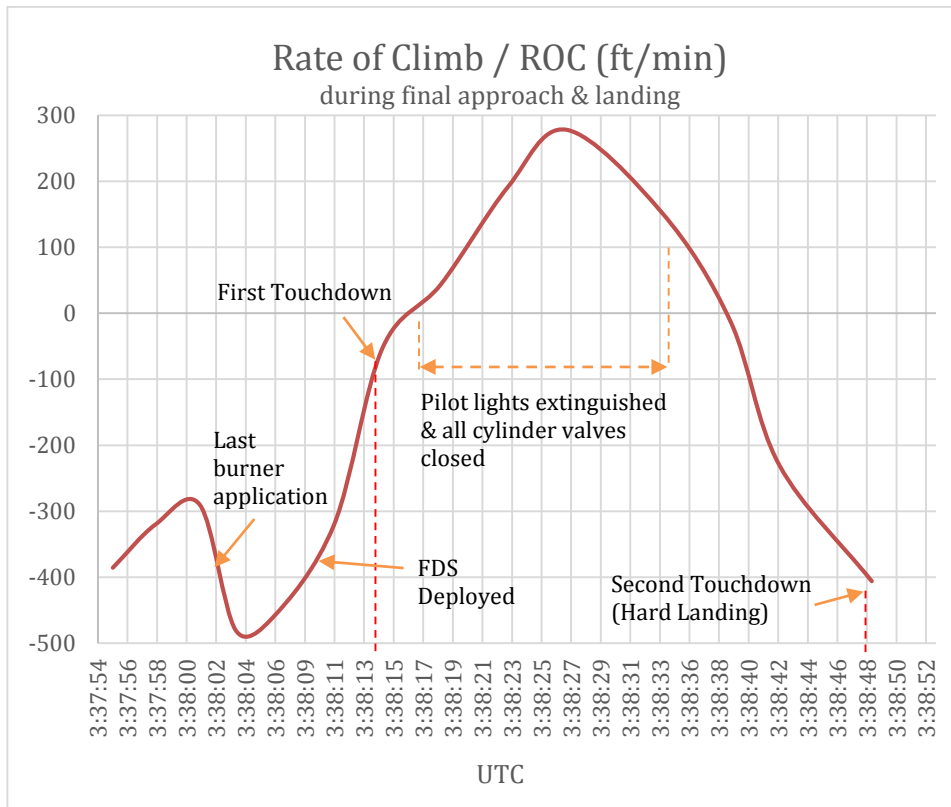
Figure 8a. Vertical speed on final approach and landing

The final burner application was estimated to have been between 10 and 12 seconds before the first touchdown, and it was continuously used for a relatively longer period.

The FDS was deployed about 1.5 to 2 meters (4.9 to 6.6 feet) above ground level.

Between 6 and 9 seconds before deploying the FDS, when the Balloon was descending from a height of 66 feet to 46 feet above ground level, and having developed rates of descent from 290 up to 480 ft/min, the Pilot, most probably, used the burners continuously to halt and reduce the rate of descent. The rate of descent (ROD) reduced, and with the deployed FDS, the Balloon touched the ground with a ROD of 53 ft/min.

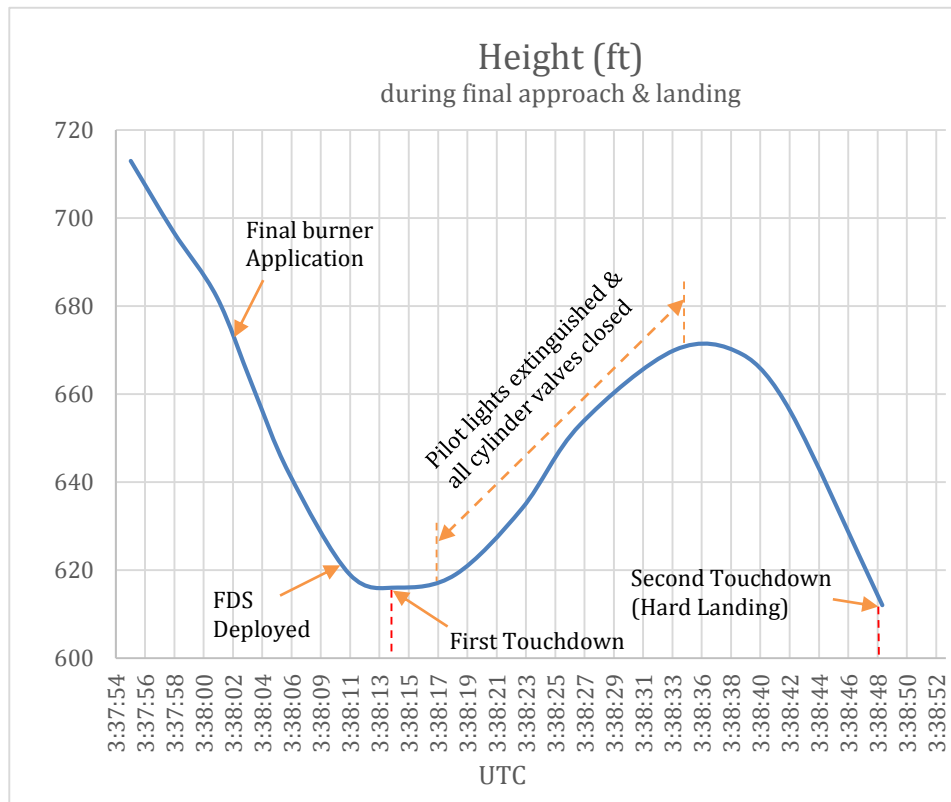
Figure 8b. Height on final approach and landing

The Pilot extinguished the pilot lights, and all the cylinder valves were closed after the first touchdown as the Balloon was climbing, before it descended again for the second touchdown.
