## Accident - Final Report -

AIFN/0001/2017

# Balloon Basket Fire on Landing

Operator:	Balloon Adventures Emirates LLC
Make and Model:	Ultramagic N-500
Nationality and Registration:	The United Arab Emirates, A6-BOB
Place:	Sharjah
State of Occurrence:	The United Arab Emirates
Date of Occurrence:	14 January 2017

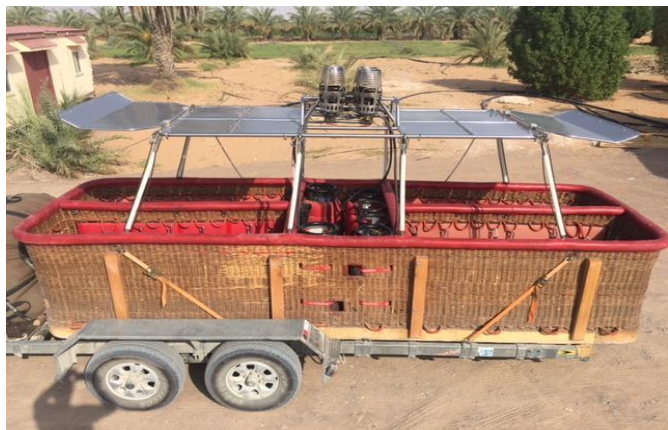
Figure 5. Basket with exposed nylon rods

All eight nylon rods were identified as broken and the envelope scoop showed signs of fire damage.

The Pilot did not observe the nylon rods before takeoff and the Balloon ascended with most of the nylon rods broken, or dislocated from their sockets.

If one (or more) of the burner nylon rods is unserviceable then the pilot should replace it with a serviceable item (assuming that one was available) prior to inflation and takeoff. If one is unserviceable during hot inflation, then this should be replaced prior to continuing with the takeoff.

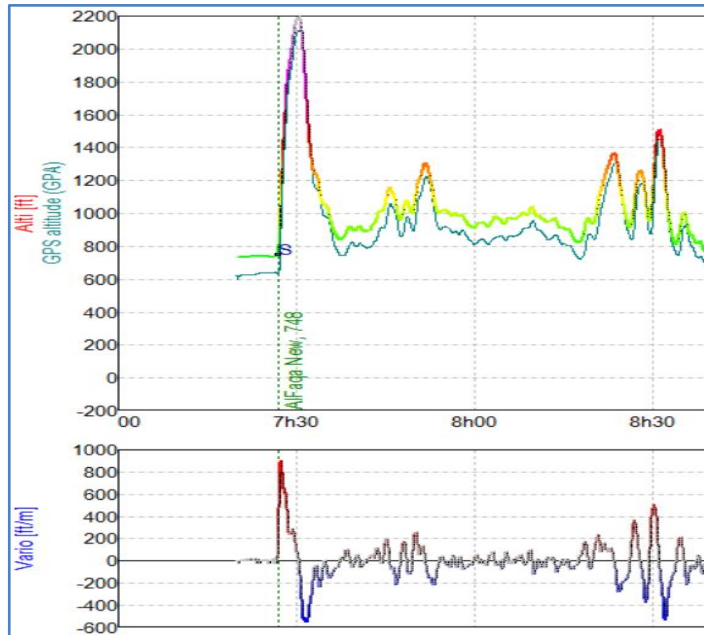
Figure 6. Vertical speed and altitude.  
[Source: on-board variometer]

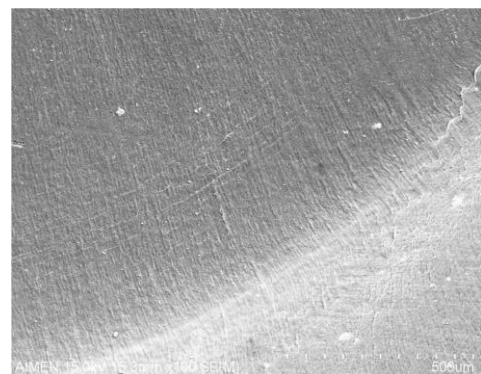
According to the examination report, a microscopic exploration was performed by scanning electron microscopy (SEM) in two fractured poles (1 and 2). The surfaces of the fracture in one pole showed various initiation points of fracture, whereas the surface showed single on other pole initiation point underneath the surface (figure 8). In both surfaces, smooth facets could be observed with some radial steps together with bands and conchoidal striations, typical of the progressive advance and a ductile aspect of the fracture. Fracture start zone (red arrow) and propagation directions (green arrows) are indicated in figure 9.

**Figure 7.** Fracture initiation zone, concentric bands of crack growth

Based on the last metallurgical examination, the Investigation believes that, except for a small pore or internal cavity in one of the poles, no other defects in the poles were detected that could have induced or facilitated the failure. No machining irregularities (cracks or creases) were found that could have weakened the poles. The fracture of the poles (2) that were studied occurred due to a progressive and ductile mechanism (fatigue), under alternating bending stresses (bending and unbending).

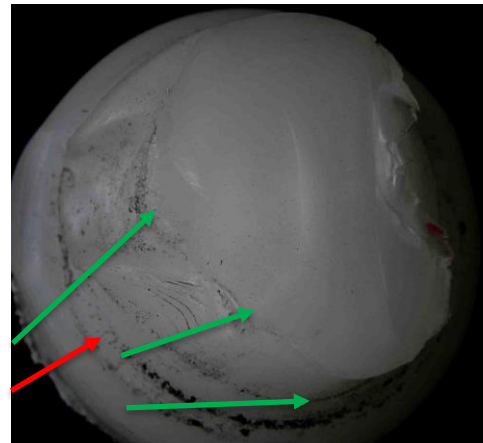
The lab report concluded that, except for a small pore or internal cavity in one of the poles, no other defects or heterogeneities in the poles were detected that could have induced or facilitated the failure. No machining irregularities (cracks or creases) were found that could have weakened the resistant section. The fracture of the studied poles 1 and 2 (figure 9) happened due to a progressive and ductile mechanism (figure 8), under alternating bending stressed (bending and unbending).

Figure 8. Fracture surface

The Investigation believes that the bending fatigue that failed one of the rods had resulted from side loads imposed by the burner (head panel). The fatigue crack, whether it was surface or sub-surface, could not have been detected by visual inspection.

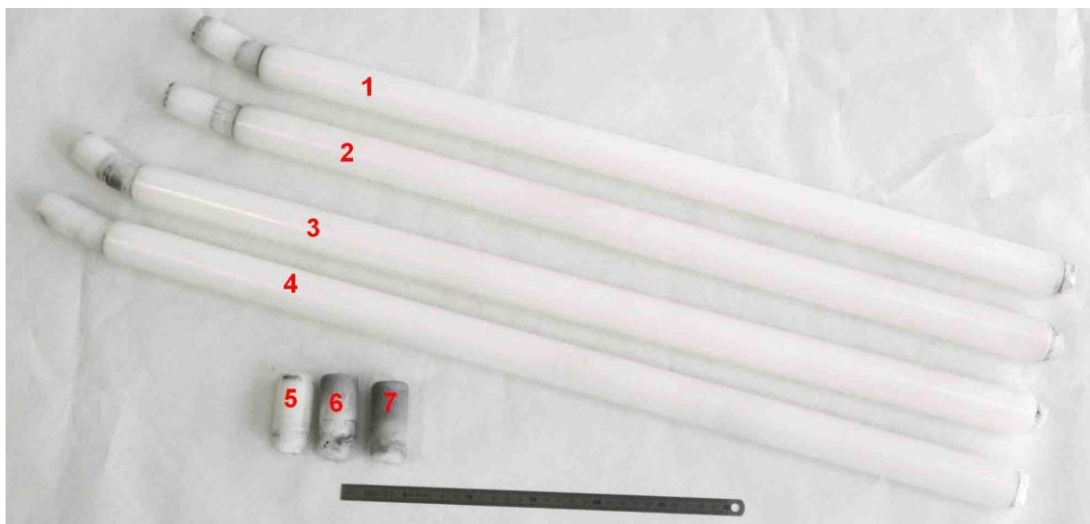
Figure 9. The four poles identification
