Air Accident Investigation Sector

AAIS Case N°: AIFN/0008/2017

Tire Failure Resulting in Loss of a Single Hydraulic System

Operator:	flydubai
Make and Model:	Boeing B737-800
Nationality and Registration:	The United Arab Emirates, A6-FDS
Place of Occurrence:	Dubai International Airport
State of Occurrence:	United Arab Emirates
Date of Occurrence:	8 August 2017

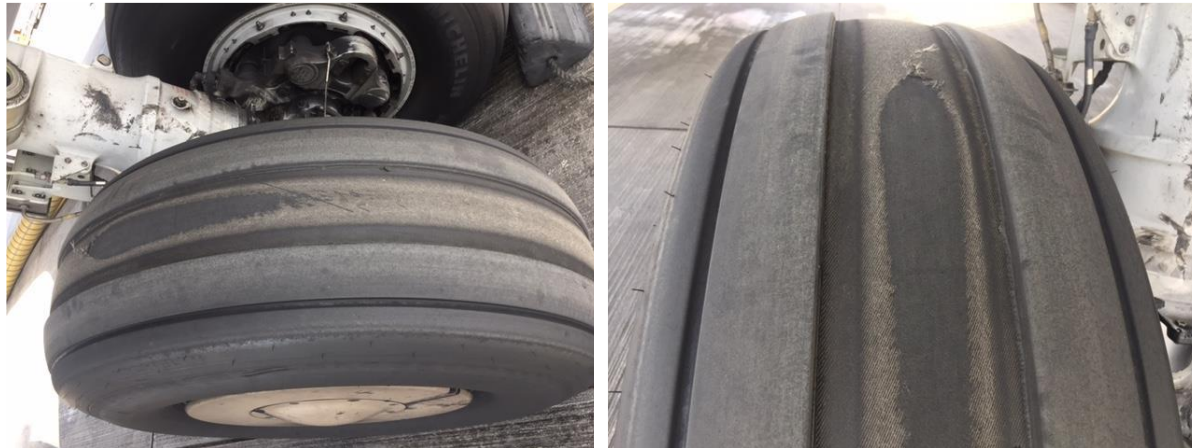
The Air Accident Investigation Sector determines that the cause of the Incident was the rotation of the damaged No. 1 tire inside the left main wheel well that consequently caused damage to some components and lines of hydraulic system A, and the subsequent hydraulic system A pressure loss.

After the landing, the Aircraft was inspected, and it was found that the No. 1 tire (left outboard tire) tread center rib had completely peeled from the tire. However, the tire was still inflated (figure 4).

Figure 4. Damaged No. 1 tire (left outboard tire)

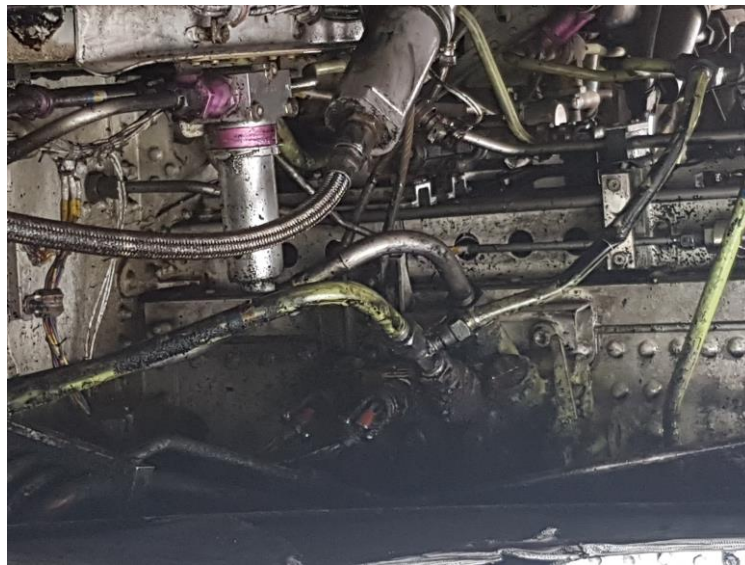
The Aircraft sustained damage to the APU fuel drain line, landing gear and hydraulic parts (see Appendix 1) inside the left main wheel well, and minor damage to structural parts adjacent to that area. Scattered hydraulic fluid leakage in the left main wheel well was found after the Aircraft landed (figure 5).

Figure 5. Scattered hydraulic oil leakage in the left main wheel well

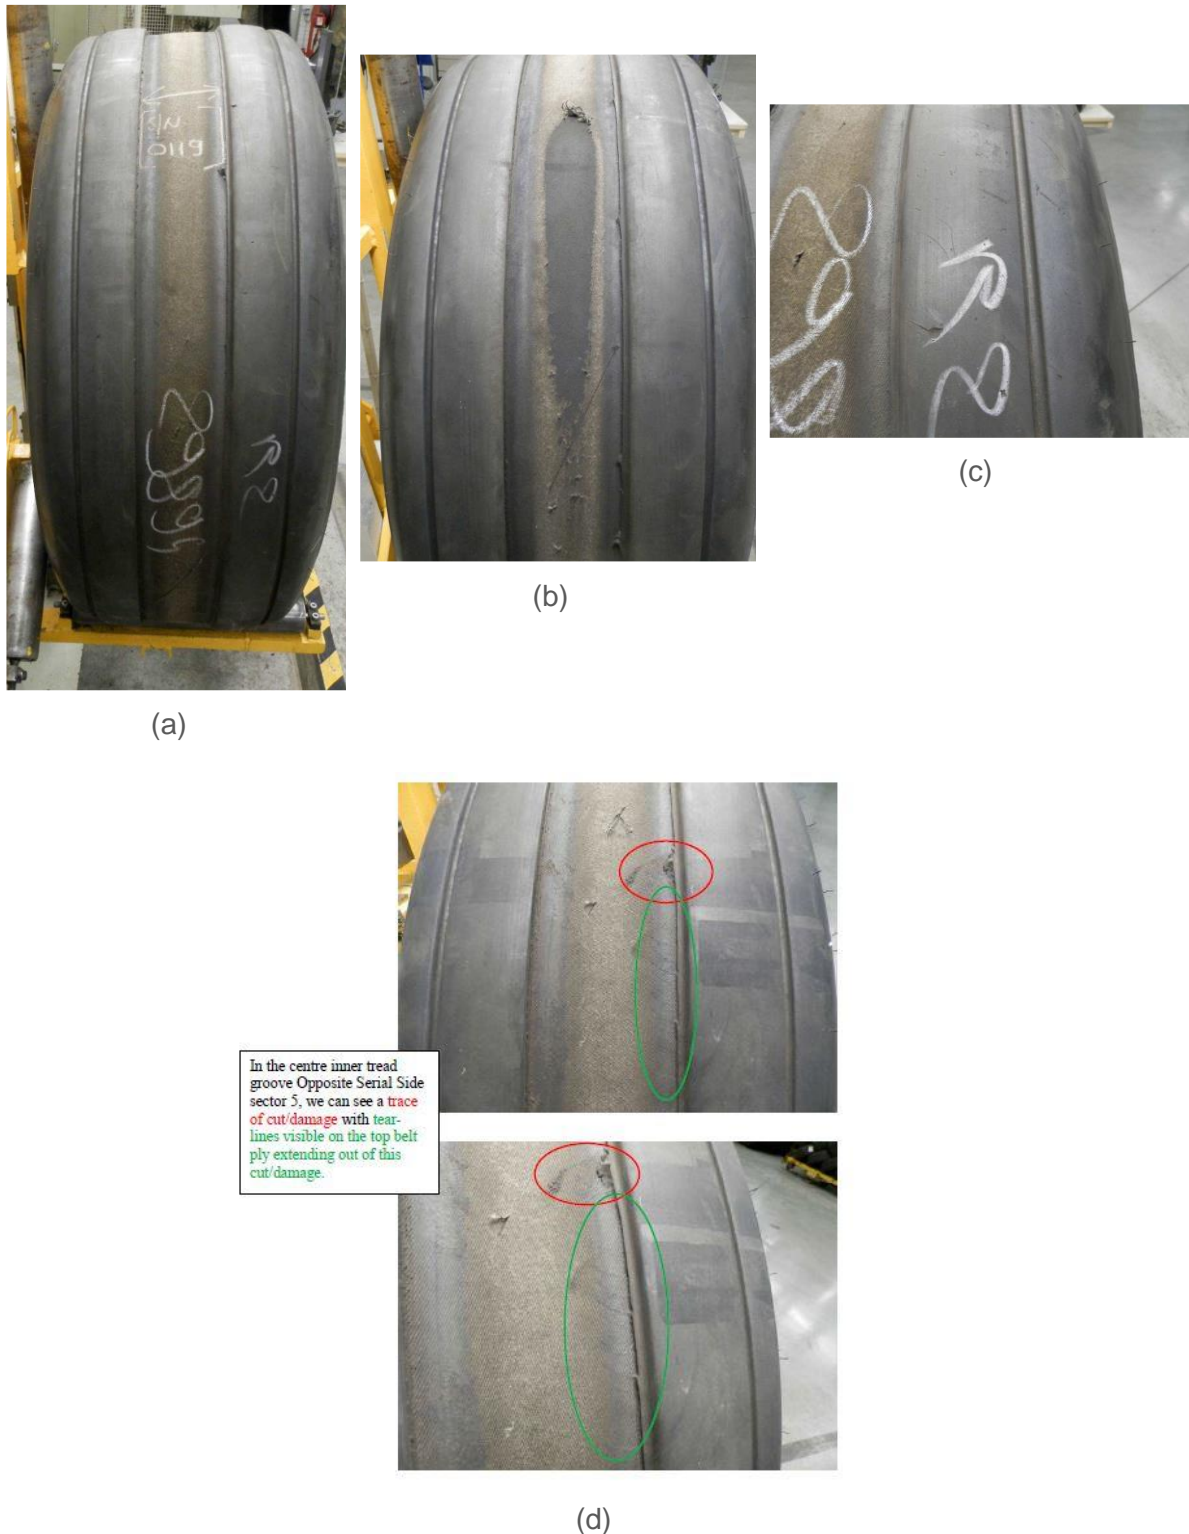
Figure 16. Damaged tire [Source: Michelin]

The tire manufacturer's report noted that the tire had lost the complete center tread rib, exposing the top belt ply (figure 16a). In one area, the top belt ply was abraded, lost, or torn away (figure 16b). The shoulder and intermediate tread rib opposite the serial side exhibited cuts and scratches (figure 16c).

In the center inner tread groove opposite serial side sector 5, a trace of cut/damage with tear-lines visible on the top belt ply extending out of this cut/damage (figure 16d), is evident.

The tire manufacturer's report concluded that the tear-lines visible on the top belt ply, and the trace of cut/damage on the center inner tread groove opposite serial side in sector 5, indicate a possible initiation site for the loss of the center tread rib. As the missing tread pieces were not returned, the tire manufacturer could not determine the root cause for the center tread rib loss.

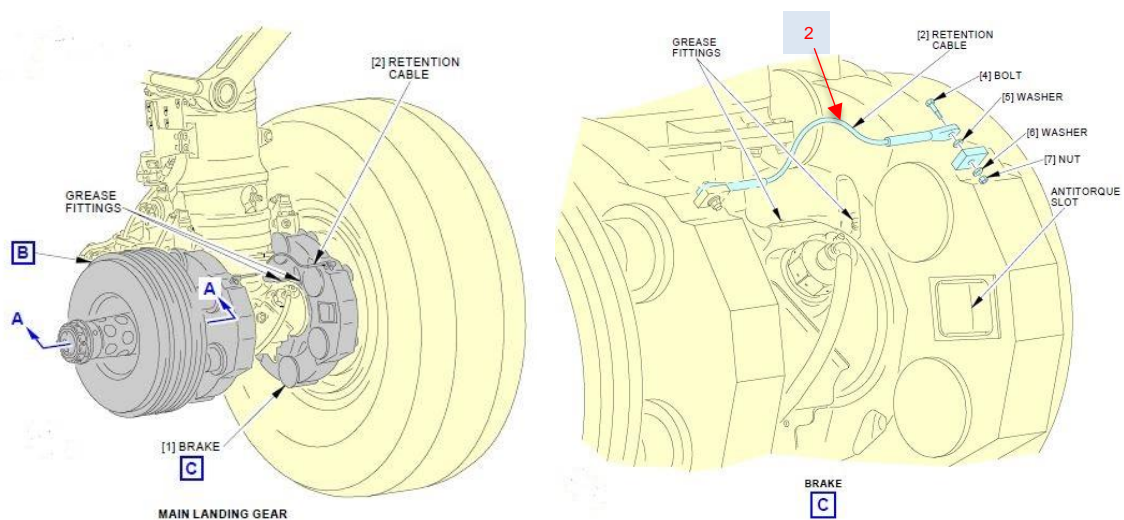
No.	Description	Part No	IPC Reference
1	APU fuel drain line Bonding jumper clamp	AN735C6, AN735DC6	29-21-52-02
2	Landing gear retention cable (figure A.1)	BACC2A5D00145BB	32-41-41-01
3	1 st blade seal upper/lower retainer (figure A.2)	149A7662-19 /149A7662-20	53-14-00-05B
4	Hydraulic line from Port 2 of system A Flight Control Module (figure A.3)	272A4451-1007	29-11-61-07
5	Hydraulic line from Port 5 of system A Flight Control Module (figure A.3)	272A4454-1008	29-11-61-07
6	Hydraulic line and tee fittings of system A Pressure Module of Union 25 (figure A.4)	AS5804T100808	29-11-52-10E
7	Centre wing spar, EMDP A support structure, bracket at left hand side view	271A1112-28	29-11-21-01
8	System A EMDP upper and lower safety cables – Screw (figure A.5)	BACS12GU3K9	29-11-21-07
9	System A EMDP upper and lower safety cables – Clamp (figure A.5)	MS21919WCF4	29-11-21-07
10	System A EMDP upper and lower safety cables – Washer (figure A.5)	NAS1149D0316J	29-11-21-07

Figure A.1. Left main landing gear [Copyright © Boeing. Reprinted with permission of The Boeing Company]

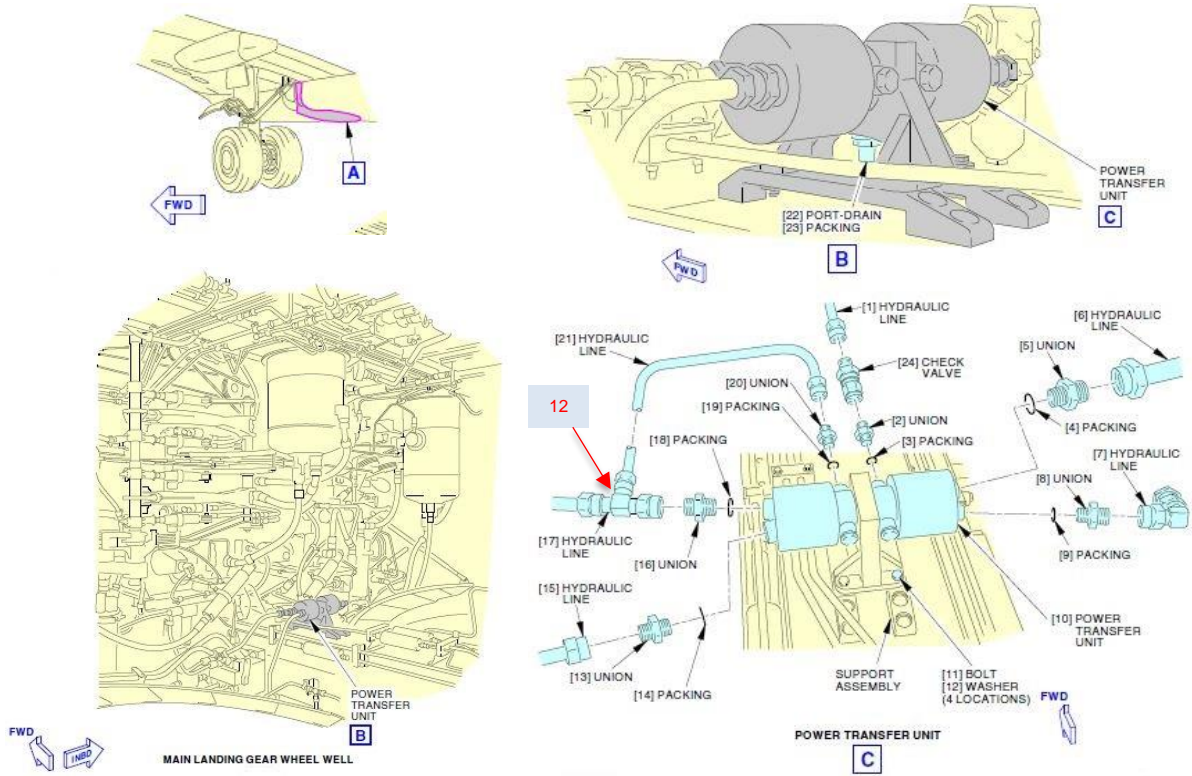
11	Power Transfer Unit hydraulic line 17D tee fitting broken (figure A.6)	272A4454-1017 /AS4139T080806	29-21-52-02D
12	Roll attitude inclinometer broken	5002R	28-40-51-01A
13	Roll attitude support bracket assy		
14	APU fuel drain line	346A2305-1	29-21-52-04
15	Forward W/W wing to body fairing support rod	149A7630-11	53-14-00-04A
16	Aft W/W wing to body fairing support rod	149A7630-3	53-14-00-04A
17	Blade seals	149A7661-21, -38, - 39, -40, -41, -42, -43, -44, -45, -46, -53, - 54, -55, 56, and 58	53-14-00-05B

Figure A.6. Hydraulic system A – power transfer unit
[Copyright © Boeing. Reprinted with permission of The Boeing Company]
