AAIS Case N° AIFN/0004/2017

Helicopter Controlled Ditching due to High Main Gearbox Oil Temperature and Associated Noise

Make and Model: AgustaWestland AW139

Nationality and Registration: The United Arab Emirates, A6-AWN

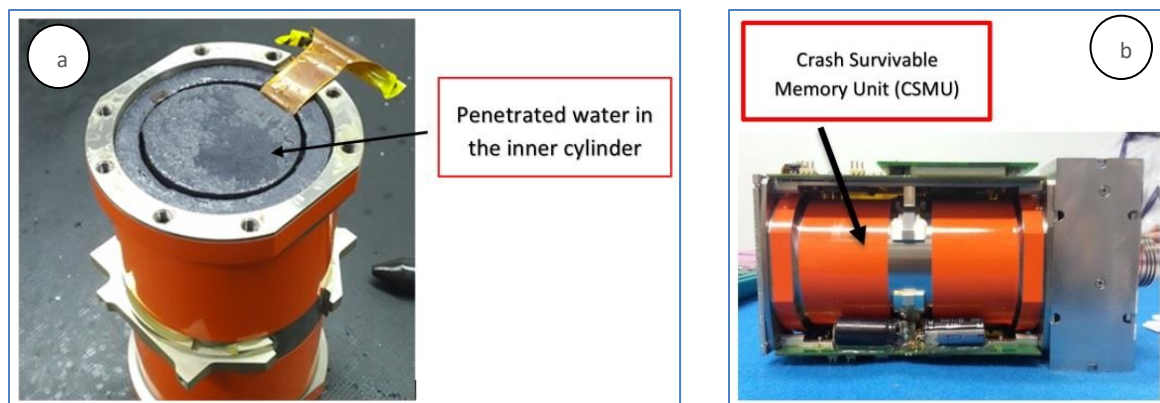
During the disassembly, it was noted that water had penetrated the outer chassis and covered the electronics controls unit. A small amount of water was also found covering the CSMU inner steel cylinder which contains the data storage memory boards.

Figure 4. CSMU and evidence of moisture penetration to inner cylinder

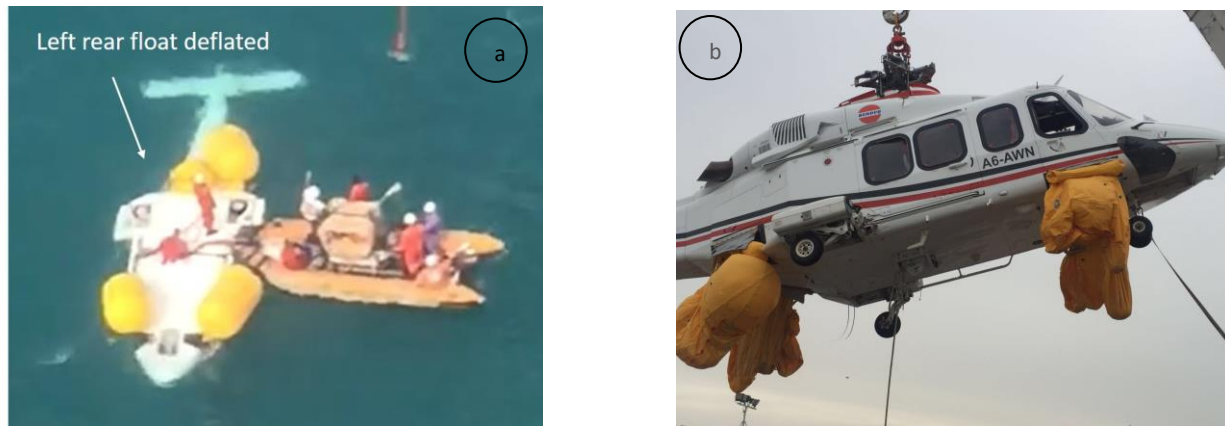
After the evacuation of the occupants, the Aircraft turned upside down and was afloat at the surface when it was recovered. The floats were penetrated by the recovery team to aid in turning the Aircraft for the recovery process.

Figure 5. Aircraft recovery

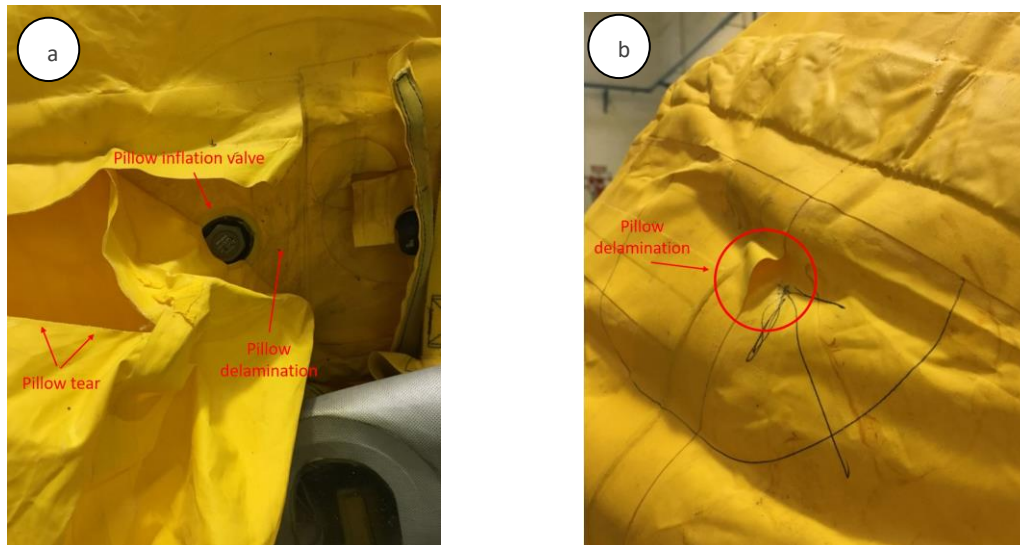
It was identified that part of the aft pillow chamber had delaminated, releasing air from the aft floatation chamber through the pillow inflation valve. A second area of delamination was found at a main chamber seam which was slowly releasing air.

Figure 7. Left aft float damage

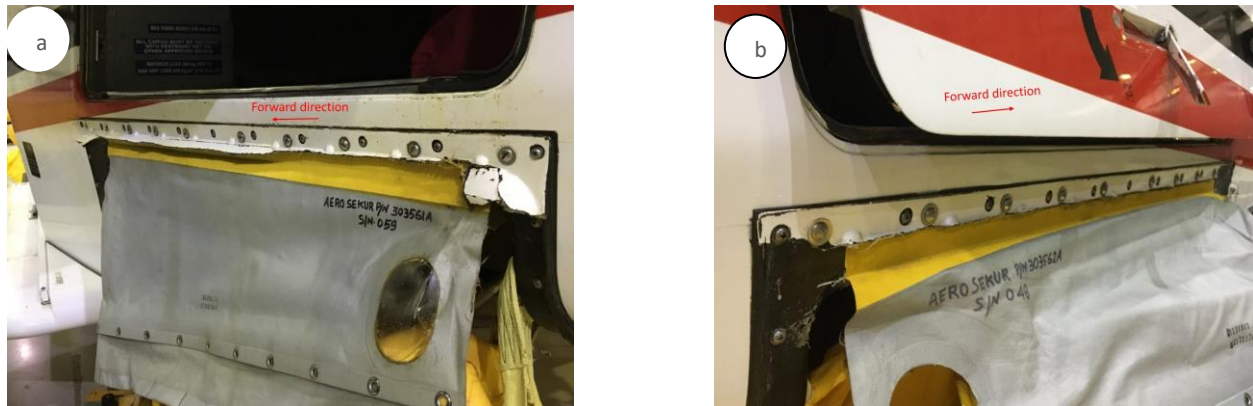
An inspection of the Aircraft identified that the shear bolts holding the upper edge of the float covers in place had not sheared causing fracturing of the float covers with the remains attached to the Aircraft.

This finding is subject to further investigation.

Figure 8. Left and right aft float cover damage

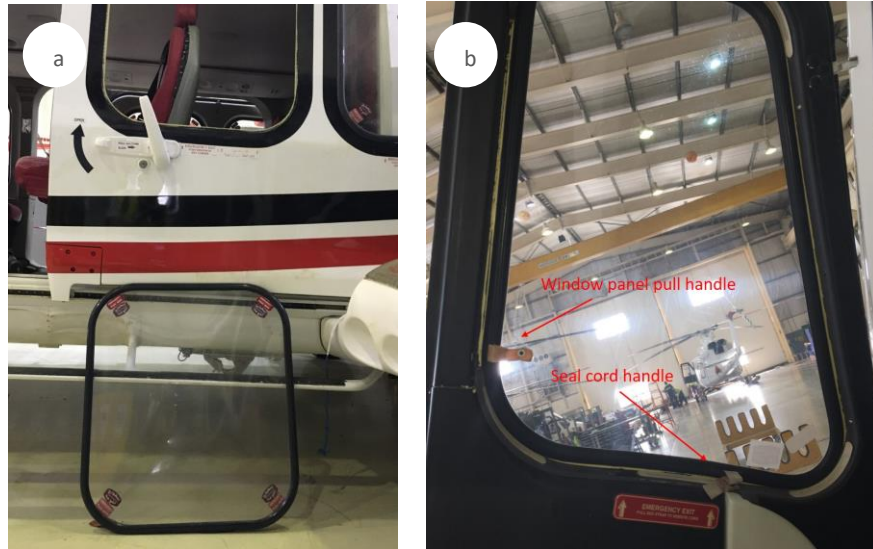
Figure 9. Aircraft cabin escape window and example of left flight deck escape window

The Copilot reported that when the left window panel handle was pulled as described in the emergency evacuation procedures, the window panel cracked in the area of the pull handle creating a hole in the panel. The Copilot was able to pull the panel inwards by using this hole as a grip point.

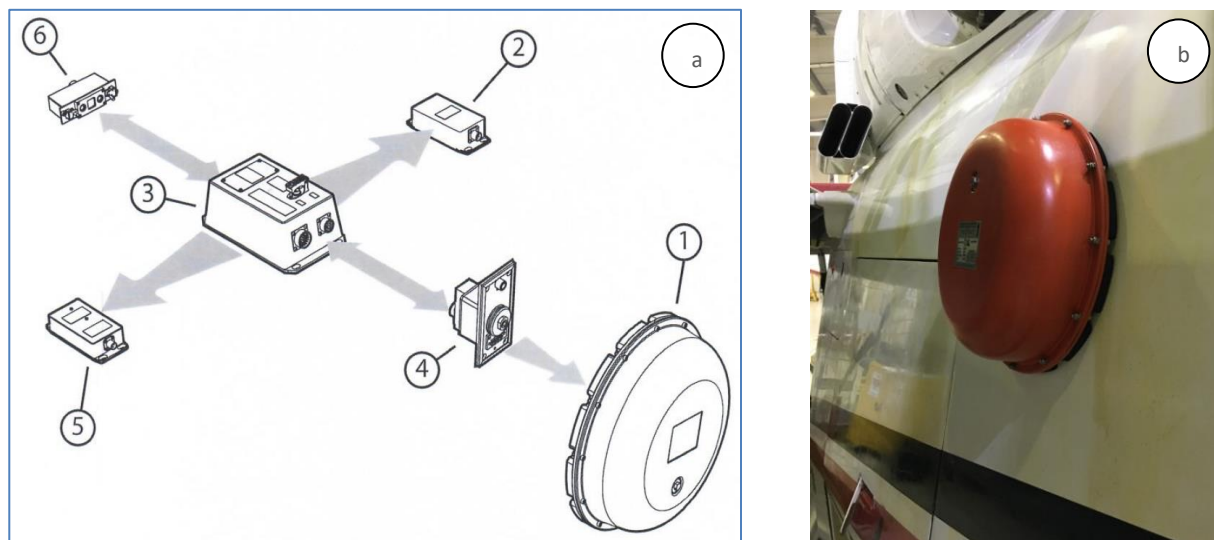
After the recovery of the Aircraft, the beacon was found attached to the beacon release unit on the rear aircraft fuselage. The reason for the failure to deploy will be further investigated.

Figure 10. Crash position location system and ELT beacon attached to fuselage

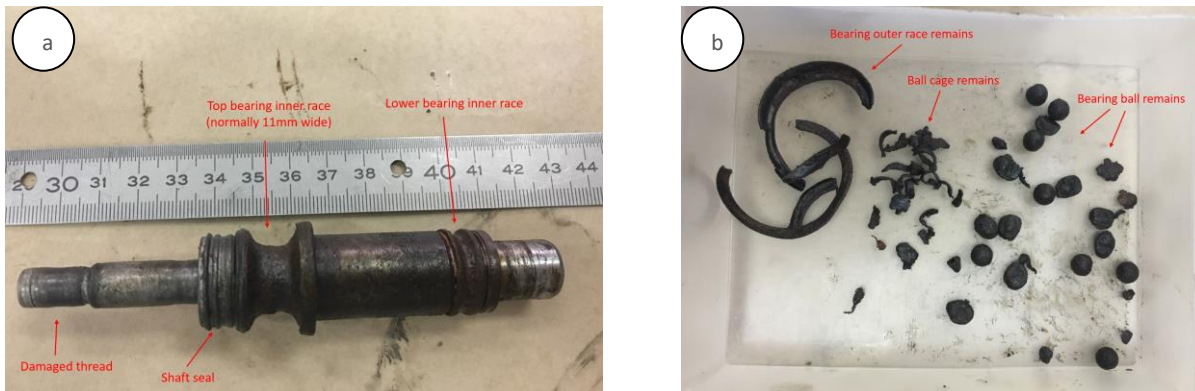
It was found that the fan shaft had lateral play of 5.3mm. The fan was not attached to the shaft and was touching the outer shroud. The left bearing was completely degraded, showing signs of overheating, with the inner bearing race physically expanding from 11mm to 18mm.

The right shaft bearing was destroyed and, together with its seal package, extended from the housing by 4.8mm. The shaft thread was stripped and showed signs of extensive heating near the lower end. The balls and ball cages from both bearings were destroyed.

The Investigation will analyze the findings to determine the root cause and the sequence of events leading to the cooling fan failure.

Figure 19. Cooling fan assembly shaft and bearing parts findings
