AIRCRAFT ACCIDENT REPORT:  
SATURN AIRWAYS, INCORPORATED,  
LOCKHEED L-382, N14ST,  
SPRINGFIELD, ILLINOIS, MAY 23, 1974

National Transportation Safety Board  
Washington, D. C.

22 January 1975

SATURN AIRWAYS, INC.  
LOCKHEED L-382, N14ST  
SPRINGFIELD, ILLINOIS  
MAY 23, 1974

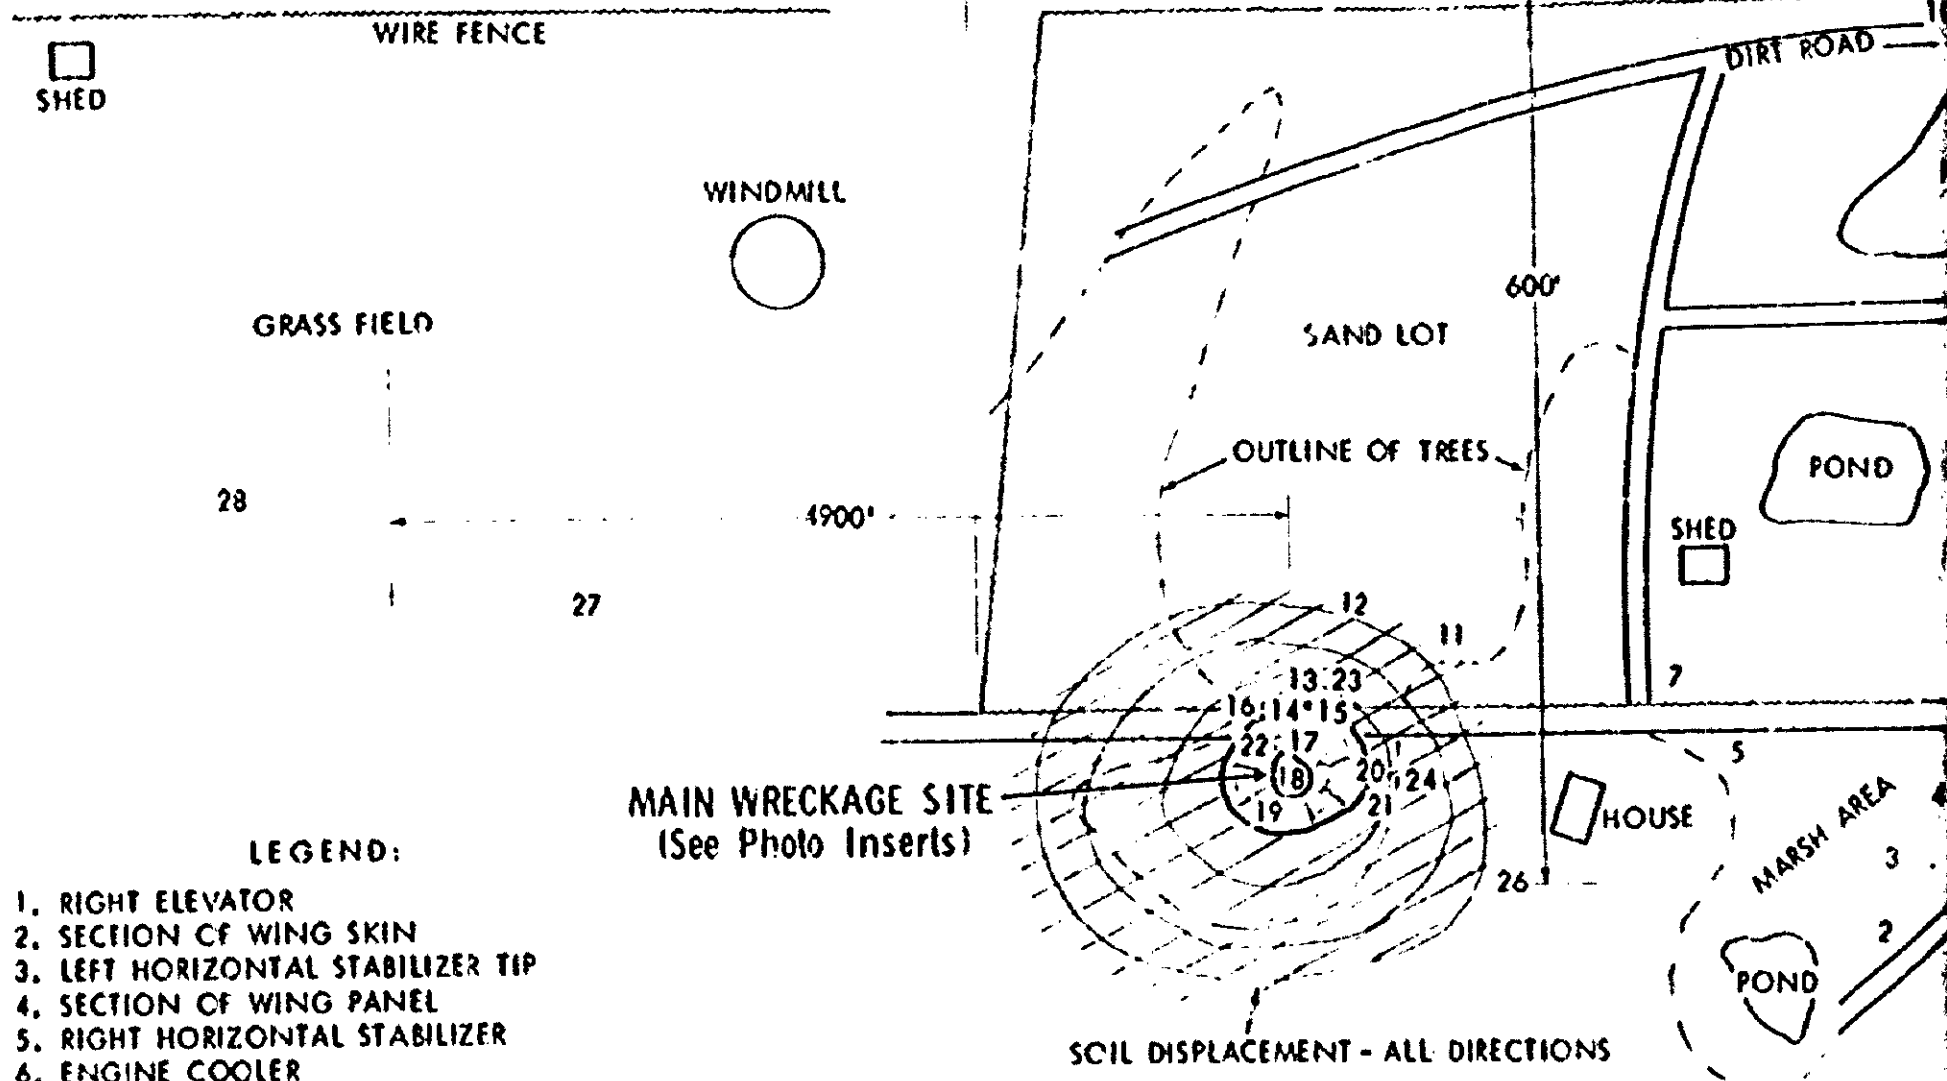
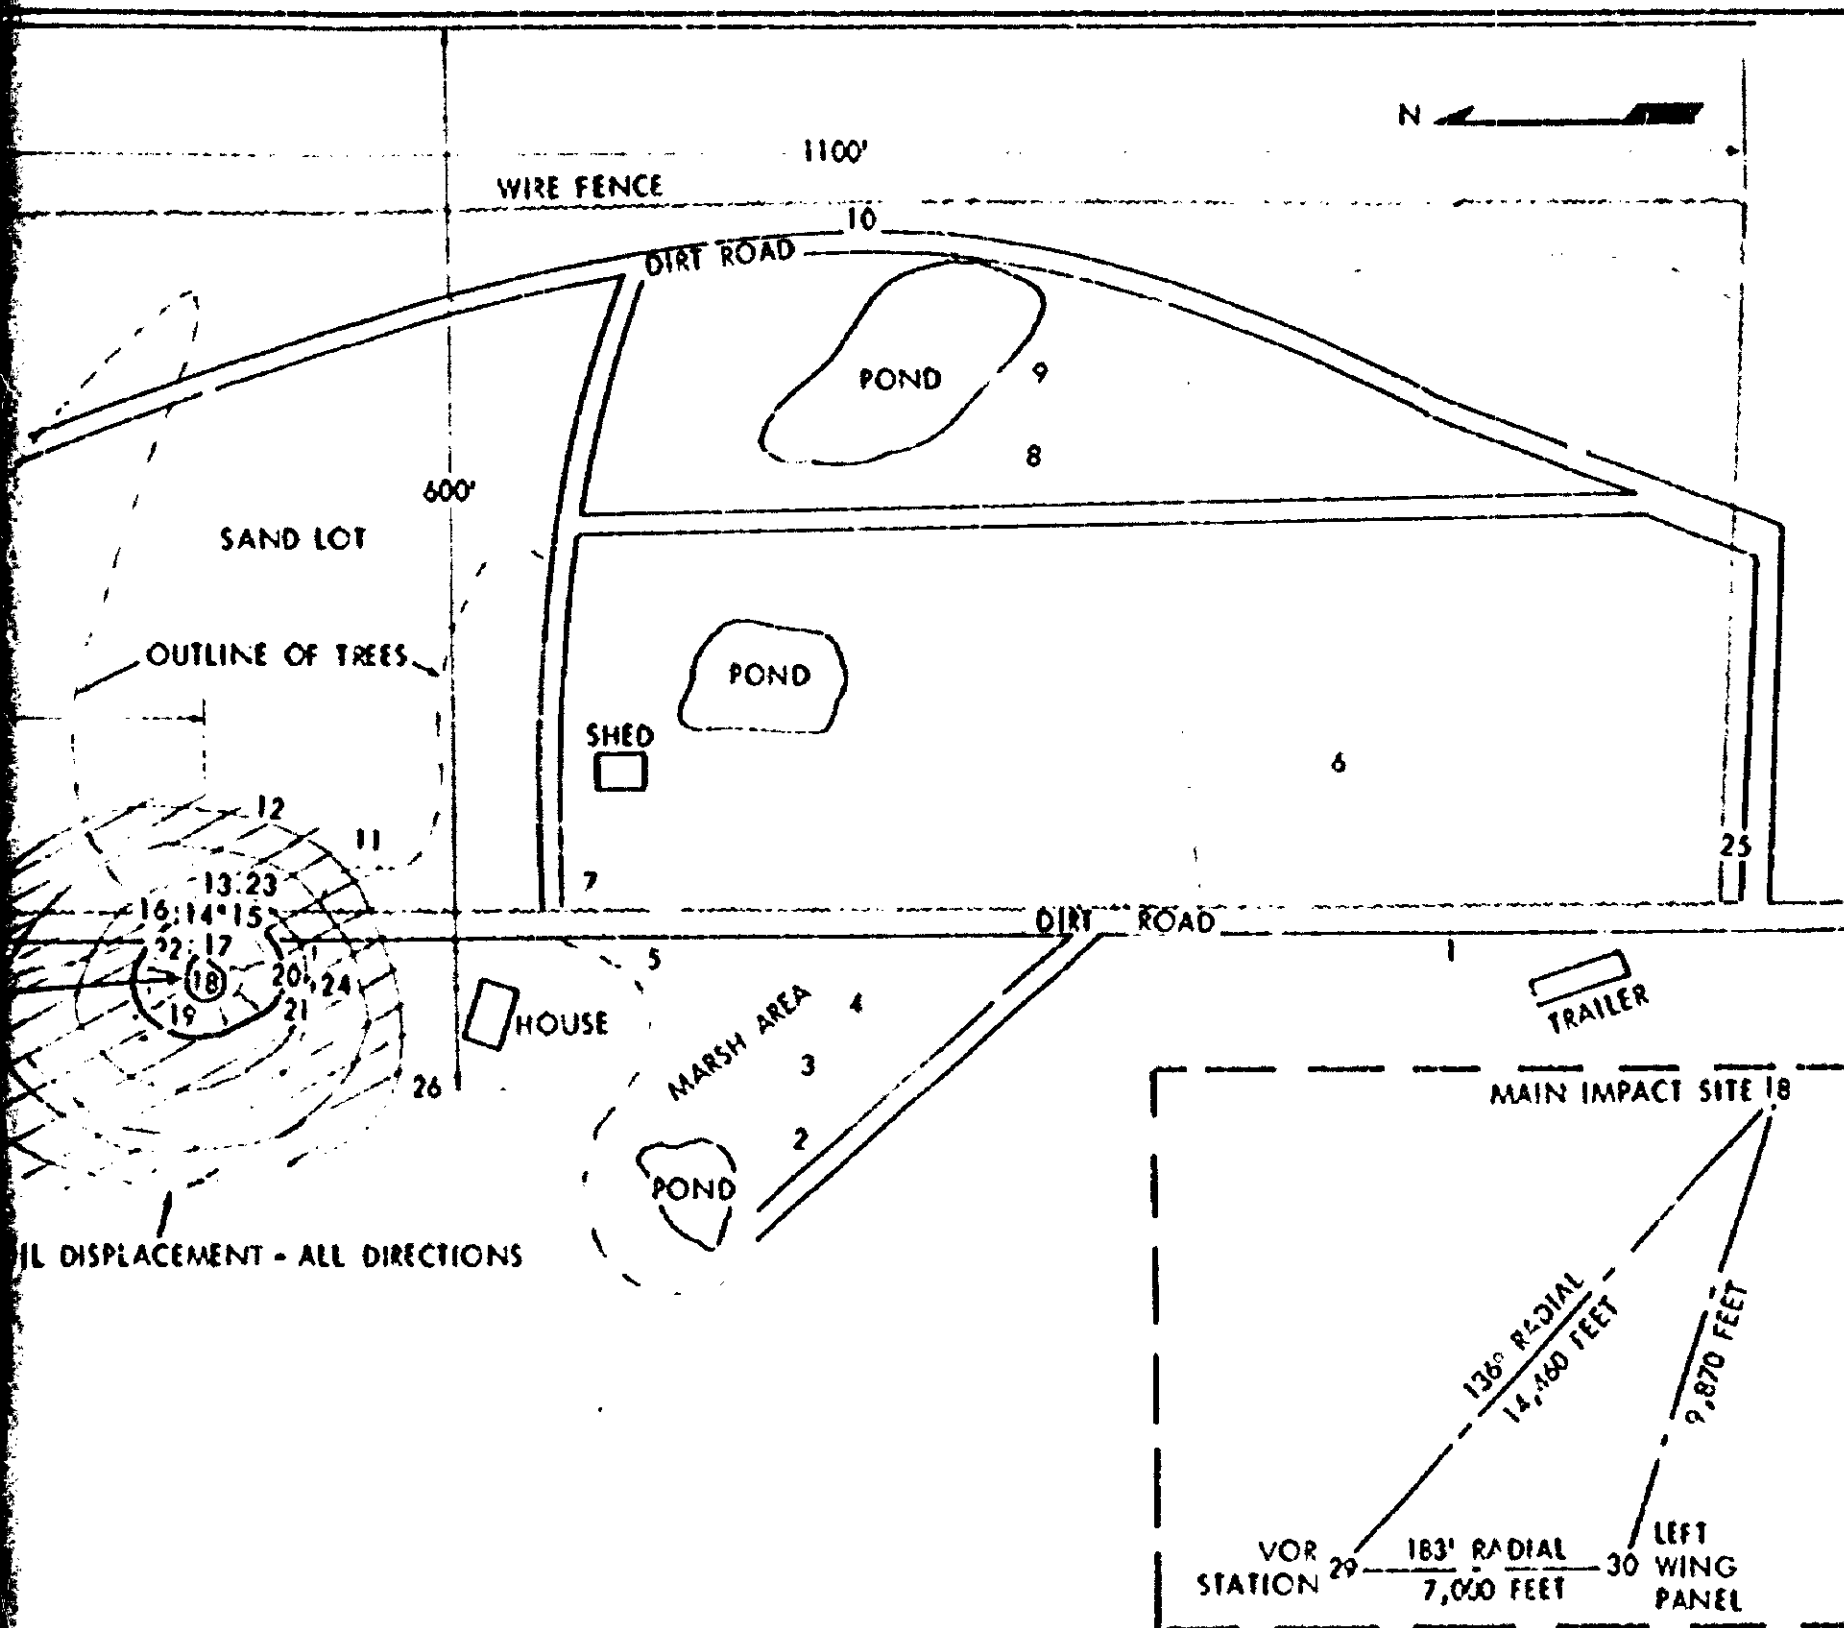
WRECKAGE DISTRIBUTION CHART  
SATURN AIRWAYS INC.  
LOCKHEED MODEL L-382  
N14ST/S/N 4225 DCA 74-A-21  
NEAR SPRINGFIELD ILLINOIS  
MAY 23, 1974

The left outer wing panel separated from the aircraft in the vicinity of the inboard rib which supported the No. 1 engine (about outer wing station 162). The panel, including the No. 1 engine and propeller assembly, was found inverted about 1.2 statute miles on a true bearing of 182° from the CAP. Investigation disclosed that the wing panel had failed in an upward or positive direction. The lower front spar cap was severed by a fracture which was dirty, contained many crack arrest marks, and displayed evidence of rubbing deformation on the mating surfaces. A crack in the front spar web progressed from the spar fracture upward for 4.9 inches. (See Appendix II.) The crack contained about 116 crack-arrest marks. There was no fire damage.

The right wing panel fragmented and separated from the aircraft in flight near outer wing station 334 (OWS 334). Two main sections of the right outer wing panel were found about 4,900 feet north of the main wreckage. A number of right wing pieces, including leading edge structure, lower wing skin, upper wing skin, and the wing tip, were recovered as far as 2 miles northeast of the main wreckage.

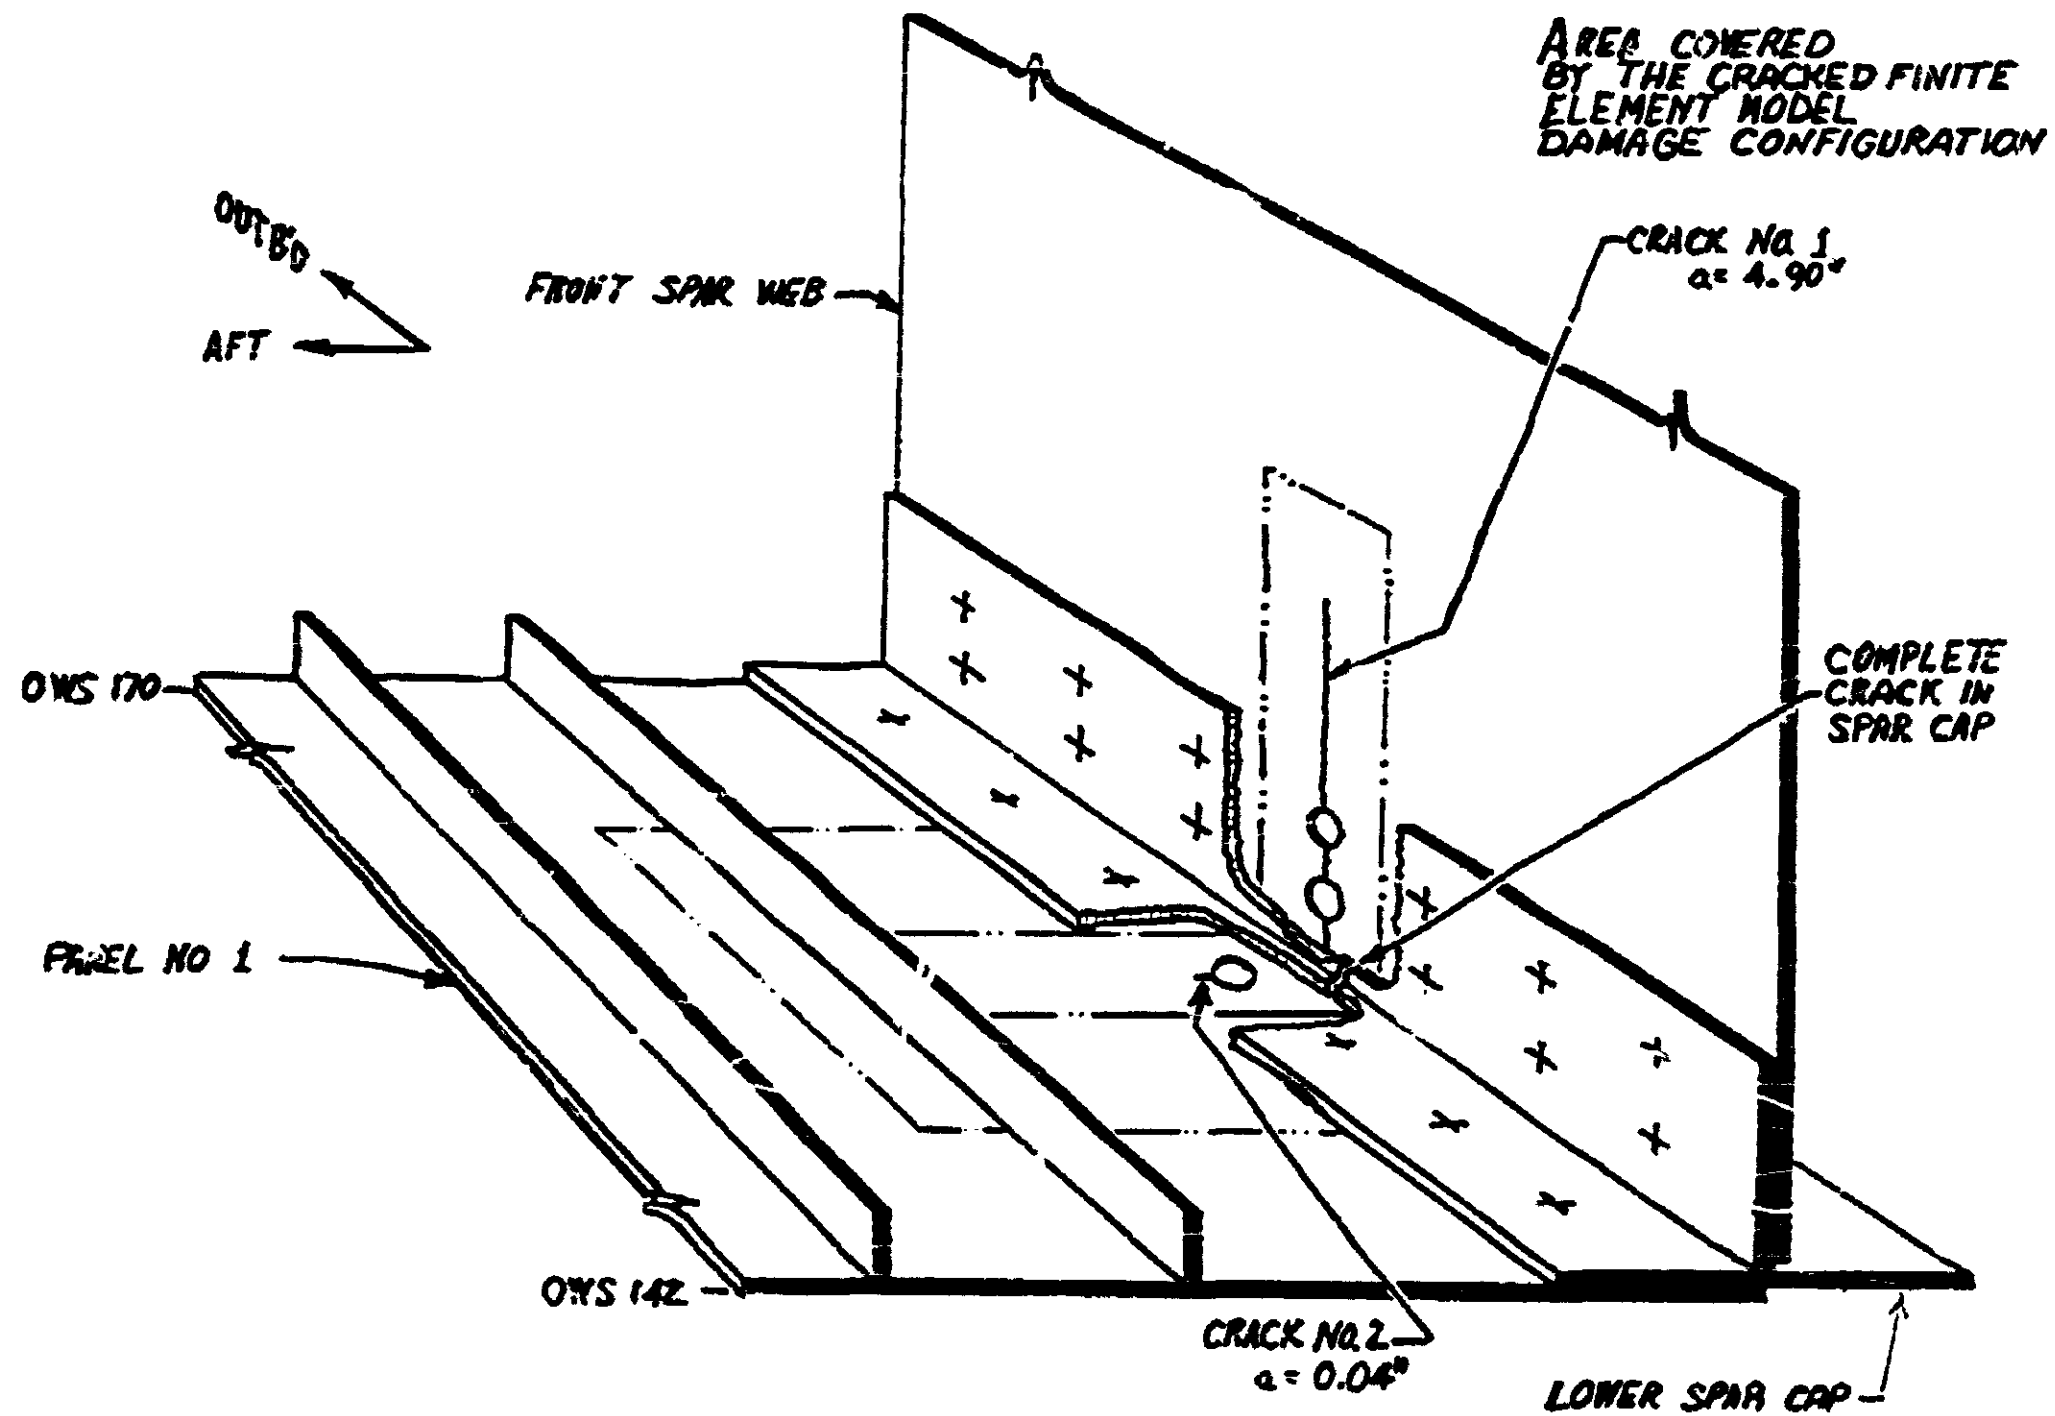
APPENDIX H

Metallurgical examination of the fractured surfaces of the left wing at outer station 162 revealed that the lower front spar cap fractured completely in fatigue. The spar cap was deformed at the primary origin area of the fatigue fracture. Hardness and electrical conductivity of the spar cap material were normal for 7075-T6511 aluminum alloy.

The lower portion of the front spar web contained an approximate 4.9-inch fatigue crack with intermittent tensile tearing.

The lower wing skin fracture stemmed from preexisting fatigue cracks at the first fastener hole which was located 3/4 inch outboard of the primary origin area at which the spar cap failed. Deformation and multiple cracks were noted at the origin of the skin fatigue fracture in the lower wing.

As a result of facts obtained by the Safety Board during its investigation of the crash of Flight 14, the FAA issued Air Worthiness Directive 74-12-06 LOCKHEED: Amendment 39-1867. The directive required that all applicable aircraft be inspected. If cracks were found in the designated inspection areas, repairs were required in accordance with Lockheed Service Bulletin 382-169A, or the later FAA-approved revision, or in an approved equivalent manner. Aircraft on which no cracks were found in the designated areas are required to be inspected at 1,000-hour intervals. Aircraft having the above repair are exempt from the periodic inspections.
