# **NATIONAL TRANSPORTATION SAFETY BOARD**

## **AIRCRAFT ACCIDENT REPORT**

**MIDAIR COLLISION OF  
WINGS WEST AIRLINES BEECH C-99 (N6399U) AND  
AESTHETEC, INC.,  
ROCKWELL COMMANDER 112TC N112SM  
NEAR SAN LUIS OBISPO, CALIFORNIA  
AUGUST 24, 1985**

NTSB / AAR-85 / 07

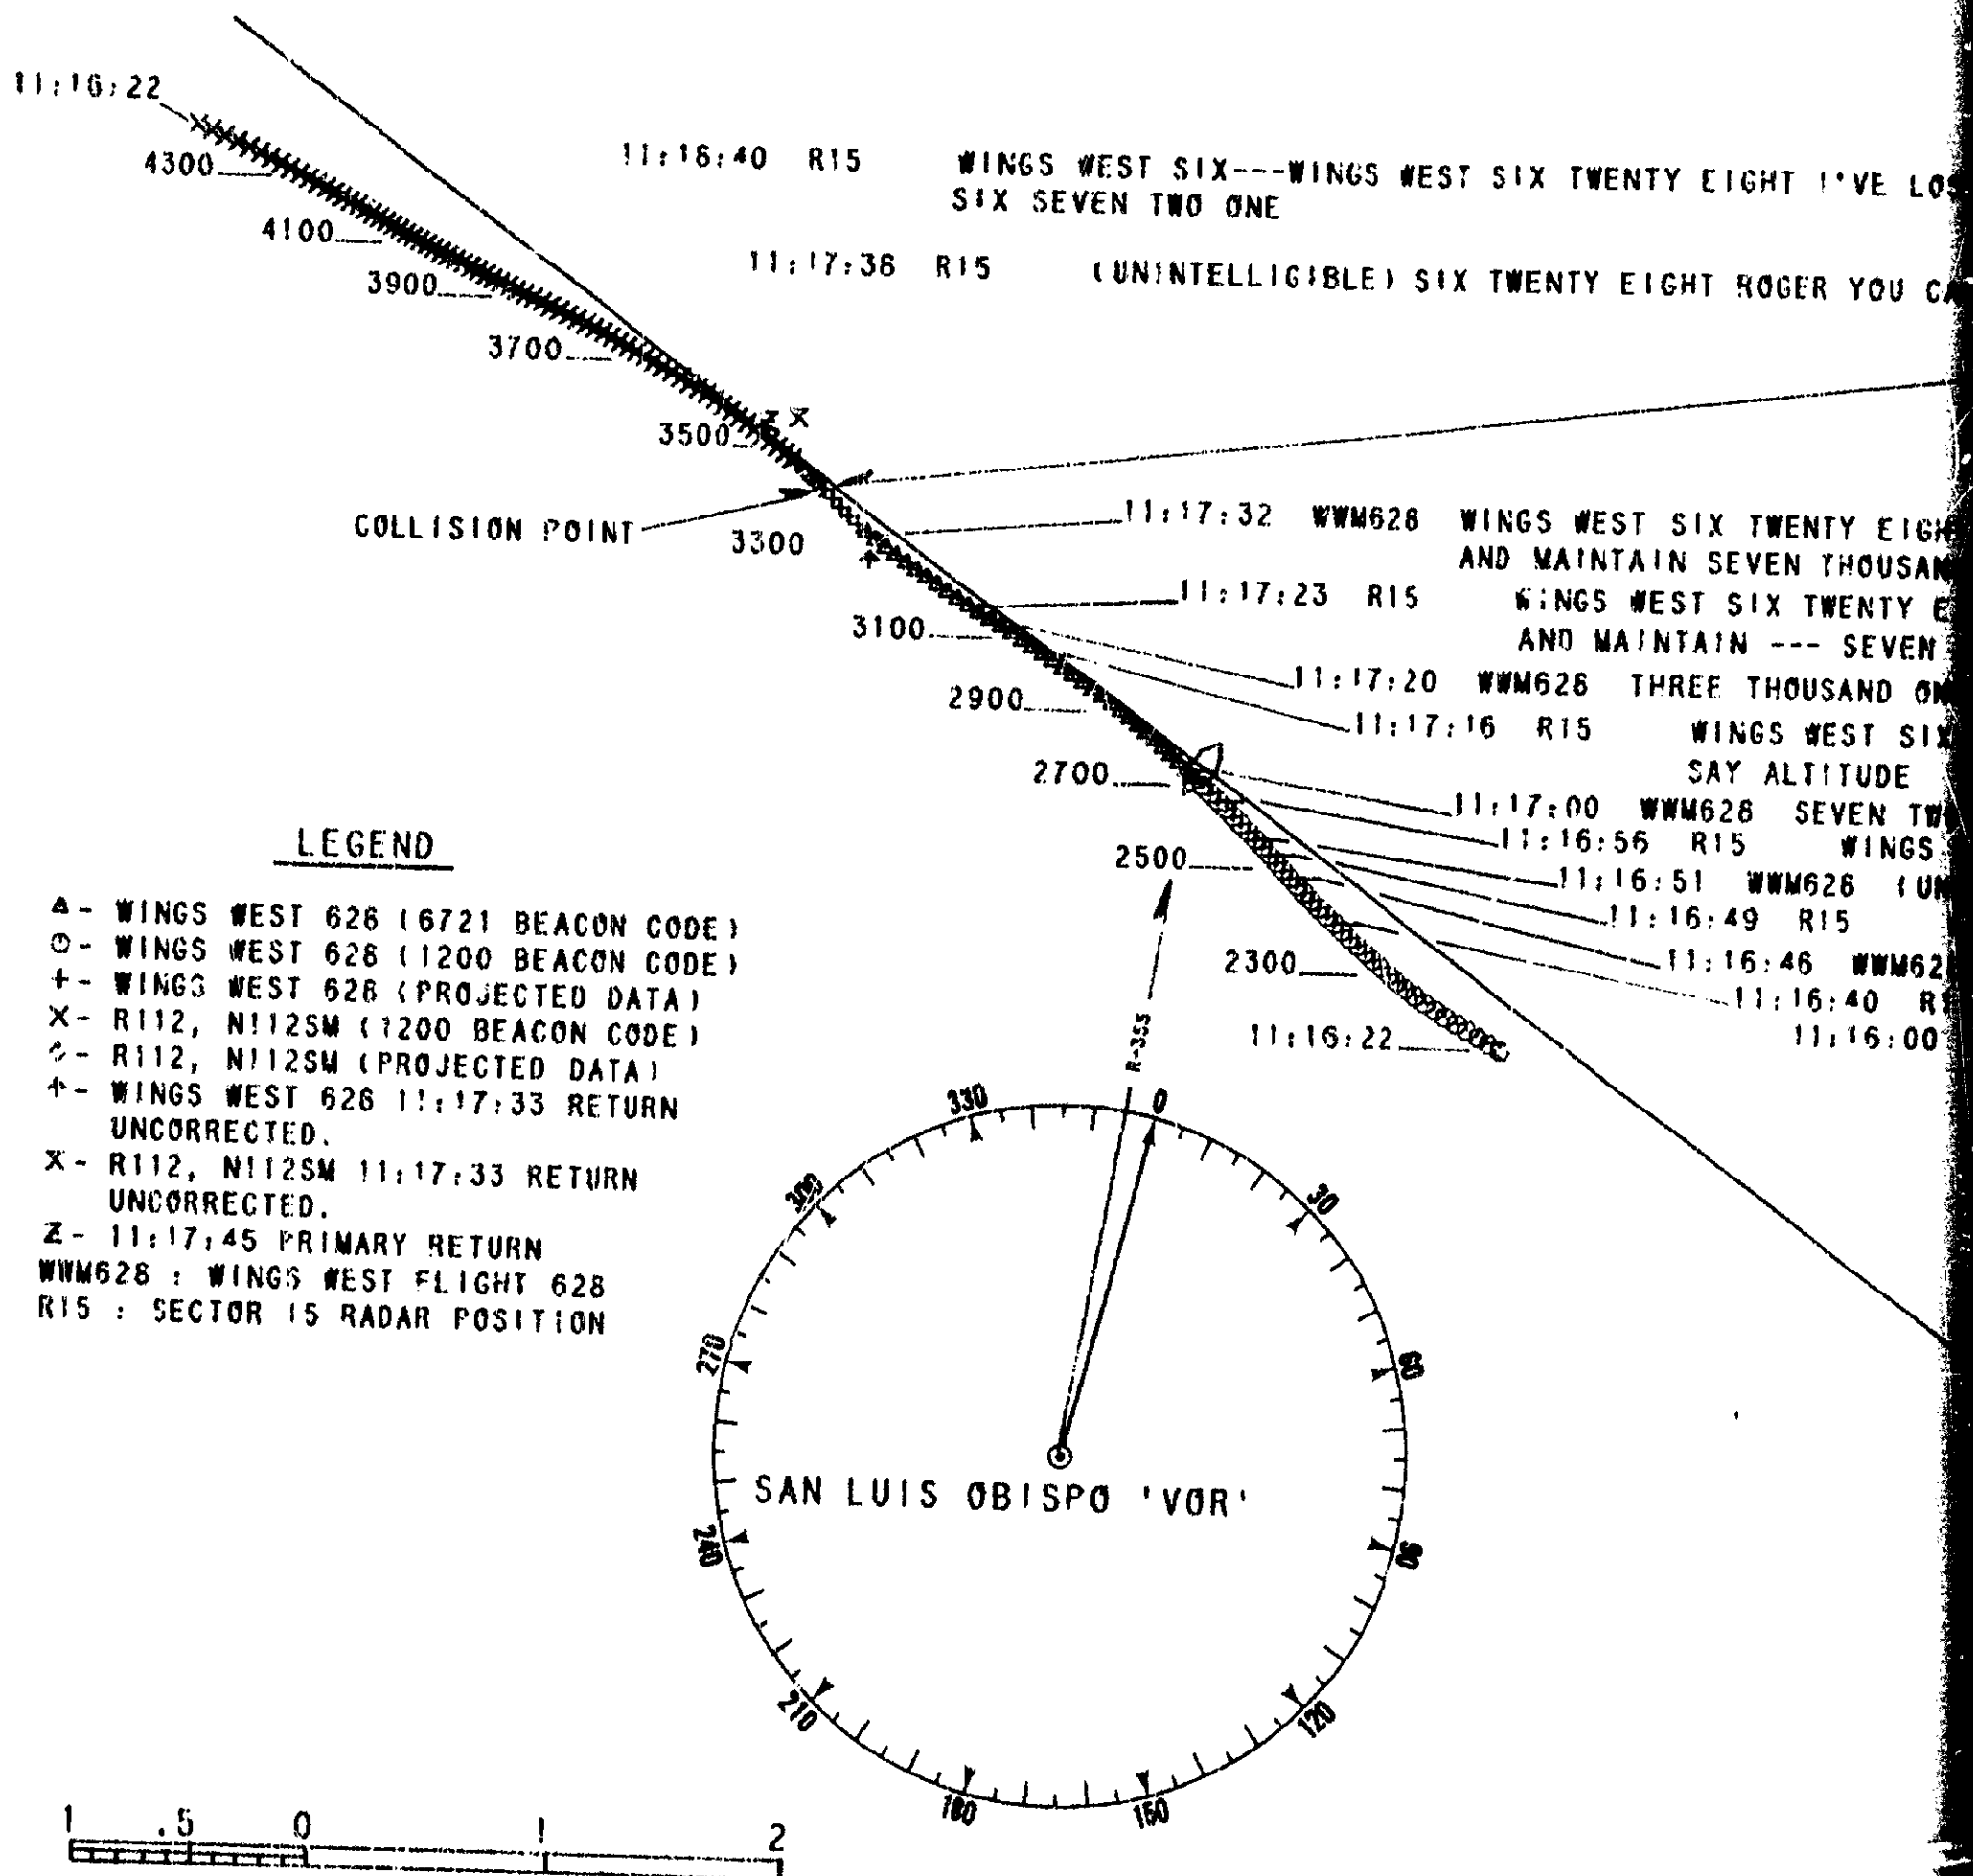
# RADAR GROUND TRACK PLOT MIDAIR COLLISION WINGS WEST FLT. 628 - ROCKWELL SAN LUIS OBISPO, CA. AUGUST 24, 1984

The Safety Board then sought to determine whether the performance of the ATC controllers, or the ATC system itself, either caused or contributed to the accident. The radar ground track plot showed that the accident occurred at 1117:38 and that Flight 628's radar return (initially as a 1200 code) was not displayed until 1116:22. The evidence showed that the developmental controller initially communicated with Flight 628 at 1116:40. At 1116:56, he assigned a discrete transponder code to the flight, and, at 1117:16, 22 seconds before the collision, he told Flight 628 that he had it "in radar contact." Thereafter, he read the flight's IFR clearance to it and listened to the readback. At 1116:22, the airplanes were about 6.9 nmi apart and the Rockwell was almost directly in front of Flight 628. Between 1116:22 and the collision, the airplanes closed on each other at about 544 fps and, except for the Rockwell Commander's slight right turn, their headings remained the same.

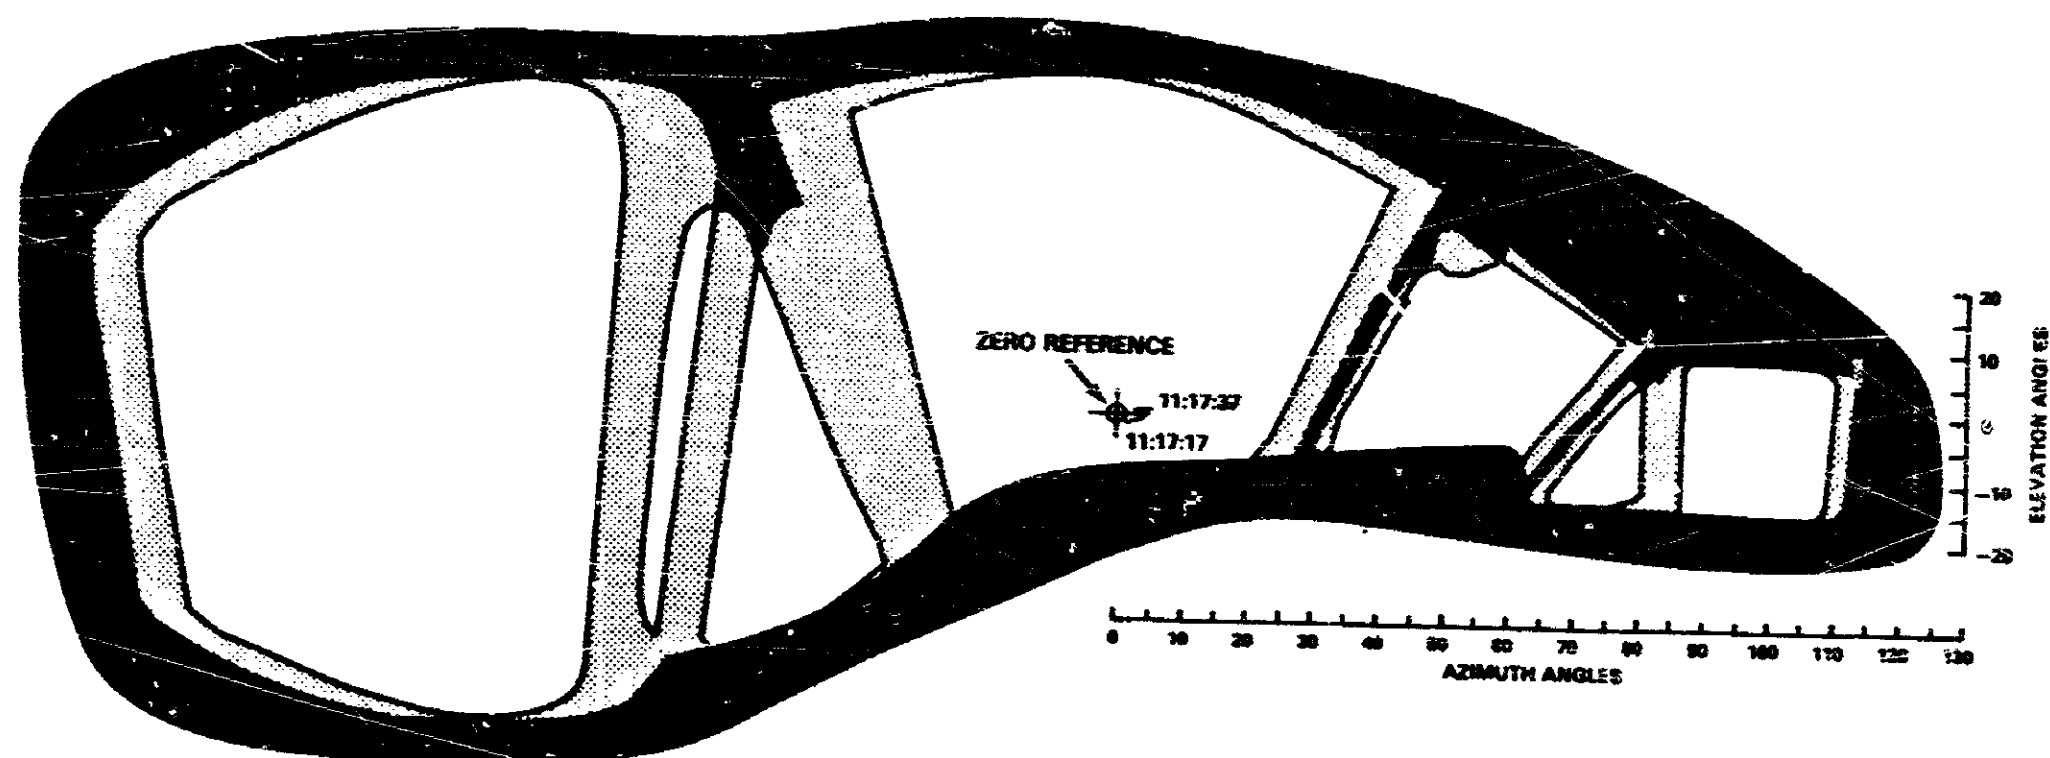
Captain

BEECHCRAFT MODEL 90  
CAMERA ATTITUDE - NORMAL  
PILOT'S EYE POSITION  
41 1/2 INCHES ABOVE FLOOR  
5 INCHES AFT REAR MOST COLUMN MOVEMENT

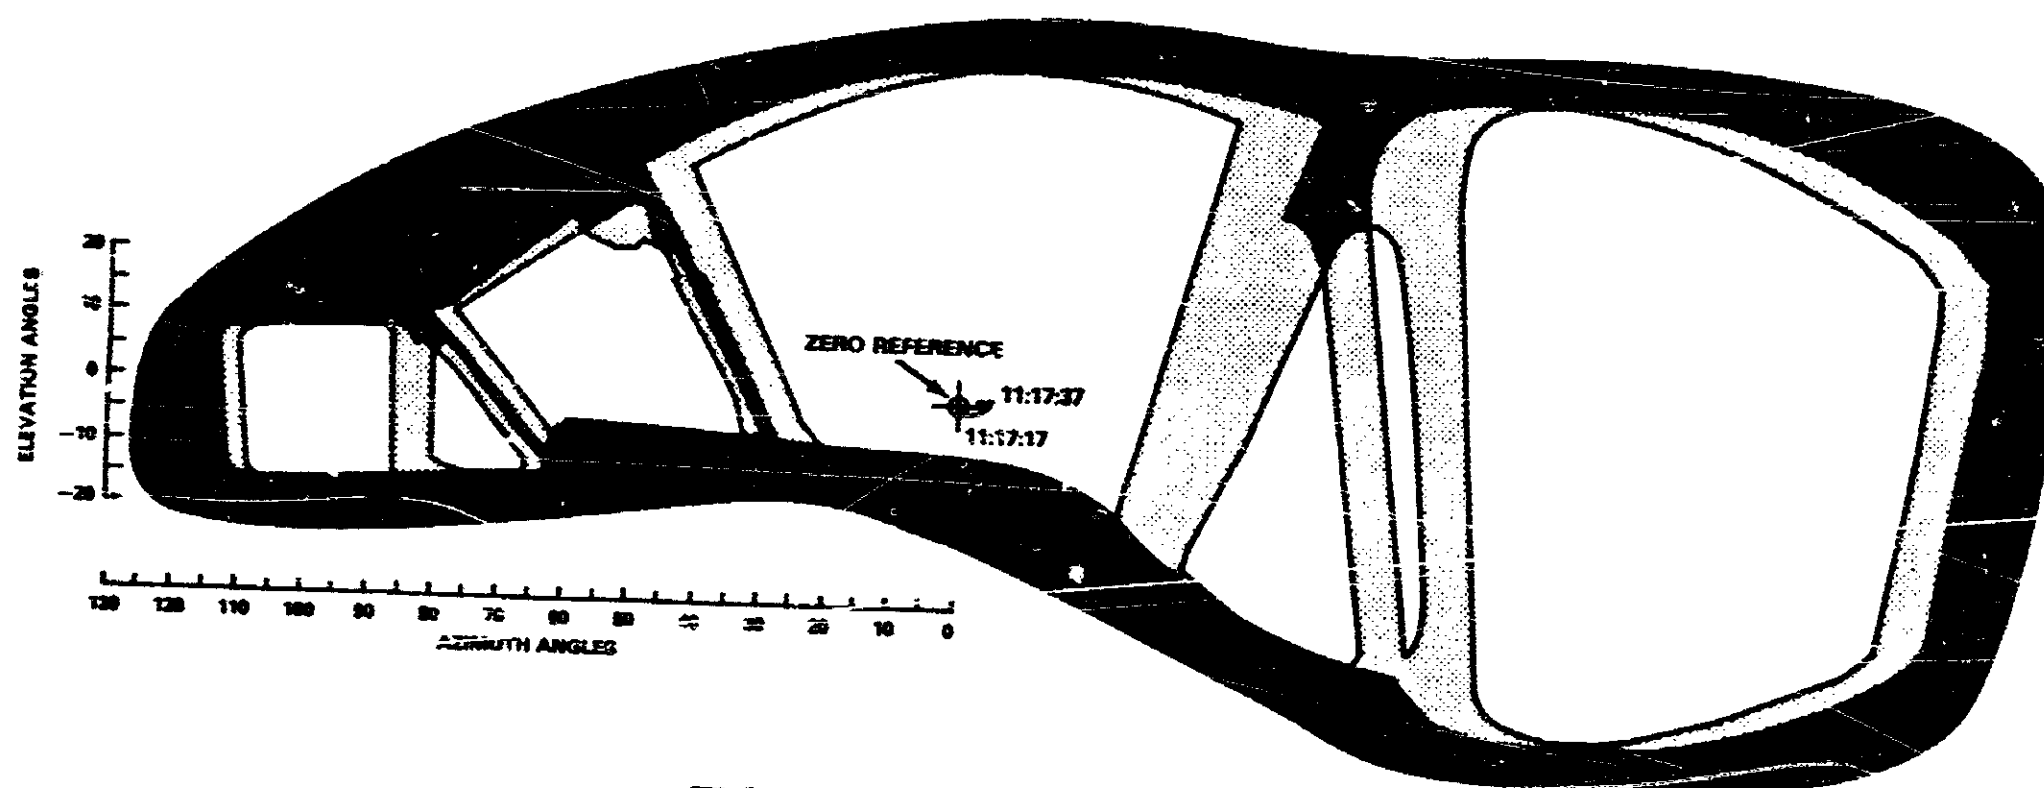
First Officer

BEECHCRAFT MODEL 99  
CAMERA ATTITUDE - NORMAL  
COPILOT'S EYE POSITION  
41 1/2 INCHES ABOVE FLOOR  
5 INCHES AFT REAR MOST COLUMN MOVEMENT

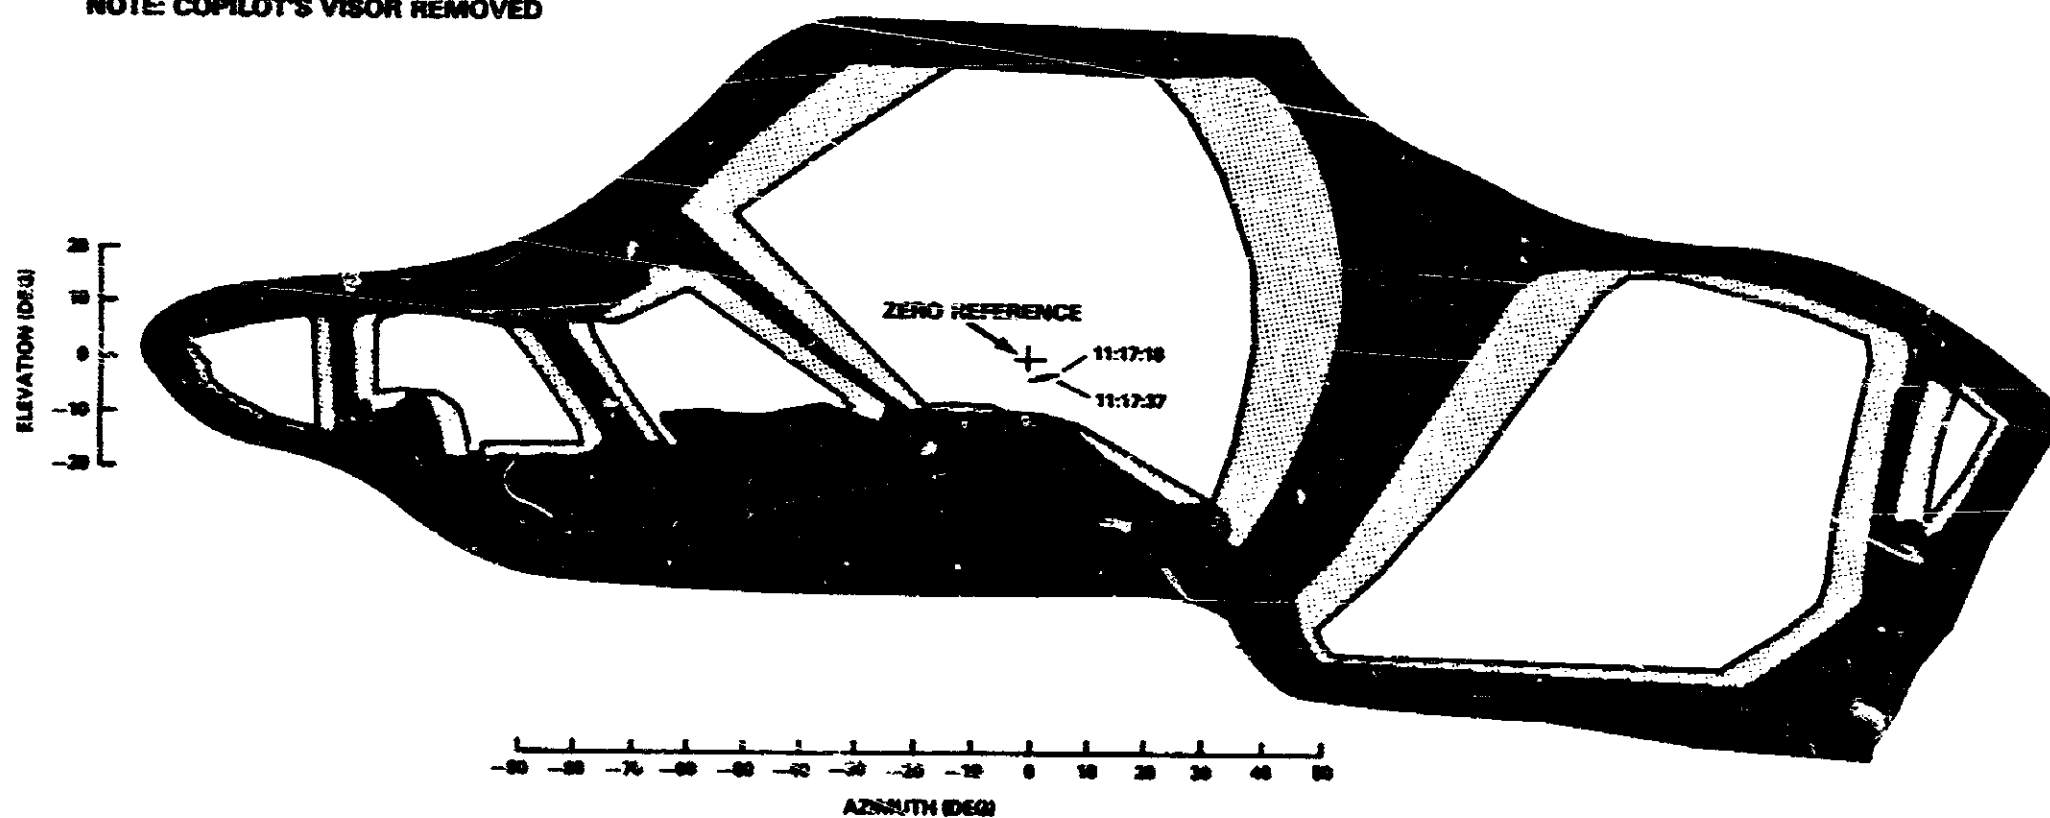
**Instructor**

ROCKWELL COMMANDER 112/114  
 COPILOT'S EYE POSITION  
 42 1/2 INCHES ABOVE FLOOR  
 2 INCHES AFT REARMOST COLUMN MOVEMENT  
 NOTE: COPILOT'S VISOR REMOVED

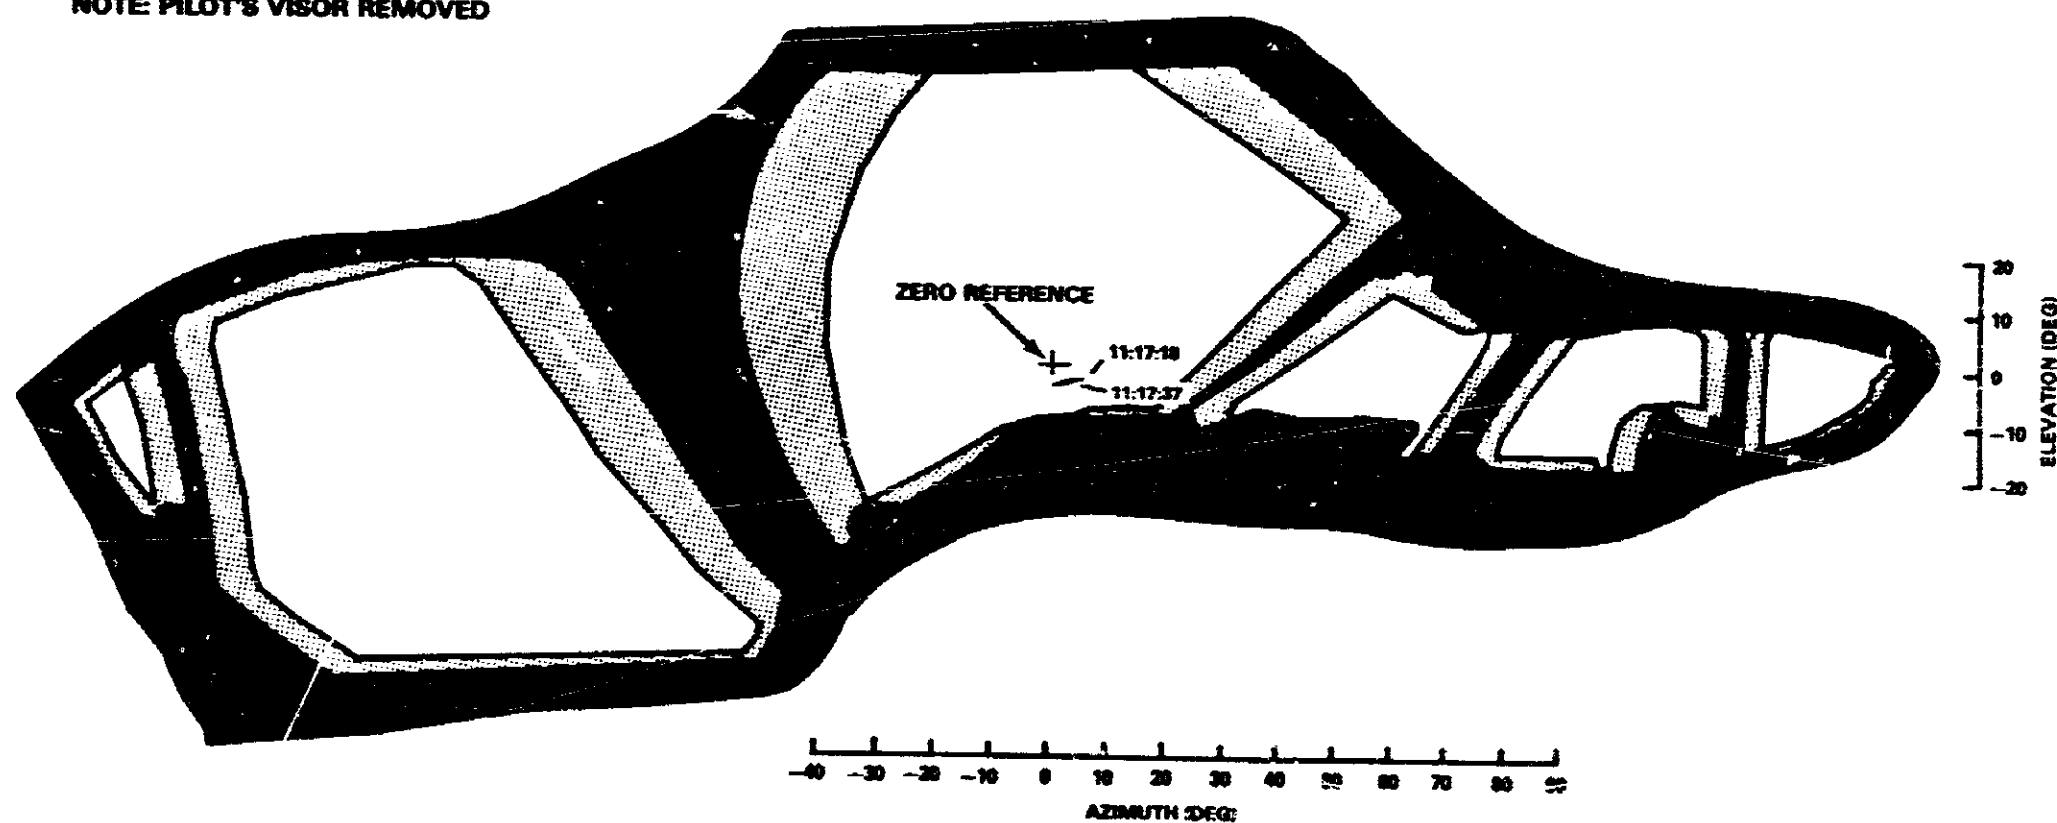
Pilot

ROCKWELL COMMANDER 112/114  
 PILOT'S EYE POSITION  
 42 1/2 INCHES ABOVE FLOOR  
 2 INCHES AFT REARMOST COLUMN MOVEMENT  
 NOTE: PILOT'S VISOR REMOVED
