| Matrícula | <b>EC-JCQ</b> |
| Tipo y modelo | <b>TECNAM P2002-JF</b> |

## **1. INFORMACIÓN SOBRE LOS HECHOS**

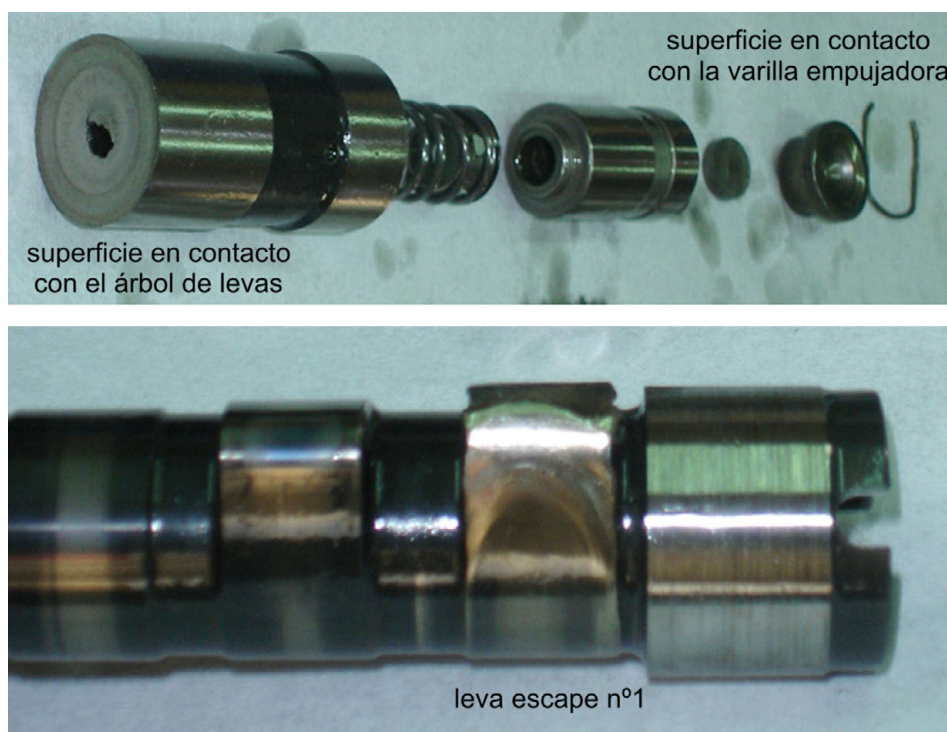
- El cigüeñal no giraba y presentaba marcas de rozamiento en las muñequillas.
- El taqué hidráulico de la válvula de escape del cilindro número 1 estaba atascado. Al extraerlo se encontró una perforación en la superficie de contacto del taqué con la leva (figura 1).

- El árbol de levas presentaba pérdida de material y desgaste en la leva correspondiente a la válvula de escape del cilindro número 1 cuyo taqué estaba perforado (figura 1).

Figura 1. Taqué hidráulico y leva del árbol de levas de la válvula de escape del cilindro n.º 1

Los análisis mecánicos y metalográficos realizados a los taqués mostraron valores de dureza superiores al mínimo de diseño en todos los taqués a excepción del perforado, en el cual se obtuvo un valor entre 53-54 HRC inferior al mínimo de 55 HRC. Este valor, según el fabricante, no es concluyente ya que, debido a la perforación que presentaba el taqué, no se pudo realizar en el lugar en el que determina el procedimiento (a 1,54 mm del centro).

Respecto a la leva del árbol de levas correspondiente al escape del cilindro número 1, que también presentaba una evidente pérdida de material, el análisis de dureza mostró que tenía un valor de 724 HV10, lo que cumplía con las características mínimas de diseño de 680 HV10.

Se considera que la pérdida de potencia causante del incidente de la aeronave EC-JCQ fue debida al fallo de la válvula de escape del cilindro número 1 por una mala transmisión del movimiento desde el árbol de levas hasta la varilla empujadora a través del taqué hidráulico y que impidieron una correcta apertura y cierre de la válvula asociada. El origen de estos problemas de funcionamiento se encuentra, según el fabricante, en un excesivo rozamiento y calentamiento entre ambas piezas producido por una excesiva rugosidad en el taqué y por la lubricación.
