FINAL REPORT

97-75/A-26

PH-TKC

Final report of the investigation into the probable cause of the accident with Transavia Boeing 757, registration PH-TKC, on December 24th, 1997 at Amsterdam Airport Schiphol.

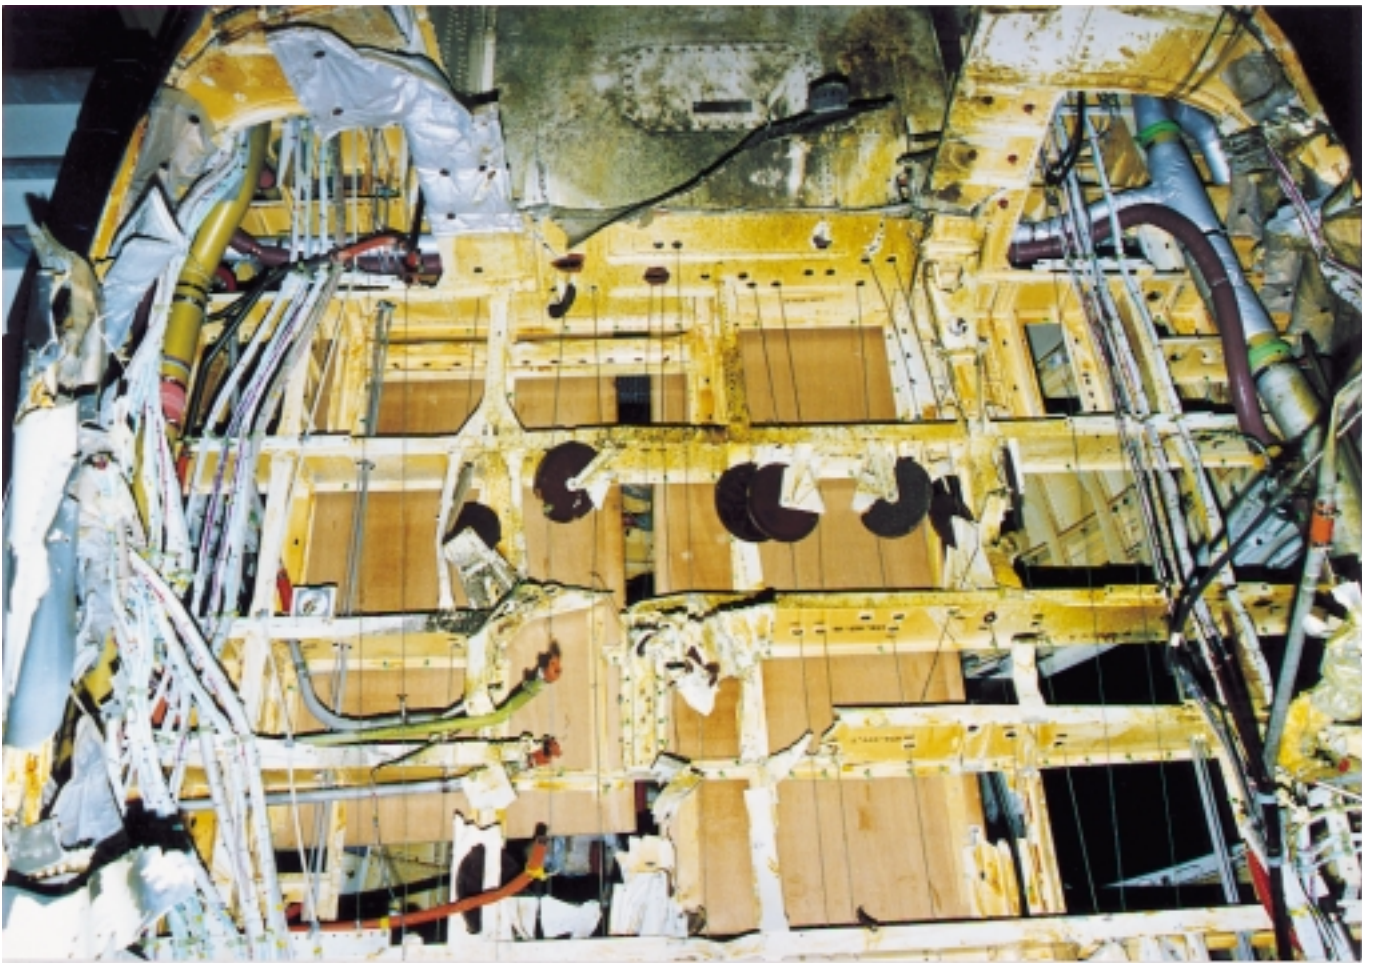
The aircraft sustained severe damage to the nose section, main undercarriage, engines and engine nacelles. In addition, as a result of the collapse of the nosewheel doghouse various engine and flight control cables located behind the nose gear well structure were ruptured. In the same area components of electric/electronic systems were damaged. Refer to the Boeing Field report in Appendix 3.1.

DAMAGE TO CONTROL CABLES

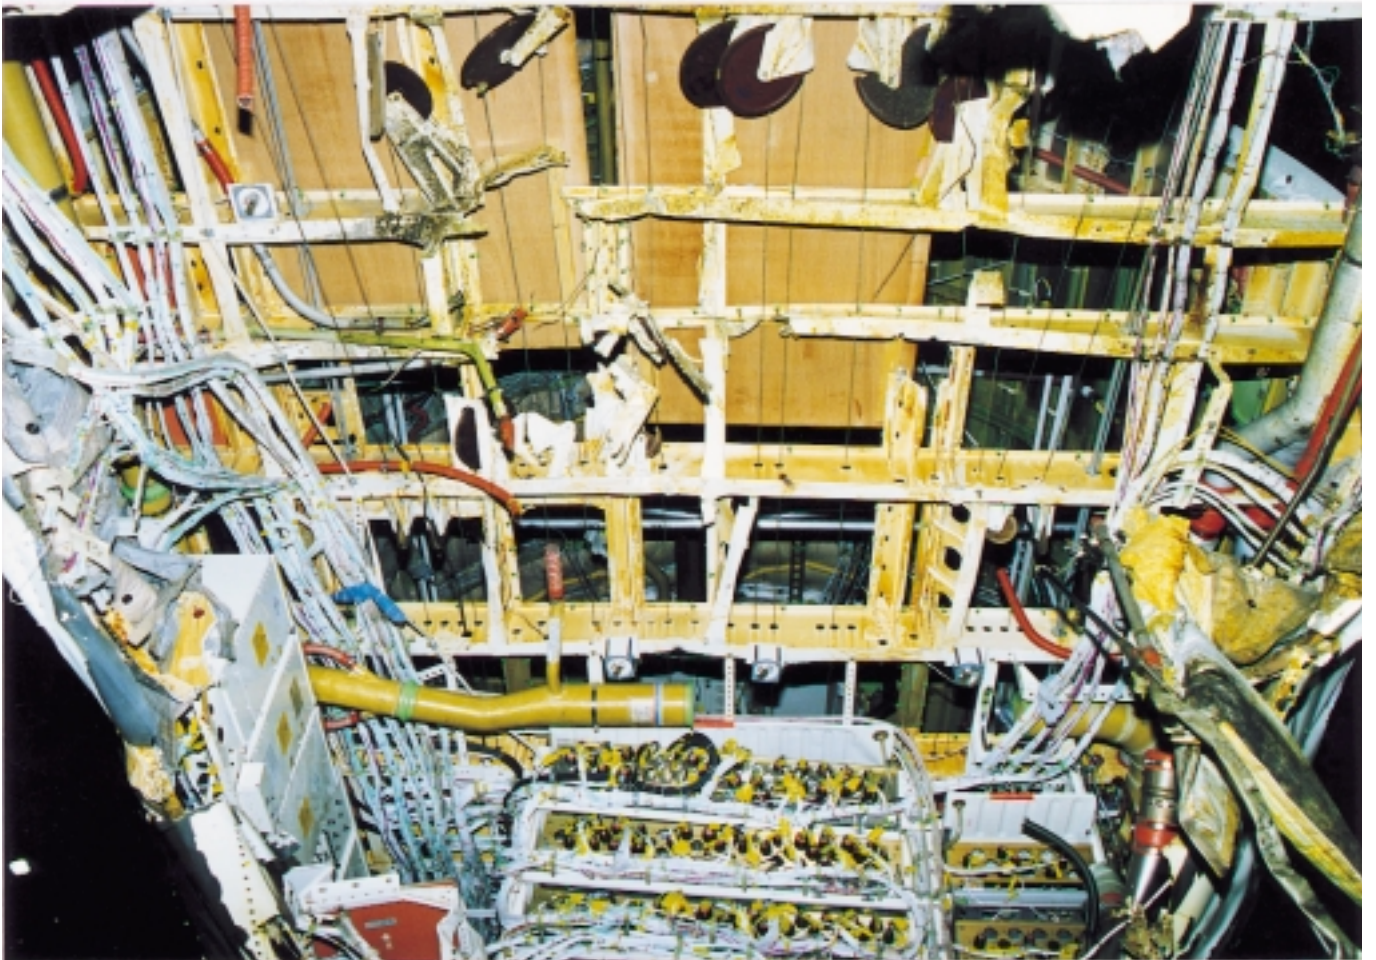
The DFDR stopped at the moment of nose wheel collapse, due to damage to the electronic compartment by the rearward movement of the nose wheel doghouse.

DAMAGE TO ELECTRONIC COMPARTMENT

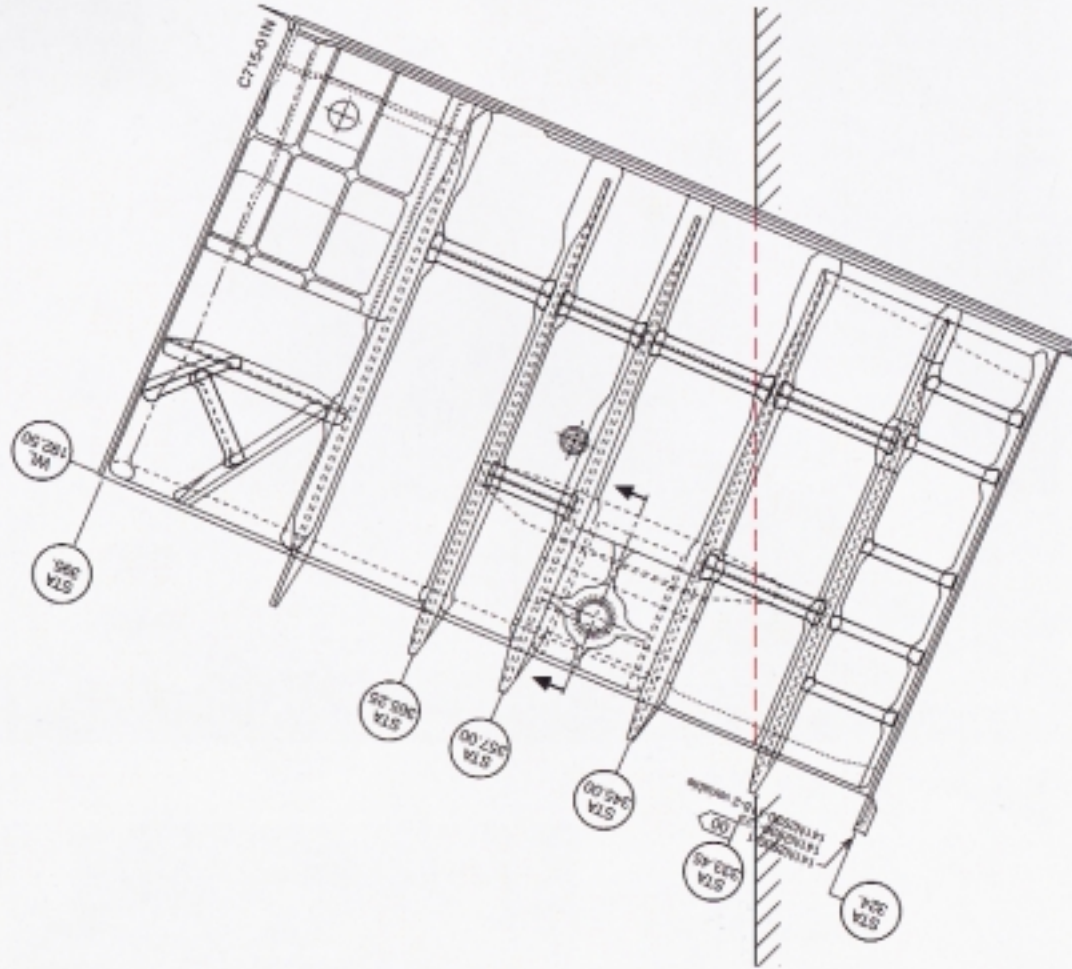
of the aft doghouse to displace in upward direction. The increased load on the STA 324 bulkhead resulted in deformation and fracture. After the aft doghouse separated from the STA 324 bulkhead the aft doghouse rotated aft, thereby bending and twisting the STA 395 frame which ultimately resulted in fracture and complete separation of the aft doghouse.

Fig. 4 Schematic of the aft doghouse in final position

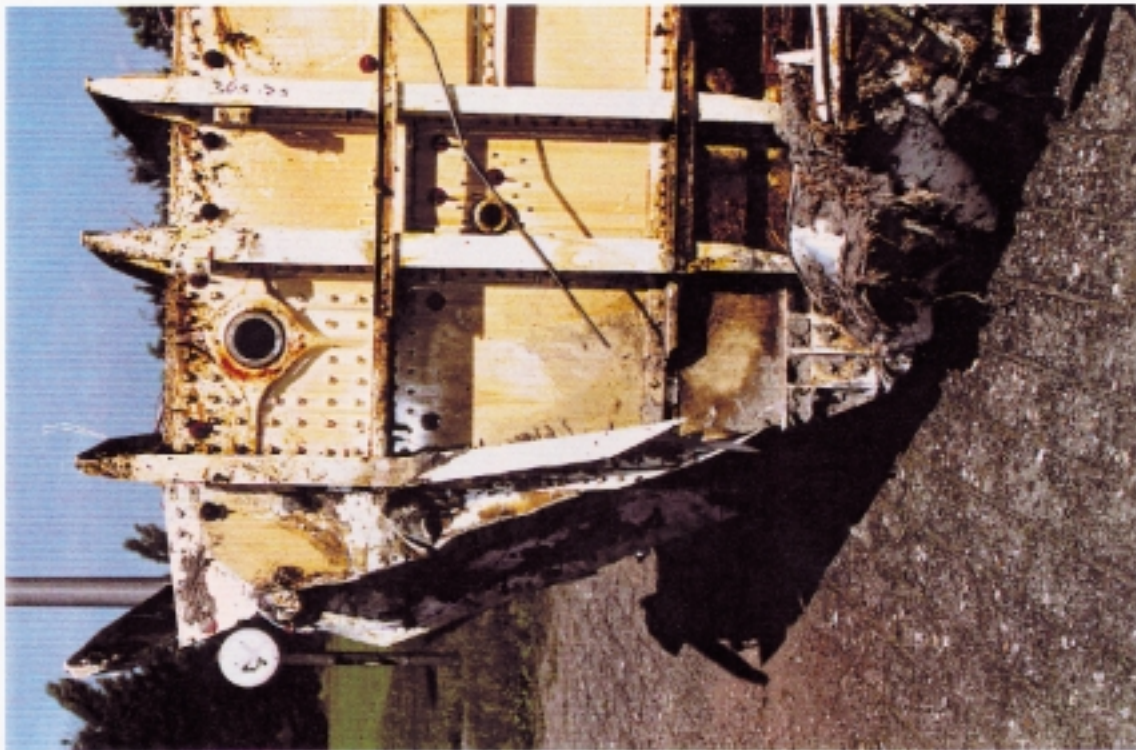
The NLR conducted an investigation into the breakaway sequence of the nosegear wheel well (Appendix 3.2). Inspection showed that the aft part of the nosegear wheel well (doghouse) was broken loose from the surrounding structure.

Fig. 3 Side view of the aft doghouse

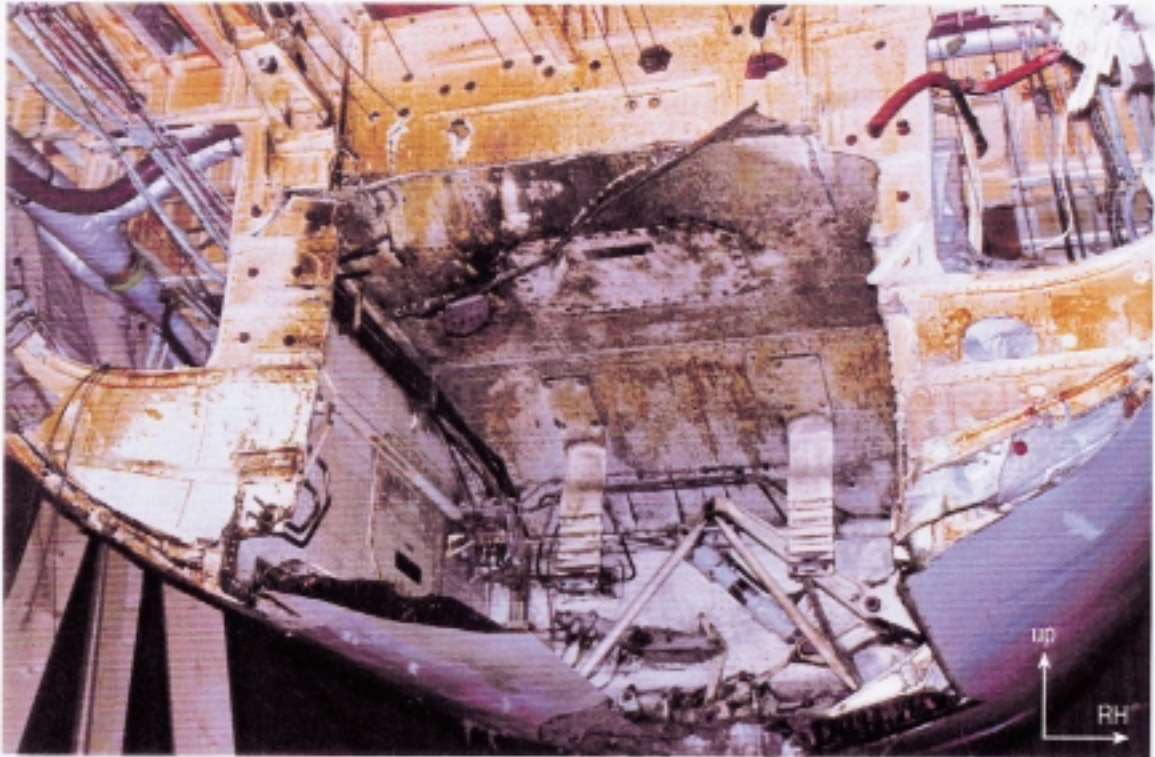
Fig. 5 Lower part of the STA 324 bulkhead

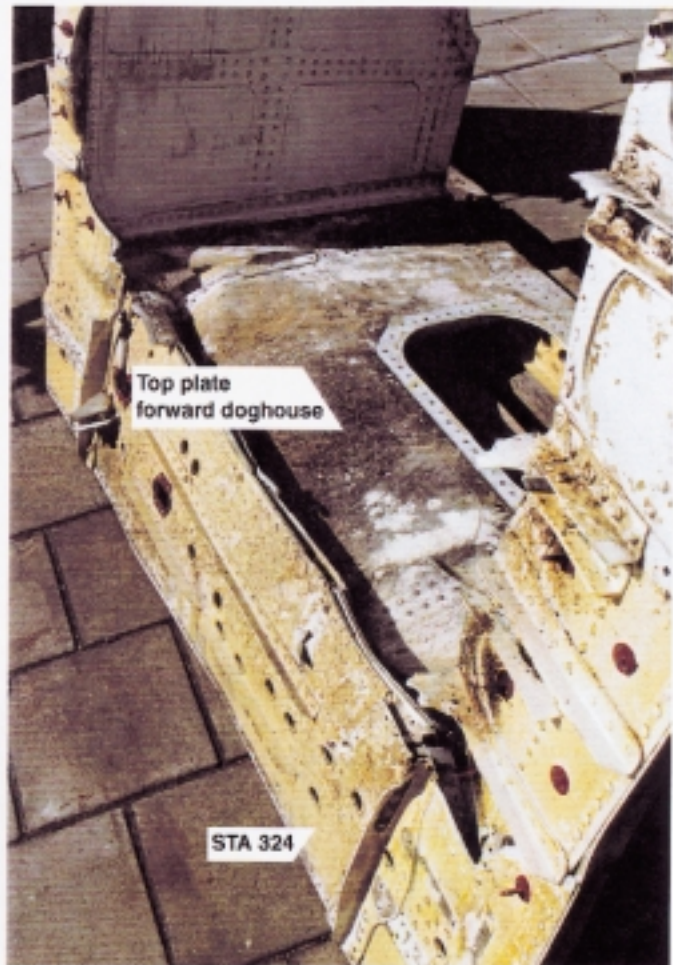
Fig. 6 Aft part of the forward doghouse
and part of the STA 324 bulkhead
(upside down position)

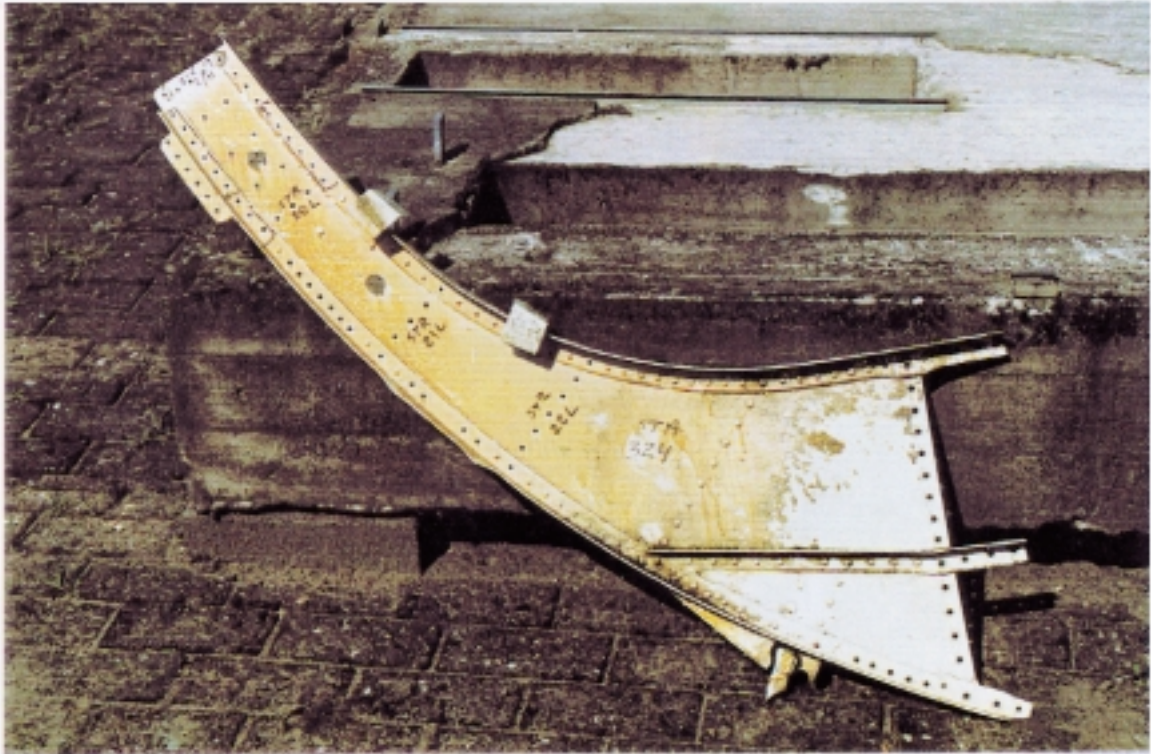
Macro-examination of the fracture surfaces of the STA 324 and 395 bulkheads showed no indications of pre-existing cracks. Macroscopic features indicated overload as the fracture mechanism.

Fig. 7 Section of the STA 324 bulkhead (LH-side)

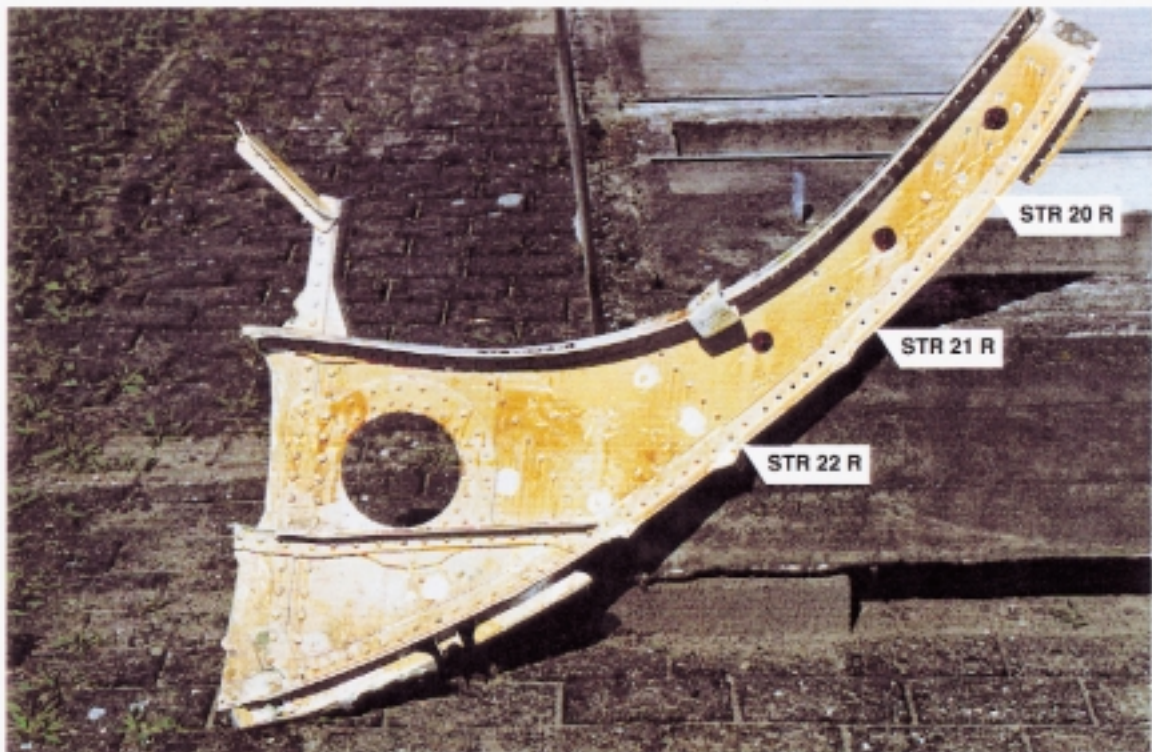
Fig. 8 Section of the STA 324 bulkhead (RH-side)

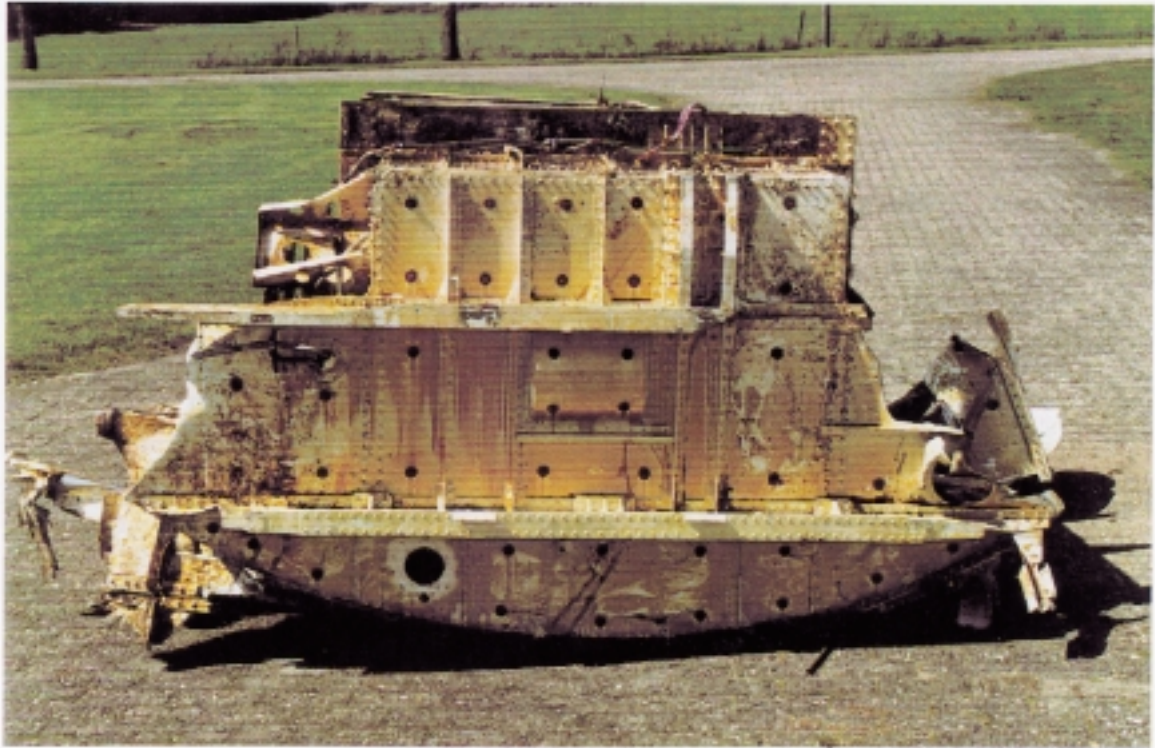
Fig. 9 Aft side of the aft doghouse

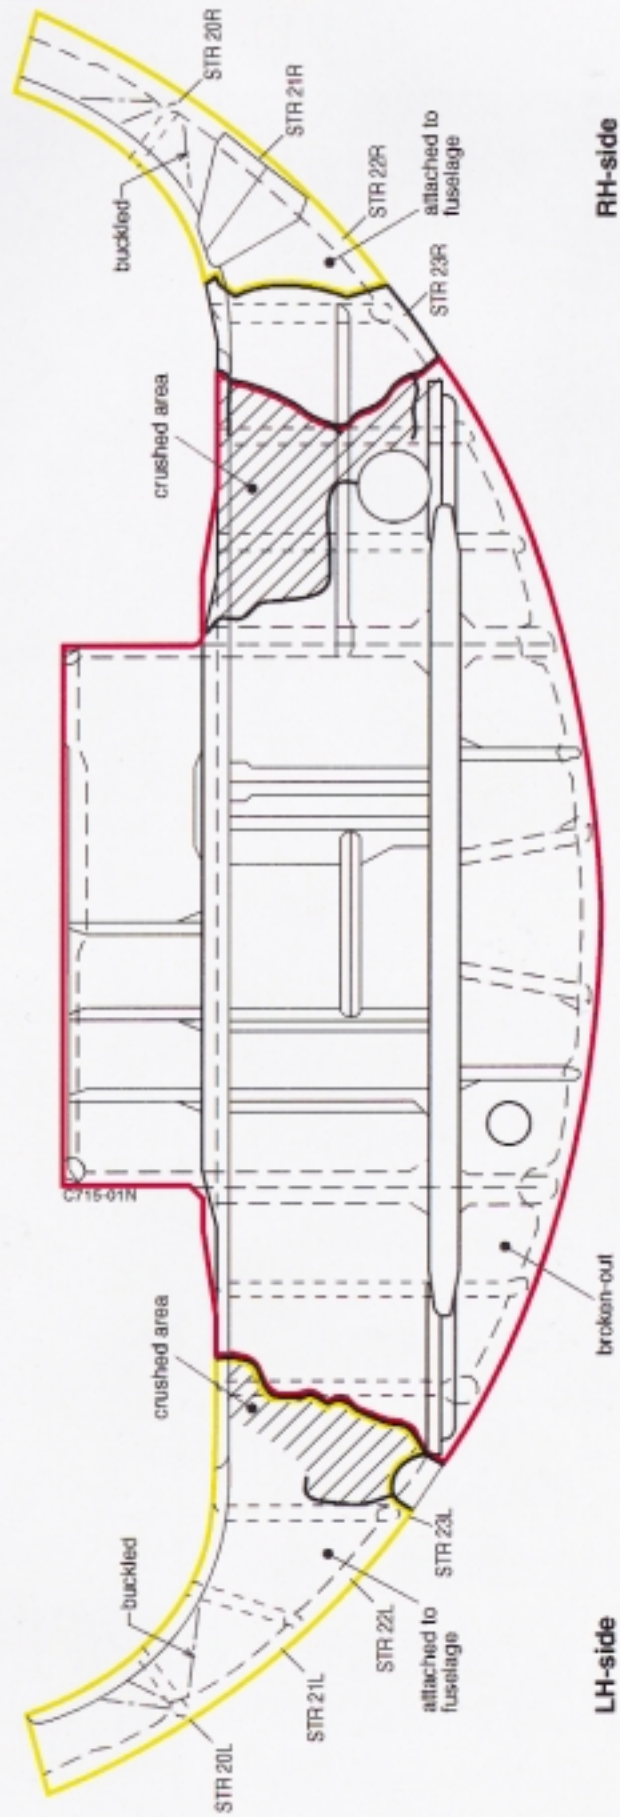
The failure started with the buckling of the STA 395 frame, which enabled the aft side

Fig. 10 Schematic of the lower STA 395 bulkhead with web fracture locations indicated

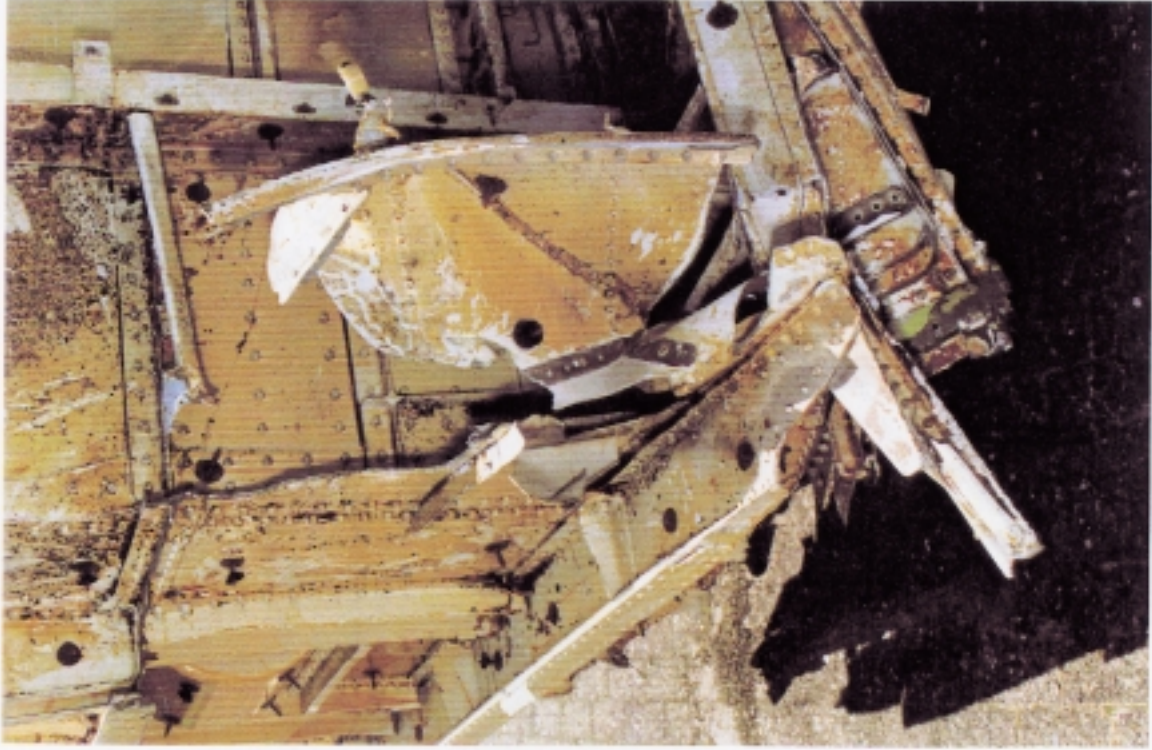
Fig. 12 Detail of the STA 395 bulkhead (RH-side)

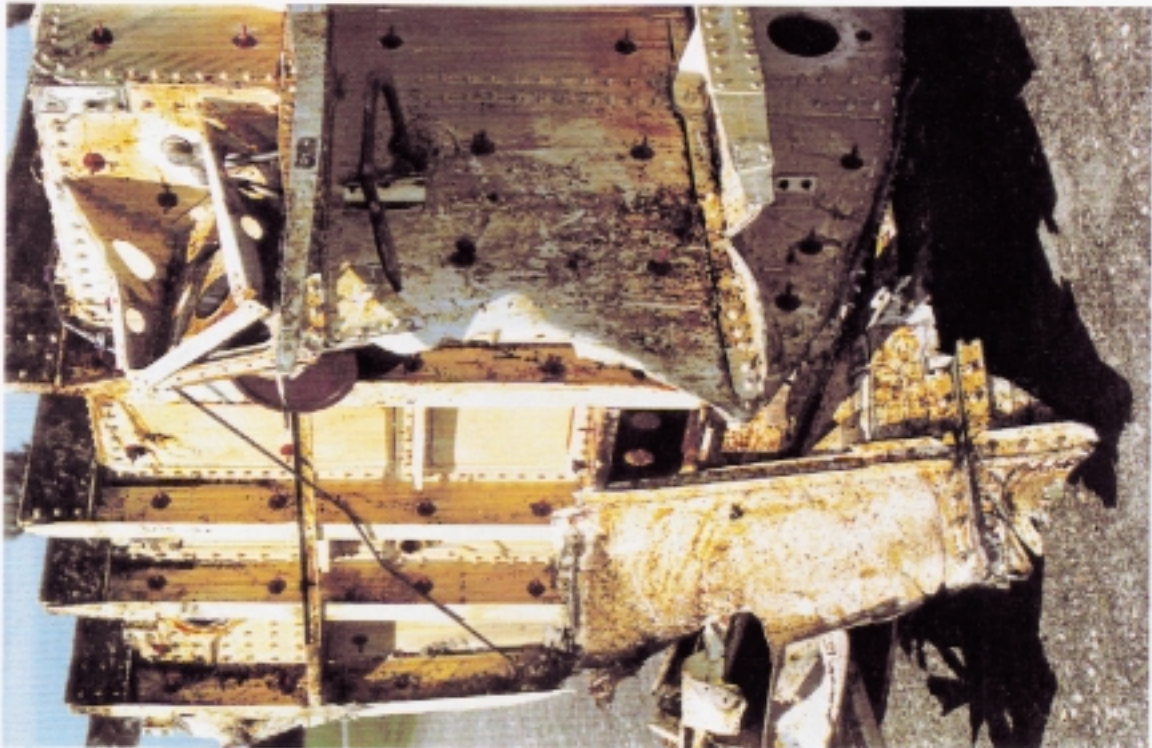
Fig. 11 Detail of the STA 395 bulkhead (LH-side)

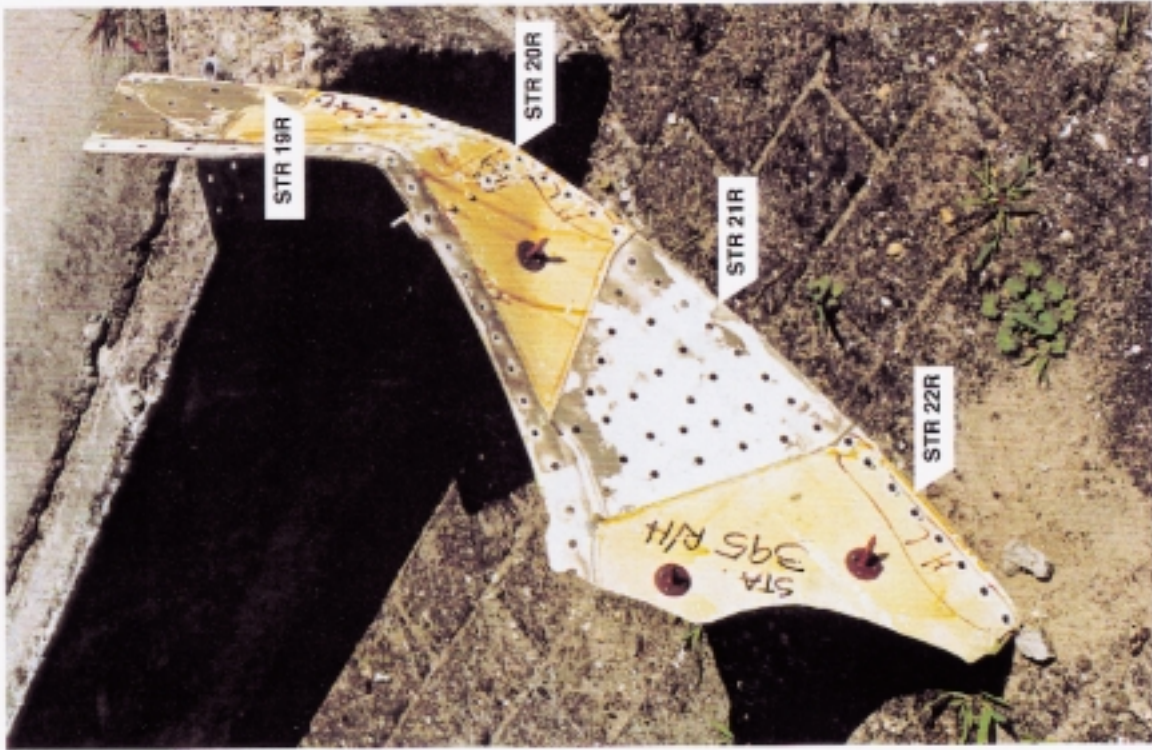
Fig. 14 Section of the STA 395 bulkhead (RH-side)

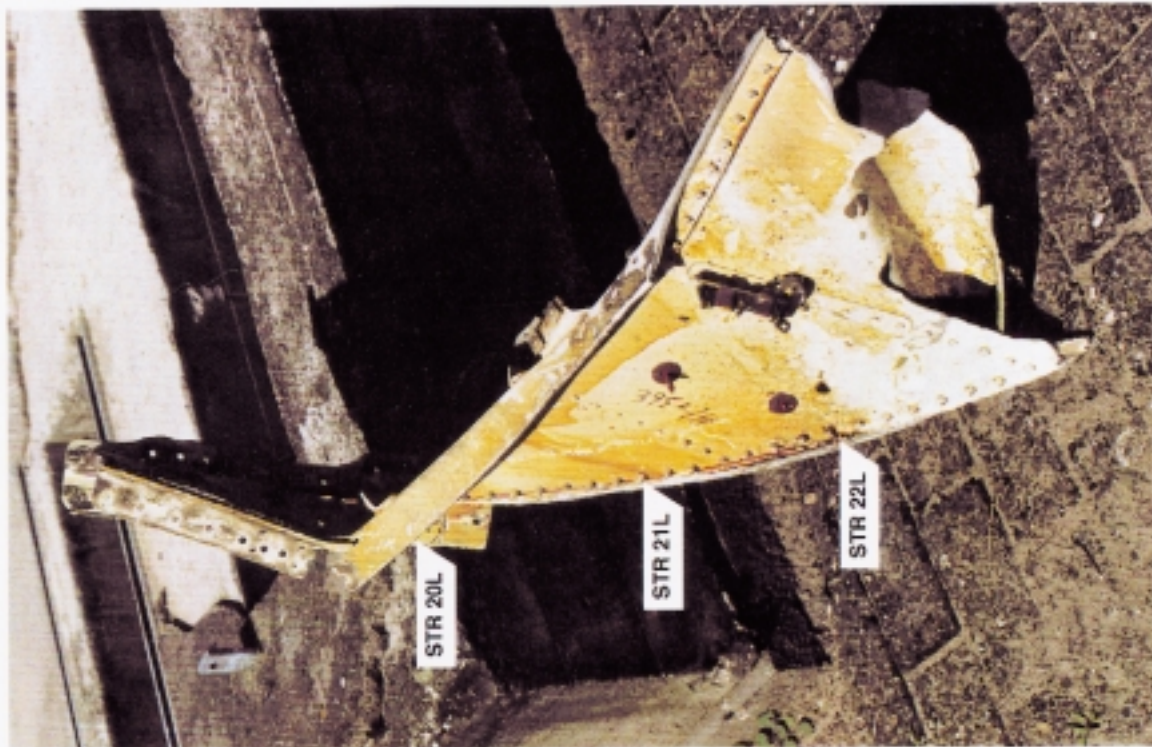
Fig. 13 Section of the STA 395 bulkhead (LH-side)
