GENERAL INFORMATION

Identification number:	2007043
Classification:	Accident
Date, time ¹ of occurrence:	12 May 2007, 20.33 hours
Location of occurrence:	Waddenzee, West of Harlingen, the Netherlands
Aircraft registration:	D-EBAA
Aircraft model:	Reims Aviation F182Q
Type of aircraft:	Single engine piston
Type of flight:	Cross-country
Phase of operation:	En-route
Damage to aircraft:	Severely damaged
Cockpit crew:	One
Passengers:	None
Injuries:	Pilot deceased
Other damage:	None
Lighting conditions:	Daylight

SUMMARY

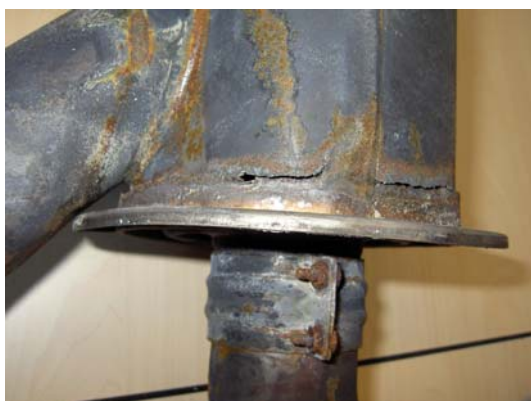
A visual inspection showed some cracks around the exhaust muffler end plates. The exhaust was distorted by impact. The engine exhaust assembly¹³, excluding the heater cuff, was investigated in a laboratory.¹⁴ The corresponding report mentions that the muffler *'is damaged by scaling of the steel used. The effect of the corrosion by the hot exhaust gas is aggravated by the flaking of the protecting scale layers when the muffler cools down. Possibly the destruction of the sensibitized austenitic steel is additionally supported by electrolytic corrosion when the engine is out of operation. In the opinion of the investigator the steel type [...] is absolutely unqualified for the conditions in the muffler. The concentration of the scaling (crack formation) to the both ends of the cylindrical muffler probably results from the highest temperature in the entrance regions of the exhaust gas and from the mechanical stresses induced by the side cover plates'*.

Some cracks in the exhaust muffler

- Cracks in the engine exhaust muffler enabled carbon monoxide to enter the cabin. This incapacitated the pilot and resulted finally in loss of control and the aircraft crashing in the Waddenzee.
- The materials used for the exhaust muffler were not according the design specifications.
- The last inspection of the exhaust muffler did not reveal the cracks.

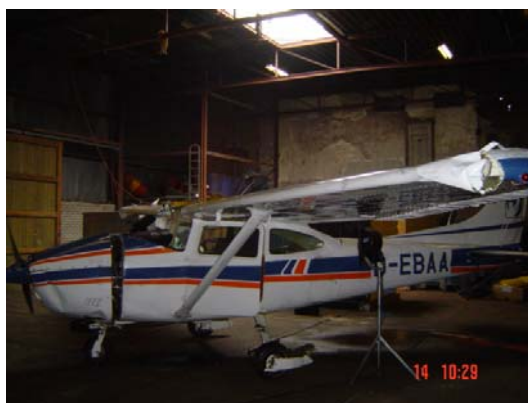
D-EBAA during technical investigation
