## ALGEMENE GEGEVENS

| Nummer voorval: | 2007043 |
| Registratie luchtvaartuig: | D-EBAA |
| Type luchtvaartuig: | Reims Aviation F182Q |

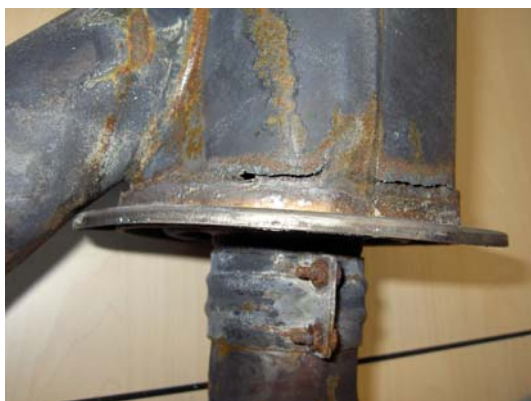
Een visuele inspectie liet een aantal scheuren rond de eindplaten van de uitlaatdemper zien. De uitlaat was vervormd door het neerstorten. De motoruitlaatassemblage<sup>13</sup>, met uitzondering van de verwarmingskraag, is onderzocht in een laboratorium.<sup>14</sup> Het laboratorium verklaarde in zijn rapport dat de demper *"is beschadigd door afbladdering van het gebruikte staal. Het effect van de corrosie door het hete uitlaatgas wordt verergerd door de afbrokkeling van de beschermende lagen als de demper afkoelt. Het kan zijn dat het "sensibilized austenitic steel" mede wordt afgebroken door elektrolytische corrosie wanneer de motor uitgeschakeld is. De onderzoeker is van mening dat het type staal [...] absoluut ongeschikt is voor de gebruiksomstandigheden in de demper. De concentratie van de afbladdering (scheurvorming) aan beide zijden van de cilindrische demper is waarschijnlijk het resultaat van de hoogste temperatuur in de ingangszone van het uitlaatgas, en van de mechanische druk uitgeoefend door de "side cover plates"*

*Enkele scheuren in de uitlaatdemper*

piloot gedurende de vlucht de "on" stand heeft geselecteerd voor de cabineverwarming. Vervolgens is koolmonoxide in het cabineverwarmingssysteem gekomen als resultaat van de scheuren in de uitlaatdemper. Daarna kwam er koolmonoxide de cabine binnen. Aangezien beide luchtkanalen dicht waren, kwam er geen verse lucht de cabine in en verergerde de situatie. Dit resulteerde in het onwel worden van de piloot. Het laatste contact tussen de piloot en de luchtverkeersleiding was om 18.14 uur. Aangezien de piloot verward klonk tijdens dit laatste radiobericht is het waarschijnlijk dat zijn bewustzijn al aan het verminderen was vanwege de koolmonoxide. Omdat de automatische piloot aan stond, bleef het vliegtuig een constante hoogte houden en volgde een min of meer stabiele koers gedurende 1 uur en 53 minuten na het laatste radiobericht. Nadat de brandstof op was geraakt, begon het vliegtuig te dalen en stortte uiteindelijk neer in de Waddenzee.

- Door scheuren in de motoruitlaatdemper kon koolmonoxide de cabine binnenkomen. Dit leidde tot het onwel worden van de piloot en resulteerde uiteindelijk in het verlies van controle en het neerstorten van het vliegtuig in de Waddenzee.
- De materialen die gebruikt zijn in de uitlaatdemper waren niet overeenkomstig de ontwerp-specificaties.
- De laatste inspectie van het vliegtuig heeft de scheuren in de uitlaatdemper niet geopenbaard.

Aangezien koolmonoxide niet gezien of geroken kan worden, is het moeilijk om de subtiele beginselen van een koolmonoxidevergiftiging te herkennen. De Raad moedigt derhalve het gebruik van koolmonoxidedetectors aan in de cockpit.

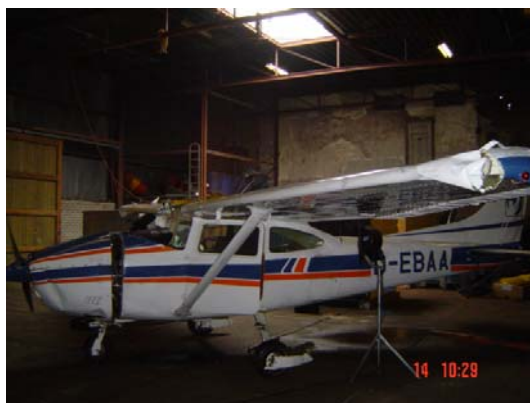
Om de piloot uit het vliegtuig te krijgen, hebben de reddingsdiensten de voorruit van het vliegtuig ingeslagen. De vleugels bij beide vleugelwortels<sup>7</sup>, de linker- en rechtervleugeluiteinden, het richtingsroer en het linkerhoogteroer zijn bij de berging van het vliegtuig beschadigd. In zowel de linker- als de rechtervleugeltank werd geen brandstof gevonden. De onderkant van de neus van het vliegtuig, de naafkap, de motorophanging, het brandschot en de neuswielstijl zijn vervormd door het neerkomen op het water. Er is geen bewijs gevonden van ernstige schade ontstaan voor de klap op het water en de propellerbladen toonden impactschade met een laag toerental.

*D-EBAA tijdens het technisch onderzoek*
