DUTCH
SAFETY BOARD

Two cases of wing fire

in Apex DR400 aeroplanes

The Hague, May 2017

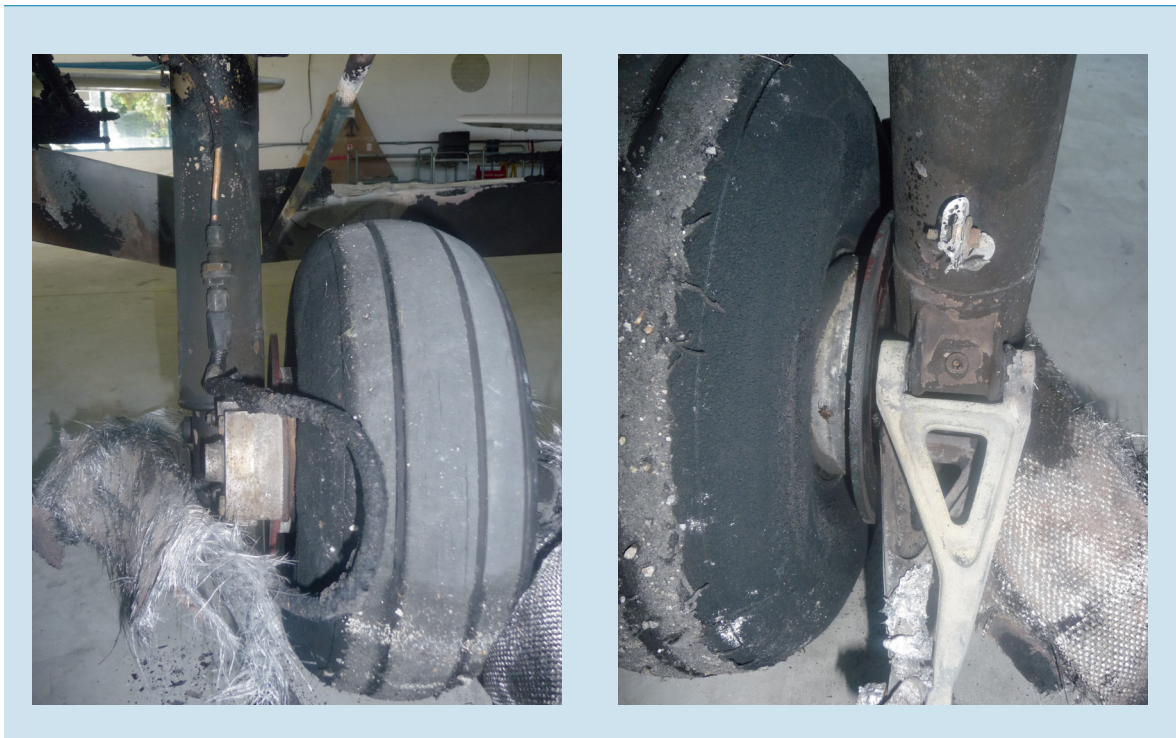
The left-hand main gear was severely damaged by fire (see figure 7). The cylinder of the left-hand main gear was fully compressed. The left-hand main gear strut fairing was almost completely consumed by fire. Only some fibreglass remained. The right side of the tyre of the left-hand main gear was damaged by heat and/or fire. Some aluminium parts of the left-hand main gear had melted, other metal parts on the left-hand wing were damaged by fire. The left-hand flexible brake line was burnt and showed leaks.

Figure 7: The destroyed left-hand main gear and strut fairing from PH-SPZ, seen from front (left picture) and from aft (right picture). (Photos: Dutch Safety Board)

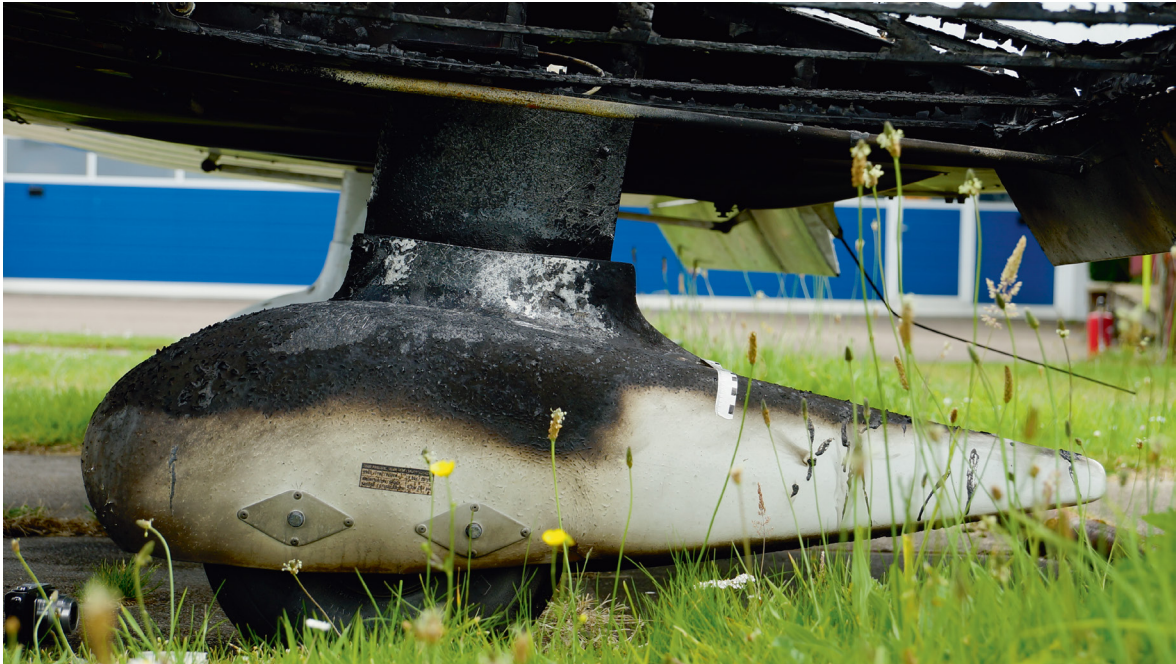
A similar technical investigation was performed on PH-HLR. The top part of the left-hand wheel fairing showed extensive heat damage whereby the individual composite matrix fibres were visible. The damage was located just above the brake connection bracket. The rest of the wheel fairing was partially blackened by heat, but the composite matrix fibres were still intact (see figure 8).

Figure 8: PH-HLR side view of left-hand wheel fairing and gear strut fairing, damaged by heat. (Photo: Dutch Safety Board)

After being removed, the top part of the left-hand wheel fairing, above the disc brake, proved to be damaged extensively (i.e. matrix visible). On the inside of the wheel fairing several green blades of grass and dirt were found.

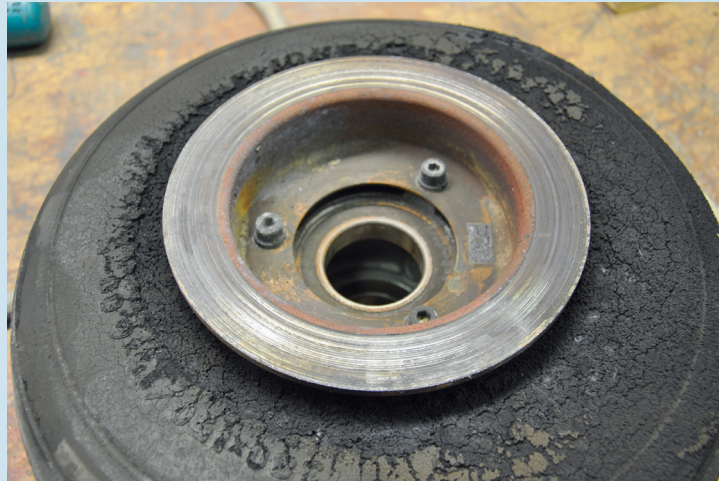
Part of the inboard side of the left-hand tyre showed a semi-circular pyrolytic imprint which corresponded to the outline of the brake disc. About one-third of the tyre showed pyrolytic damage exceeding the contour of the brake disc (see figure 9).

The brake disc surface was found to be scratched but disc thickness was within specifications. The two brake pads were found intact. Both brake cylinder assemblies were intact (i.e. not broken). The piston including the O-ring seal was intact.

Figure 9: PH-HLR left wheel with damaged tyre and brake disc. (Photo: Dutch Safety Board)

Figure 9 showed two distinct patterns of pyrolytic damage to PH-HLR's left-hand tyre. The circular shape congruent with the brake disc, shows that friction resulted in a brake disc that heated up to very high temperatures, which radiated onto the rubber tyre nearby.⁷ The cause of this friction remains as yet unknown, as neither a technical cause nor any design aspects leading to unintentional pilot braking could be ruled out in the investigation.

The part of the PH-HLR tyre showing the larger damage pattern (shown on the right-hand side of figure 9) was damaged through a different mechanism than friction from the brake disc. This pyrolysis damage was not caused by radiation from hot metal parts, but by hot combustion gases inside the wheel and strut fairings. This part of the tyre was in an upward position after the aeroplane had come to a stop.

The gear strut fairing, acting as a chimney, caused hot combustion gases, and eventually fire, from the burning parts of the aeroplane to flow down from the wing towards the wheel. This gas flow caused the typical damage pattern to the PH-HLR left-hand wheel fairing (see figure 8). The blackened fire damage line marks the boundary of the hot gas that filled the upper part of the fairing. Note the step-wise pattern in line with the gear strut, indicating that hot gases were pushed down into the wheel fairing from the burning part of the aeroplane above (i.e. the wing), not the other way around. The fairing does not show any sign of radiation from the hot wheel axis, as the distance from the axis to the fairing is too large.

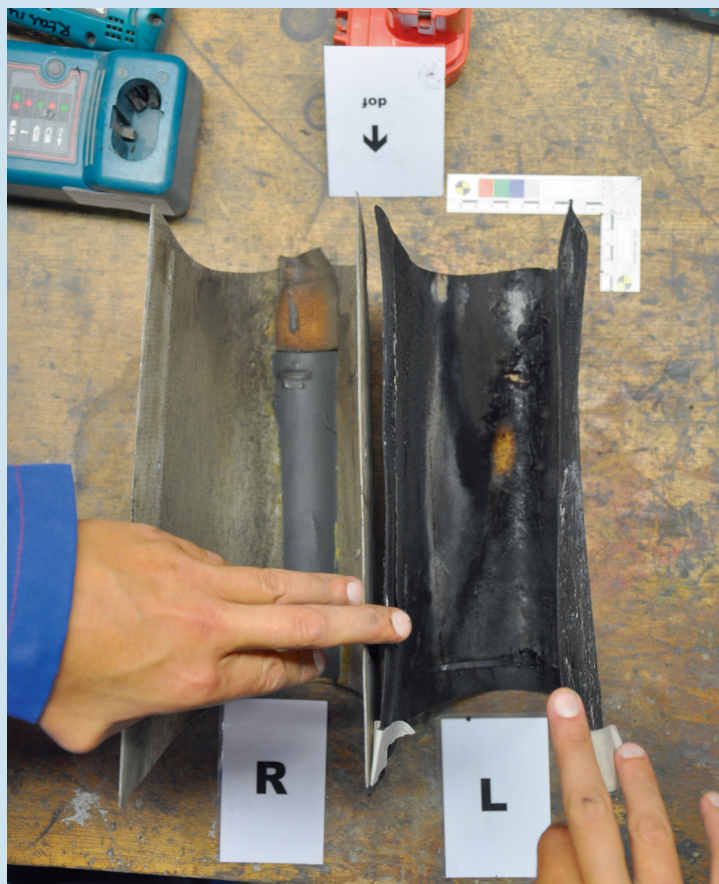
The strut fairing was damaged by heat and fire. Within the fairing, two burned pieces of material were found. Inspection of the right-hand fairing revealed that inner lining material and a piece of leather were located here. This material provided protection against chafing of the gear strut fairing against the connecting lug on the strut (see figure 10).

Figure 10: Inside view of left and right strut fairings. (Photo: Dutch Safety Board)

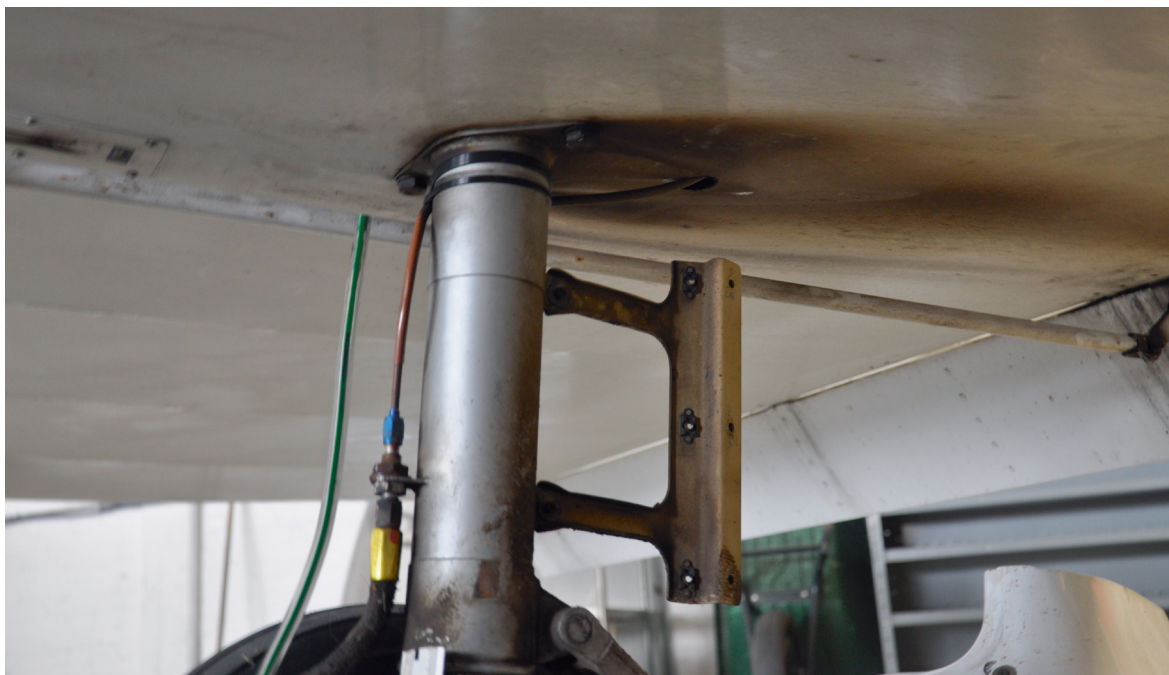
After disassembling the *right-hand* wheel fairing, the underside of the right-hand wing showed a distinctive, dark coloured mark. This mark extended towards the aft side of the aeroplane (see figure 11). Even though this mark first appeared to be a burn mark, it soon became clear that it was dirt and the structure underneath proved undamaged.

Figure 11: PH-HLR side-view of right-hand gear strut with both fairings removed, showing the dark coloured mark on the wing covering. (Photo: Dutch Safety Board)

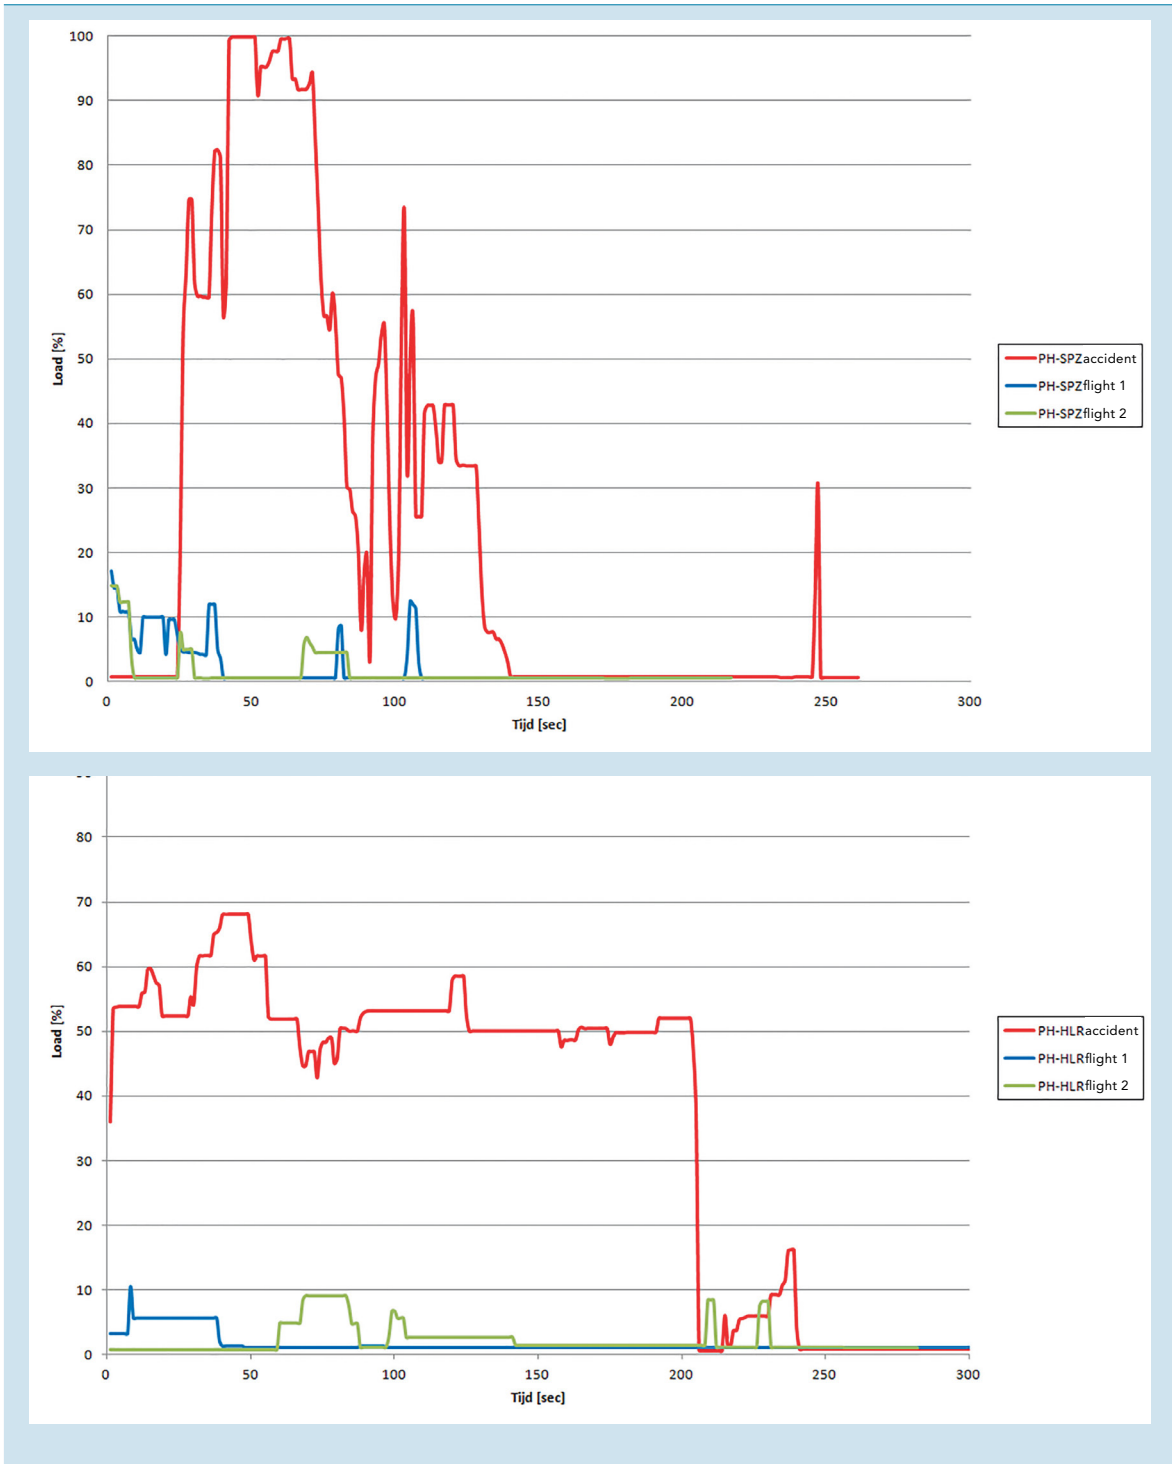
The FADEC data from the PH-SPZ and PH-HLR were downloaded after the events and analysed by the Dutch Safety Board. Figure 12 shows the selected load (i.e. throttle position) data of both aeroplanes plotted against time (in seconds) just after the moment of touchdown ($T=0$). The graphs show the two previous landings of each aeroplane depicted in green and blue, and the accident landing of each aeroplane in red. It shows that, in both accident flights, selected load during taxiing was significantly higher than in the last flights before the accident.

Figure 12: Data from both accident aeroplanes (top: PH-SPZ; bottom: PH-HLR) as recorded on the aeroplanes' FADECs. Time=0 indicates touchdown. (Source: Dutch Safety Board)

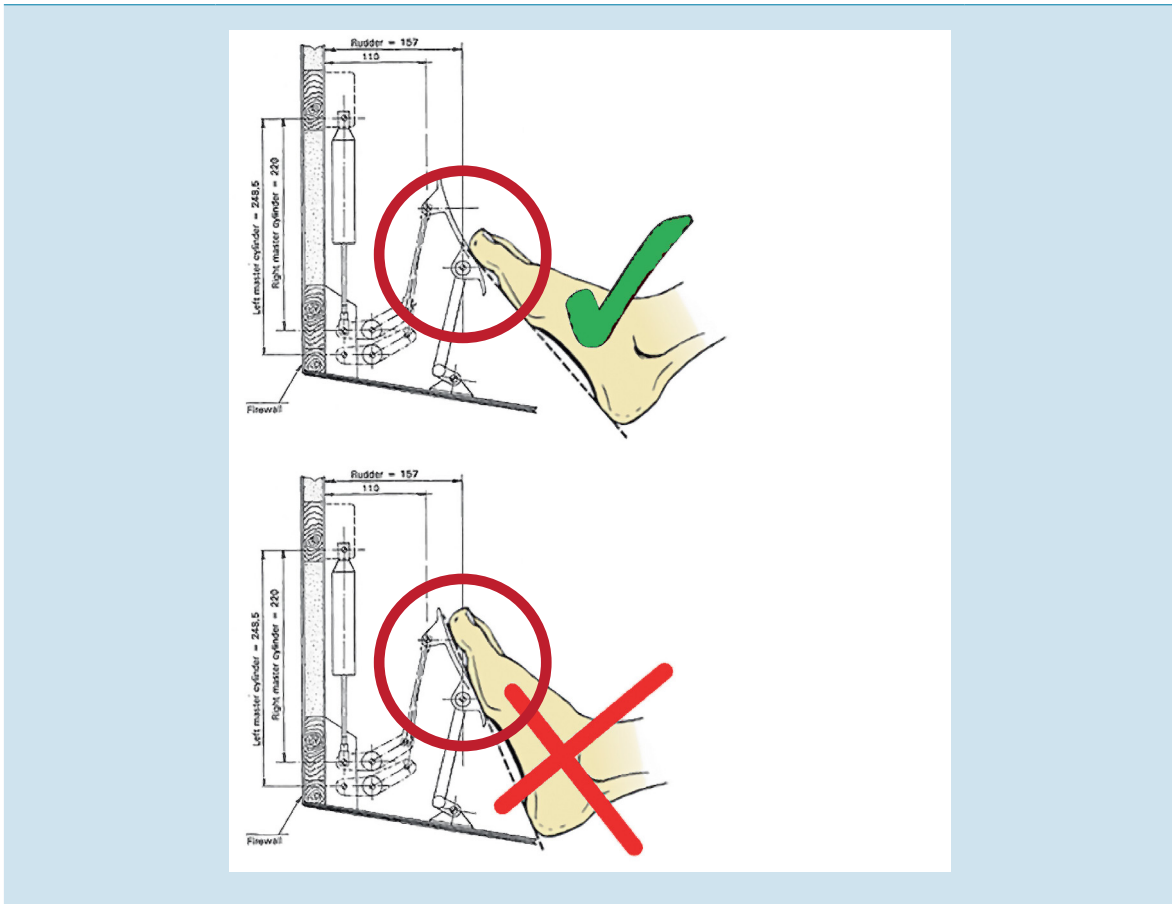
The DR400 maintenance documentation states that permanent rubbing on the brake disc by the brake pads can be caused by unintentional application of brake pressure as a result of an incorrect feet position on the pedals. This phenomenon is known as 'brake riding'. During taxiing, the pilot's feet must be positioned on the lower end of the pedals to steer the nose wheel. Only during braking, the feet must be moved to the upper side of the pedals, see figure 13.

Figure 13: Correct and incorrect positioning of the feet on the pedals. (Source: Vliegclub Rotterdam, circles by Dutch Safety Board)

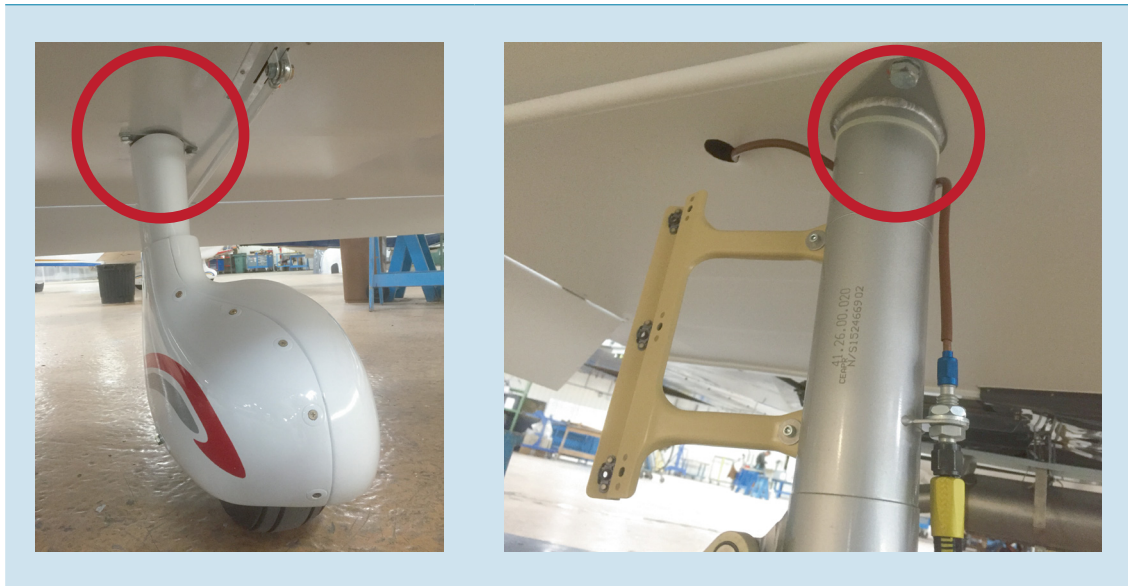
Figure 15: The wing-strut connection plate (marked in red), seen with and without fairing, during construction.
(Photos: Dutch Safety Board)

The analyses suggested the fires first ignited in the wing, as a result of heat conduction from the hot brake unit through the metal strut. The fires likely started at the point where the strut is connected to the wood and polyester of the wing structure, which served as fuel. Oil and grease on the strut may have added to the development of the fire. From the burning wing, fire and hot combustion gases spread downwards into the strut and wheel fairings. It can not ruled out completely that the fire started near the brake unit.

- Advise the manufacturer of the Apex DR400 to improve the aeroplane's brake unit, as to prevent overheating of the brake disk as a result of friction between the brake disk and brake pads.
