**FINAL**  
KNKT.12.12.27A.04

**NATIONAL  
TRANSPORTATION  
SAFETY  
COMMITTEE**

**Safety Investigation Report**

**Electrical Failure  
Soekarno-Hatta International Airport  
Tangerang, Banten  
Republic of Indonesia**

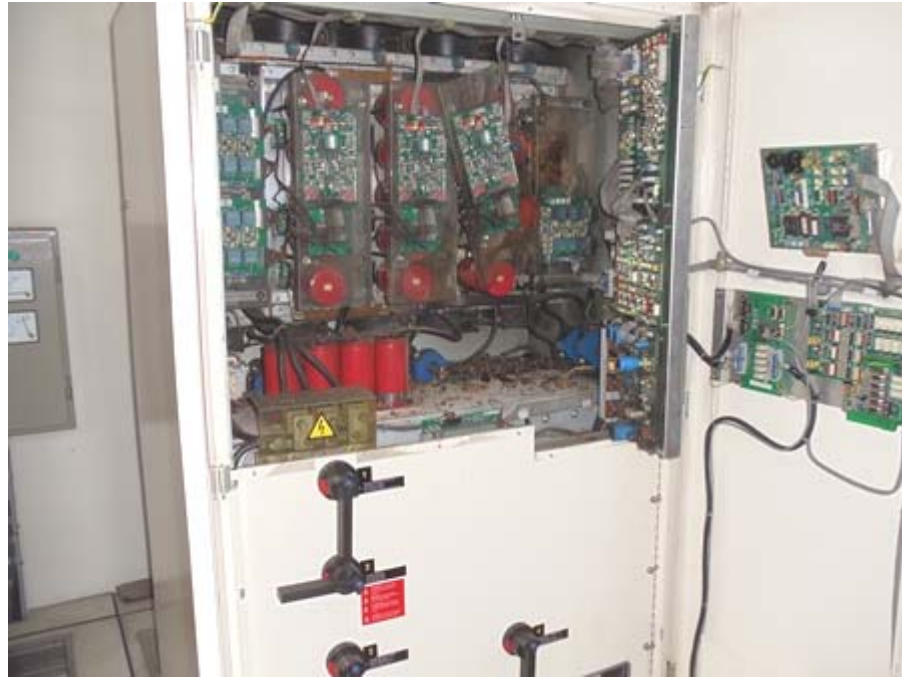
**Figure 1: The UPS 1**

The electrical technician went to the second floor to check the UPS number 1 (UPS 1), he founded that the UPS room was smoky with burned smell and the UPS 1 was off. The technician switched the electrical power from the UPS 1 to the UPS 2 using manual selector.

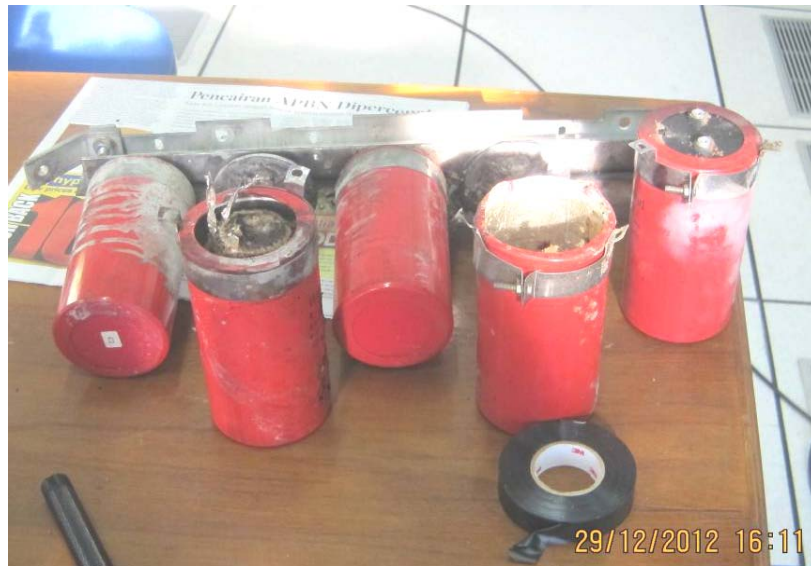
- Two of five capacitors exploded on one of the inverter;
- Two Insulation Gate Bipolar Transistors (IGBT) burned and exploded;
- The exploded debris capacitors materials mostly accumulated at the inverter control system, and shorted the bus bar to ground;
- Plastic that covered the inverter module was melted.

**Figure 2: The capacitors**

Since installation on 1992 up to the occurrence it was 20 years operation, the investigation did not find any replacement of rectifier, it might degraded the function or failed to convert the alternating current to direct impulse current, caused the battery power supplied a high direct current to the capacitors and the weakest one exploded and also burned the Insulation Gate Bipolar Transistors (IGBT).

Degradation of the capacitors could be detected by an inspection using capacitance meter in certain interval a replace as necessary to prevent the failure.

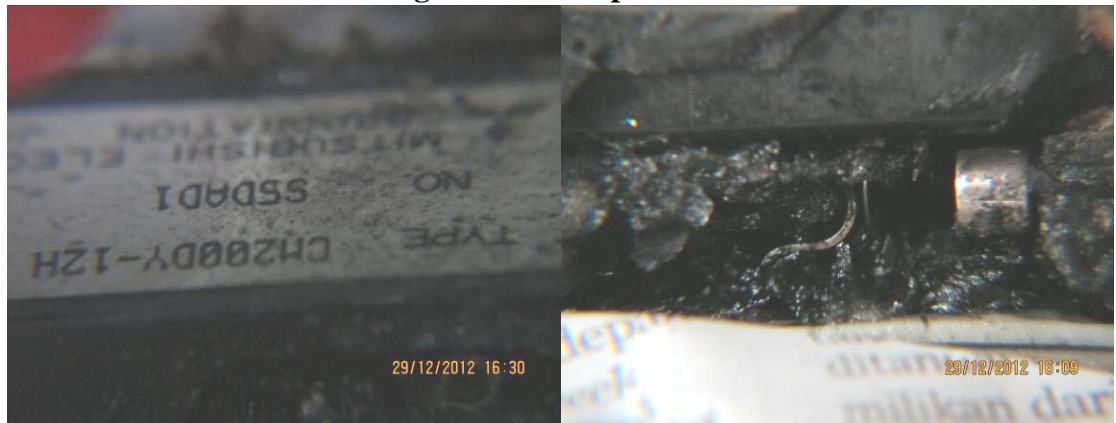
**Figure 3: The Insulation Gate Bipolar Transistors (IGBT)**

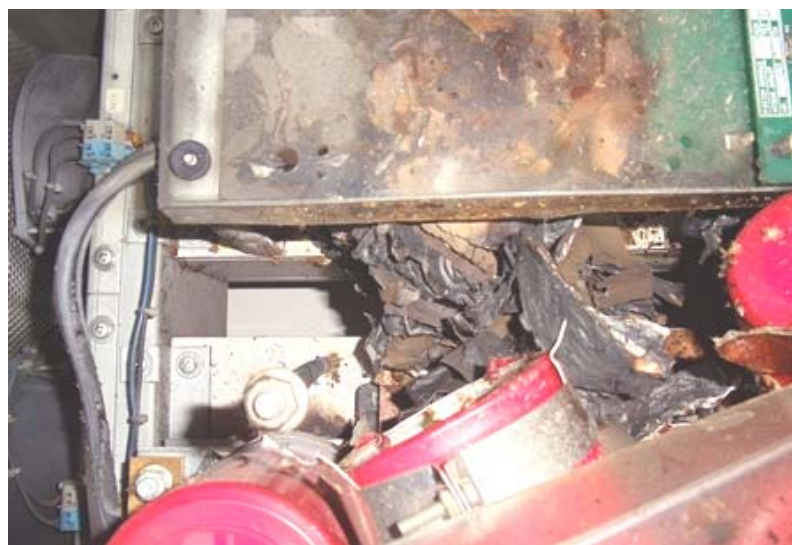
**Figure 4: The capacitor materials debris at the inverter control system bus bar**

There were any sparking carbons marked at the cabinet and investigation also found the dielectric debris shorted at the inverter control bus bar.

The exploded material sprayed through to the inverter control system and sorted the bus bar to ground caused the system failed transferring the electrical power from UPS 1 to UPS2.

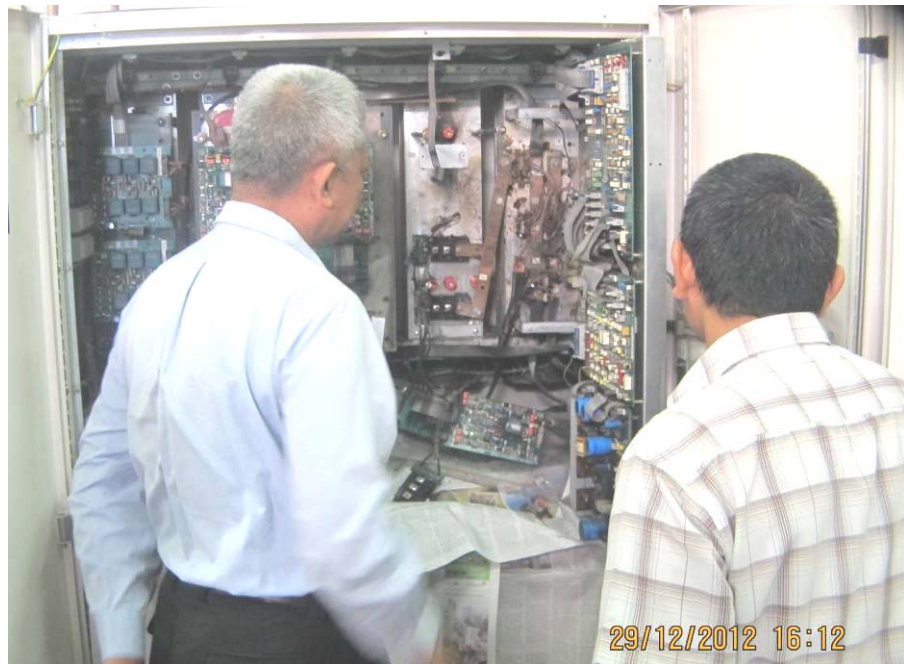
**Figure 5: The inverter control terminal after cleaned from debris**

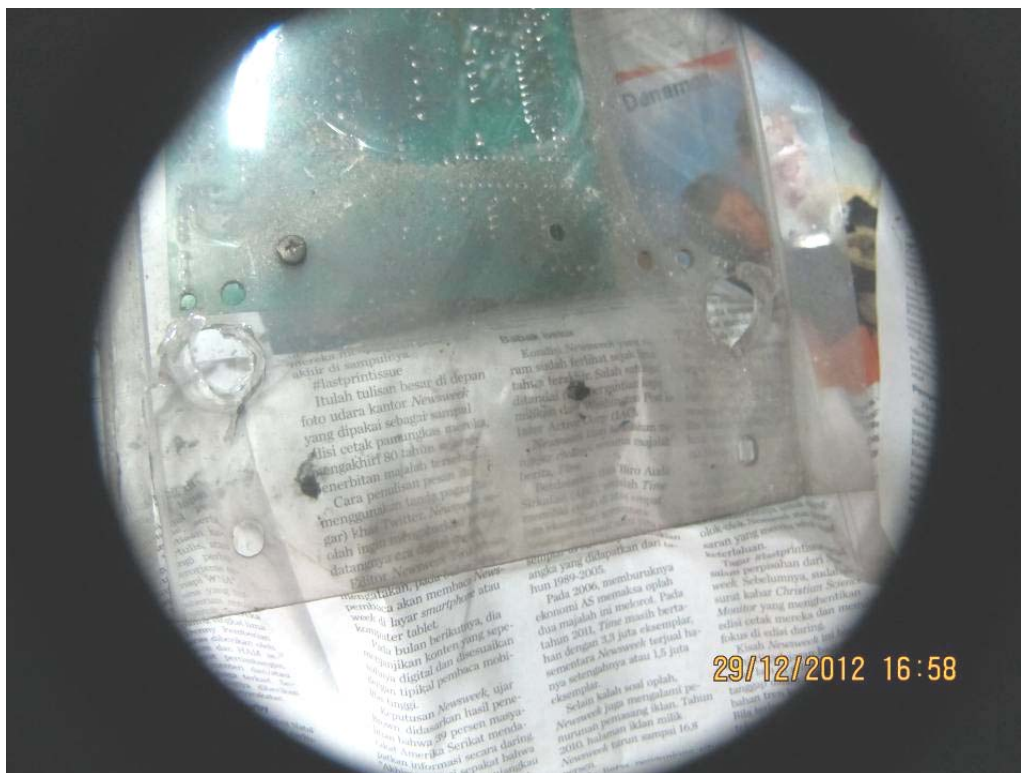
**Figure 6: The melted plastic cover**

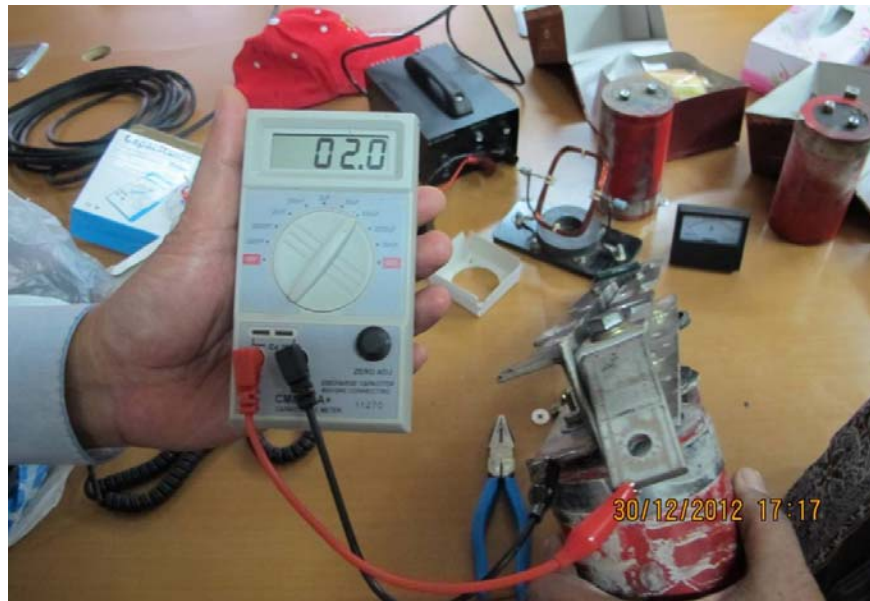
The investigation conducted a functional check of the three capacitors at the same module of the exploded capacitors. The capacitance value from the one of them was 2 micro-farad, it degraded significantly meanwhile the standard value of the capacitance is 2,200 micro-farad.

**Figure 7: Capacitor functional check**

Component inspection of the three capacitors at the same module to the exploded capacitors was found a significant degradation, one of them was 2 microfarad deviated from the standard of 2,200 microfarad.
