KNKT.08.10.24.04

Aircraft Accident Investigation Report

**PT. Garuda Indonesia
PK – GZI
Boeing Company 737-400
Ngurah Rai Airport, Denpasar, Bali
Republic of Indonesia**

28 October 2008

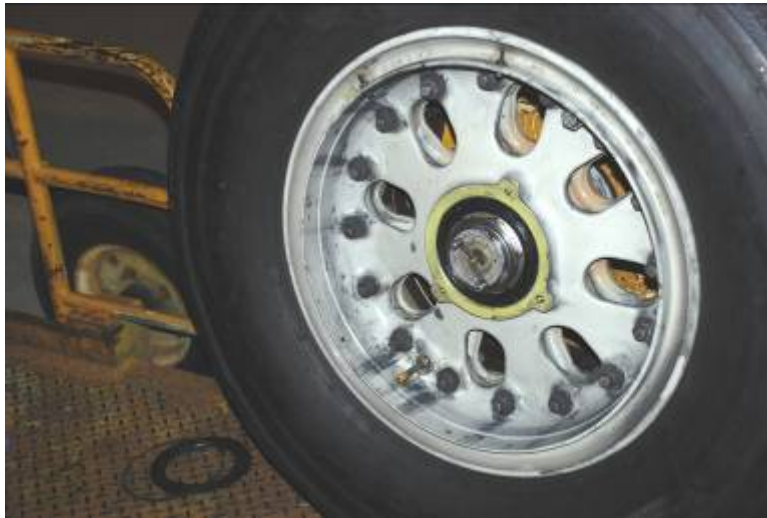
The number-one main landing gear axle was broken and detached from its landing gear strut.

Figure 1: The number-one wheel and axle.

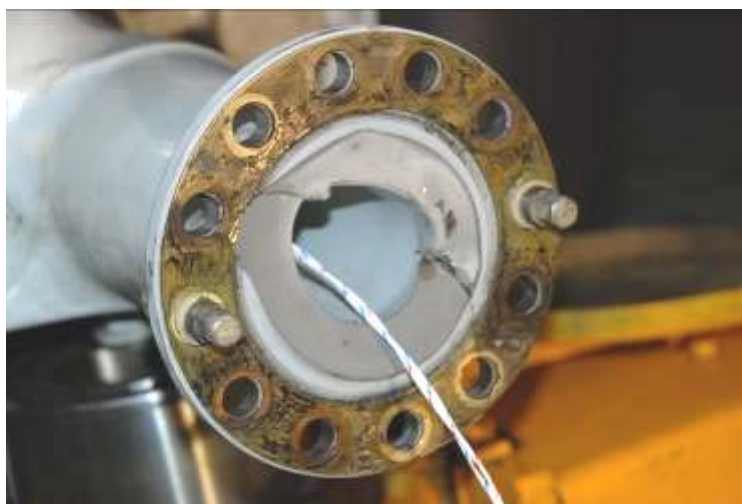
The number-one main landing gear axle fractured.

Figure 2: The fractured number-one axle showing that the failure occurred near the brake attachment flange

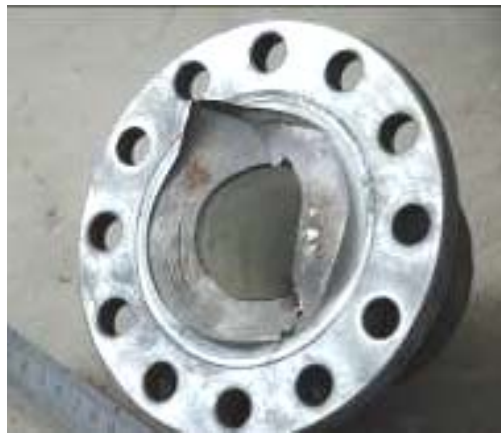
The crack on the axle originated from one of the brake assembly attachment holes at the axle flange.

The crack propagated about 8 cm until a fast final failure occurred.

Figure 3: View of the fracture surface. The fatigue crack initiated from the 5 o'clock attachment hole

Portions of the crack were present at least 43 cycles before the inner cylinder was last overhauled. The crack was present about 50 cycles before the failure.

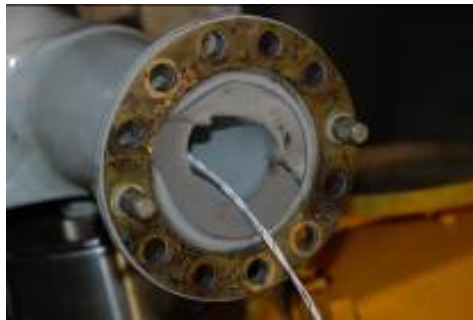
Figure 1: Broken axle. Failure occurred near the brake attachment flange

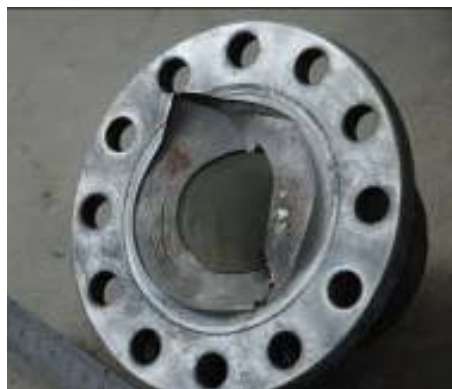
Figure 2: Fracture surface: final failure. Fatigue crack was initiated from the 5 o'clock attachment hole.

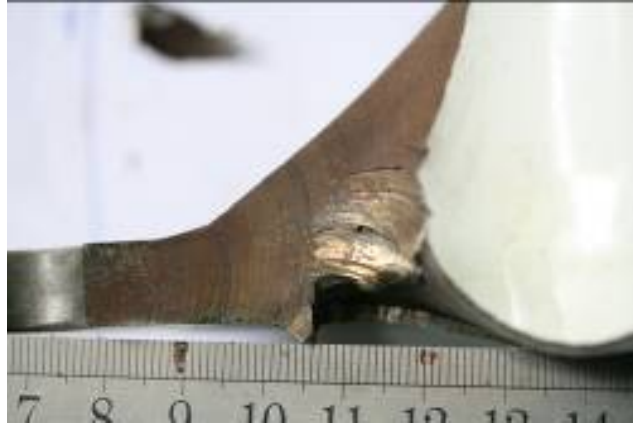
Figure 3: Beach marks started from the hole, propagated inward toward the axle.

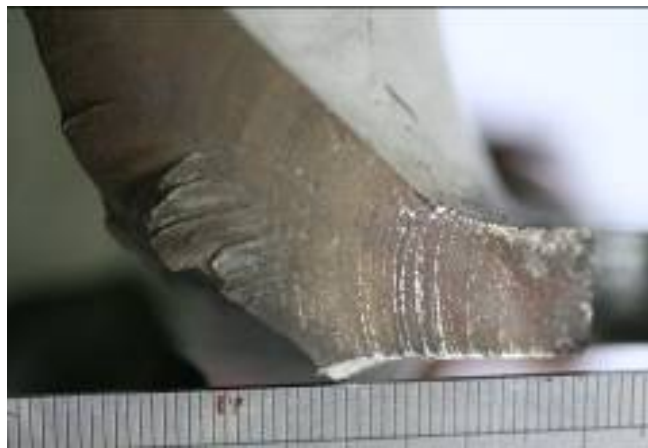
Figure 4: The appearance of fracture surface on the matching piece. Beach-marks reached approximately 8 cm from the hole.

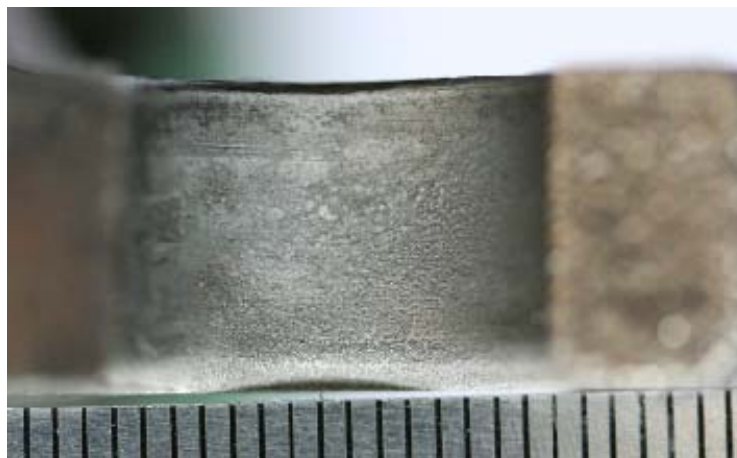
Figure 5: Fretting/corrosion pits on the surface of the flange hole

- a. The fatigue crack had propagated up-to 8 cm from the origin.
- b. The beachmark is certainly of large number of cycles. The failure occurred at 8 flight cycles after the overhaul at SUMMIT Aerospace, USA.
- c. Fretting/corrosion pits were observed on the surface of the flange hole.
- d. The fatigue crack was initiated from that fretting pits.

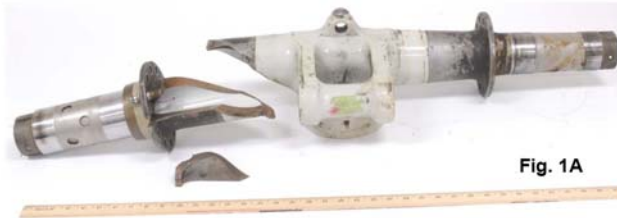
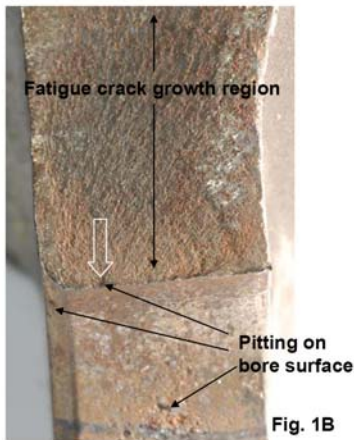
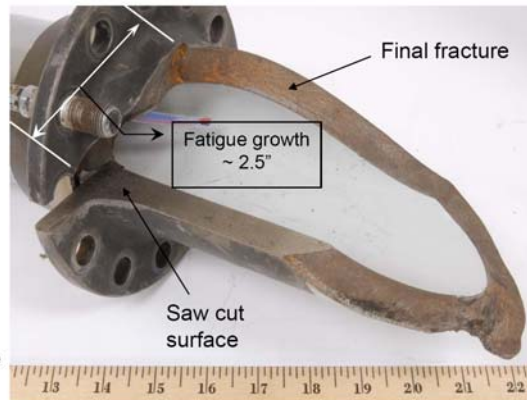
Figure 1:

- 1) Figure 1 shows the as-received condition the portion of the inner cylinder that was submitted to Boeing. The right hand side axle fractured between the brake flange and the vertical post section of the inner cylinder (fig. 1A). Examination of the fracture surface revealed that the origin was located at the surface of one of holes in the brake flange (white arrow in figure 1B).

- 2) The bore surface exhibited scattered corrosion pitting which served as the initiation site for the fracture which occurred by a fatigue mechanism. The crack propagated by fatigue for a length of approximately 2.5" before final fracture through the axle wall occurred by ductile separation (figure 1C).

- 3) The holes in the brake flange exhibited loss of the original primer. Deterioration of this protective finish can lead to fretting damage and corrosion pitting of the base metal, with both conditions capable of contributing to fatigue crack initiation.

Fatigue crack initiation at pitting on bore (white arrow Fig 1B). Crack propagation by fatigue for ~2.5" prior to final separation (Fig 1C).

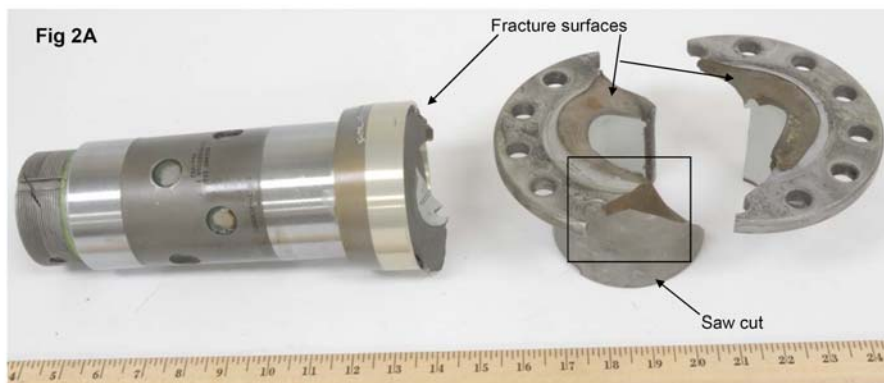
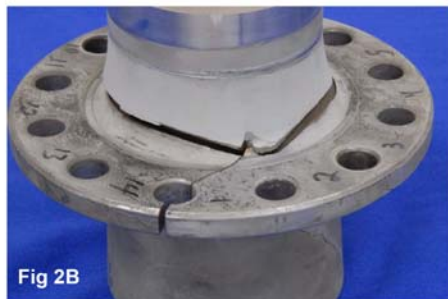
- 1) Figure 2 shows the as-received condition of the fractured axle segments that were submitted to Boeing. The fracture emanated from a bolt hole on the brake flange and progressed in a helical direction through the axle wall.

Figure 2: Photographs showing the as-received condition of submitted axle segments. Note that crack emanated from flange hole and progressed in a helical direction through the axle wall.

Fig 2A shows pieces separated to expose fracture path. Box in Fig. 2A indicates area of fracture presented in figure 3. Fig 2B show relationship between axle segments when fitted together.

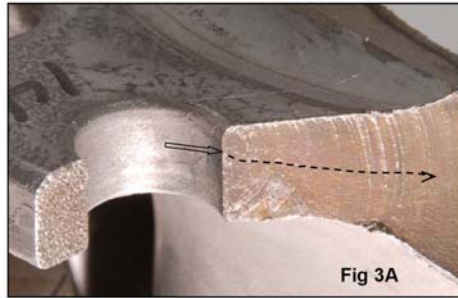
- 2) Examination of the fracture surface revealed that the origin was located at the surface of one of the holes in the brake flange (arrowhead in figure 3A). Crack initiation and propagation were the result of a fatigue mechanism.

Figure 3A & 3B: Photographs showing fracture surface details.

Fig. 3A shows the fracture initiation site located at surface of brake flange bolt hole indicated by arrowhead. Initiation and propagation were the result of a fatigue mechanism with crack growth in the direction indicated by dashed arrow.

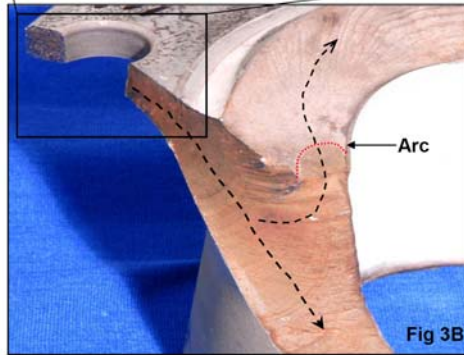
- 3) The fracture surface exhibited two distinct colors (figure 3B). The majority of the surface displayed light oxidation consistent with heat tinting which develops when alloy steel is exposed to temperatures of approximately 350F - 400F. This is the temperature used at overhaul for stress relief and hydrogen relief bakes. The remainder of the fracture surface was dull gray, typical of a fairly recent separation event. The presence of the oxidation suggests that the discolored portions of the crack were present when the inner cylinder was last overhauled.

Fig. 3B shows the crack propagation path as indicated by dashed black arrows. Note change in coloration on the fracture surface indicated by the dashed red arc. The bronze color inside the arc was consistent with light heat tinting oxidation. The dull gray color outside the arc was free of oxidation and corrosion, and consistent with a more recent fracture.

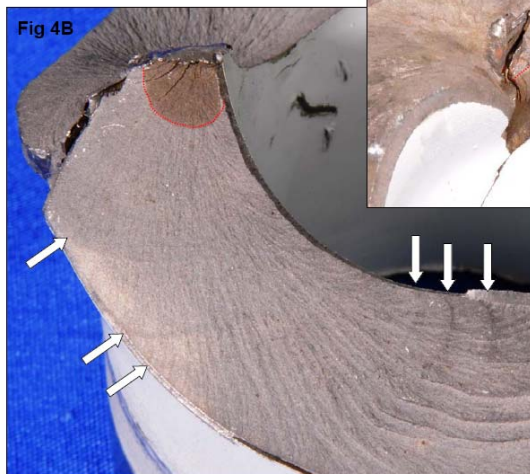
Figures 4A & 4B:

5) The fracture throughout the discolored region was the result of fatigue propagation which had progressed for a distance of approximately 3” to reach the terminus identified by the red arc. Several crack arrest marks were also visible on the gray colored fracture surface beyond the arc (figures 4A and 4B). These marks indicated that this portion of the fracture was due to incremental ductile separation which occurred once the part was returned to service after overhaul.

Photograph showing the mating fracture surfaces in the area of the coloration change denoted by red arcs and shown in Fig 3B. Note multiple visible crack arrest marks (at white arrowheads) beyond red arc indicating additional cyclic crack propagation prior to final fracture.

Figure 4A is surface on segment containing brake attach flange.

Figure 4B is mating surface on segment containing wheel bearing journals.

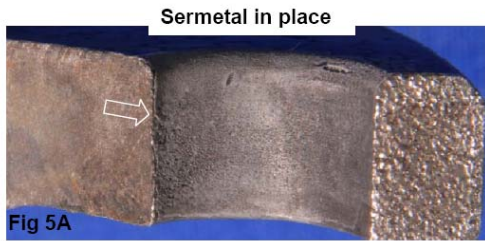
Figure 5A: Bore surface at fracture origin (arrow) with Sermetel coating in place.

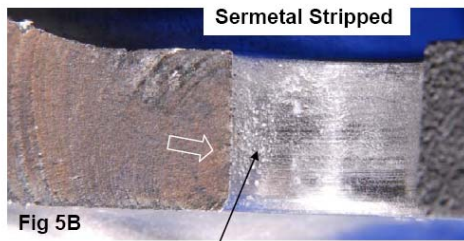
6) Stripping of the Sermetel coating on the flange and bolt holes in the area of the fracture revealed the presence of underlying corrosion pitting in the base metal (figure 5A – 5C). The fracture initiated from one of the areas of heavy pitting (figure 5B).

Figure 5B: Bore surface at fracture origin (arrow) with Sermetel removed which exposed underlying corrosion pitting in base metal.

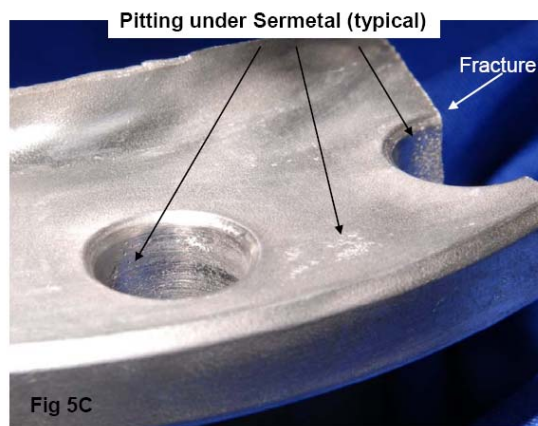
Figure 5C: Flange and bore surface adjacent to fracture with Sermetel removed to expose underlying base metal pitting.
