**FINAL**  
KNKT.12.03.06.04

# NATIONAL TRANSPORTATION SAFETY COMMITTEE

Aircraft Accident Investigation Report

**PT. Airfast Indonesia**  
**Eurocopter AS 350B3 ; PK-ODA**

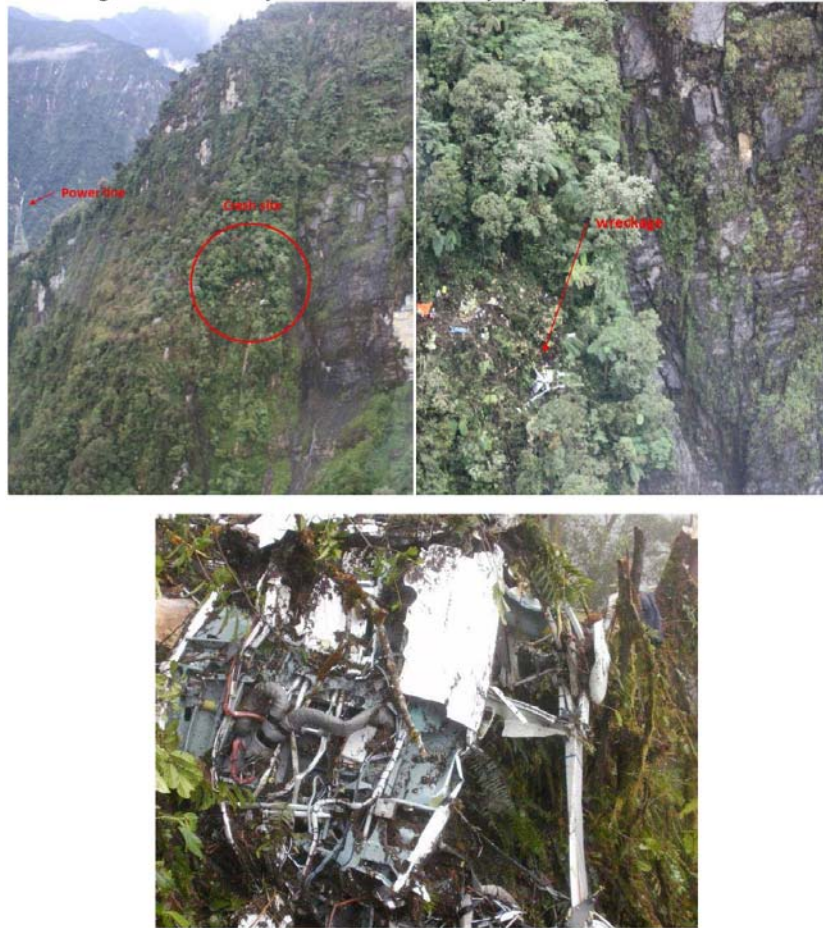
Figure 2: The accident site

At 2200 on 17 March 2012, the Freeport search team from MP 66 found the helicopter position at coordinate 04° 07.34 S 137° 05.40 E at elevation of 8,000 feet. The helicopter was destroyed and all occupants were fatally injured.

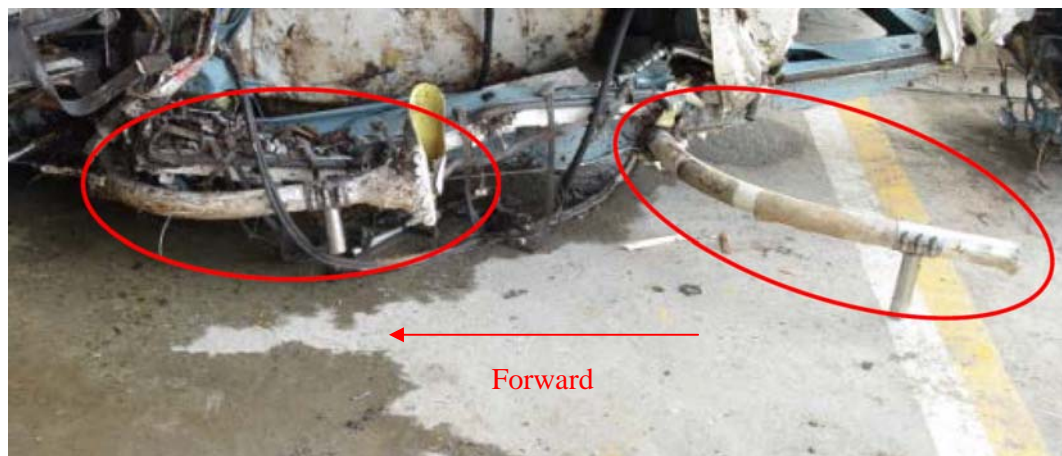
Figure 4: damages of the landing skid cross tube.

The front cross tubes of the left landing skid was found bent backward and twisted while the aft cross tube was bent backward (as showed on figure 6). These types of damages were resulted by horizontal and lateral forces.

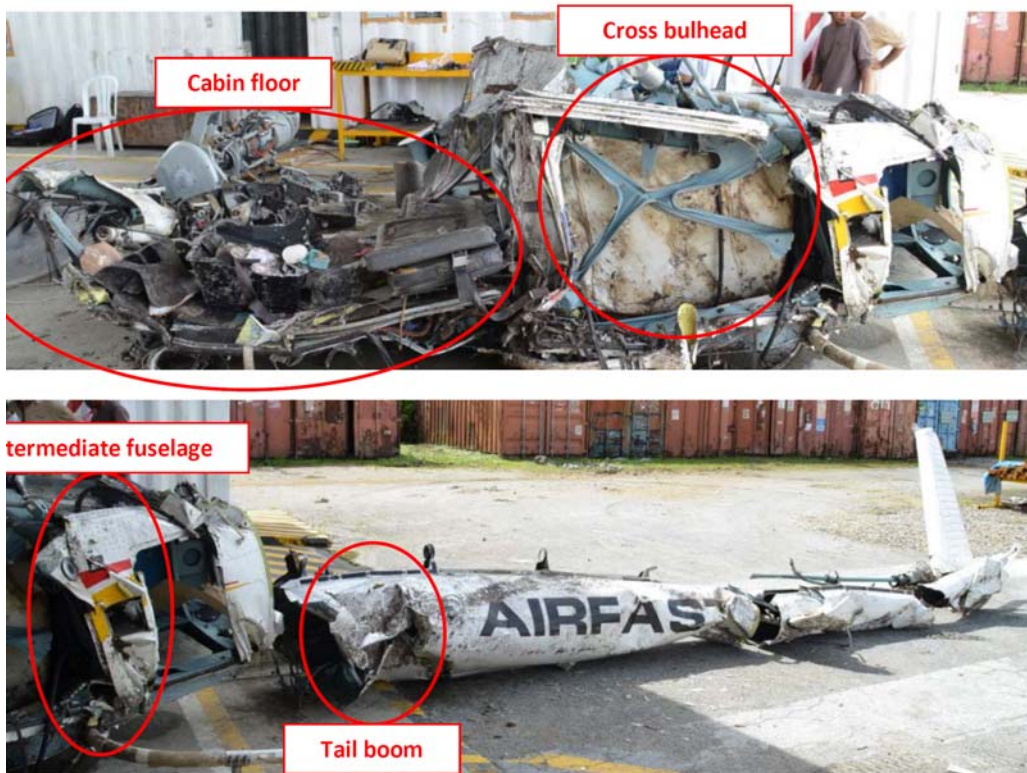
Figure 5: The damage of the main structure

indicated a significant forward force.

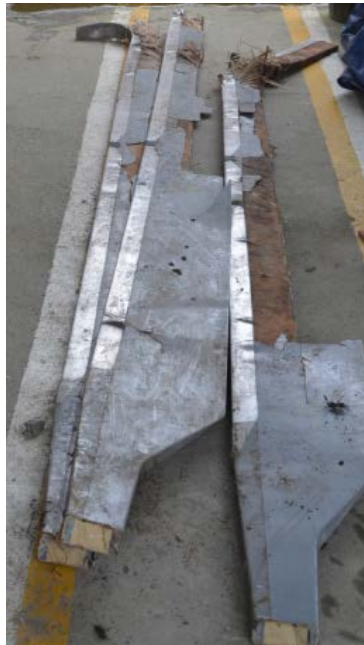
**Figure 6: General condition of the Main Rotor Blades**

The main rotor blades were severely damaged on the leading edges near the blade tips. These damages were typical of high speed impact damage. High speed impact on the main rotor blades indicated that the engine was still operating prior to impact.

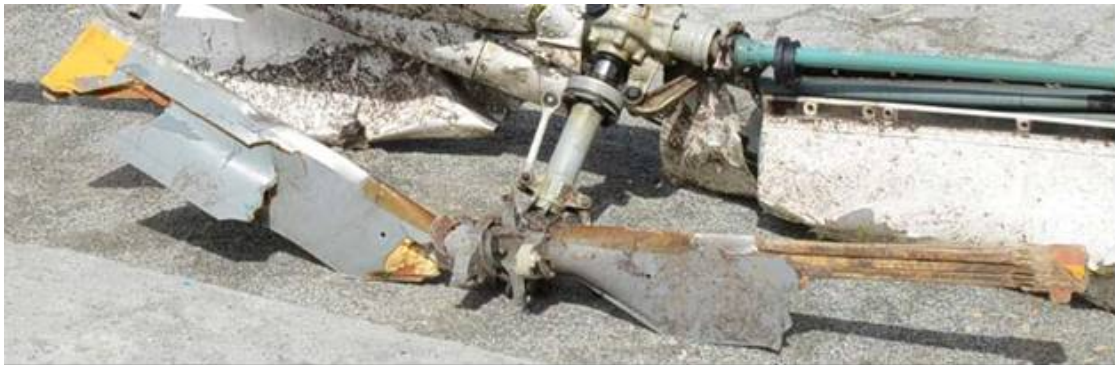
**Figure 7: The tail rotor blades conditions**

The tail rotor blades were severely damaged due to impact. This was indication of significant rotor speed during the impact.

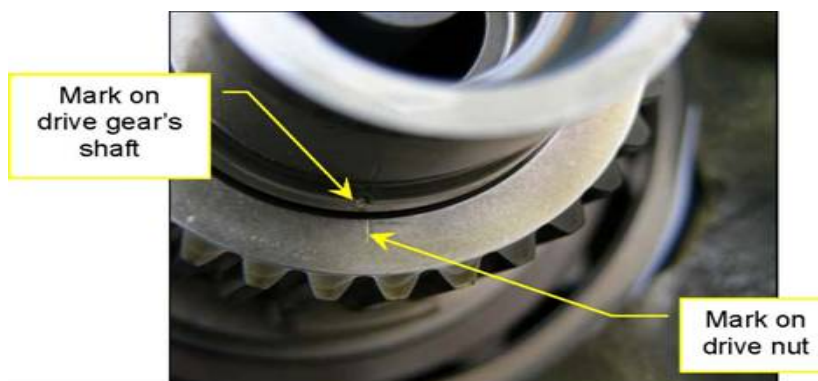
**Figure 12: The misalignment marks**

It was found misalignment of the mark on the drive nut with respect to the mark on the drive gear's shaft. This misalignment occurred when the engine encountered an important sudden increase in resistant torque whilst delivering power. The torque increase was likely to have occurred when the main rotor (blades or rotor head) hit the solid obstacles (trees or ground).

The misalignment indicates that the engine was delivering power at the time of the impact.

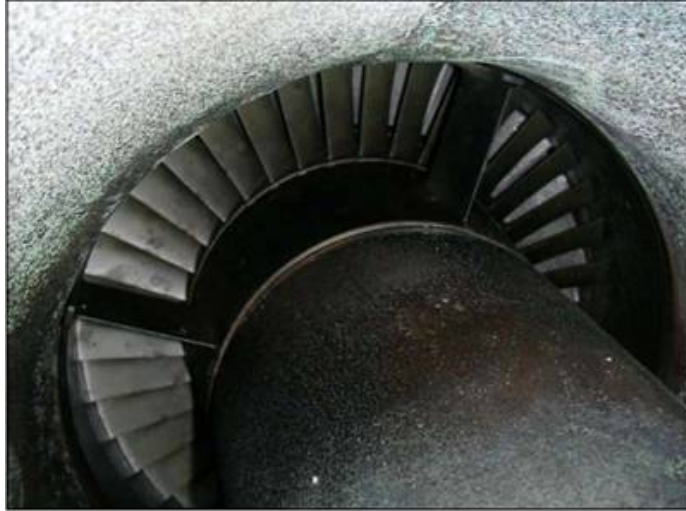
**Figure 13: Turbine blades**

There were no particular findings to report regarding the MO4 casings. All the Free Turbine's blades were present and appeared in nominal condition. The free turbine wheel could be rotated by hand. The rotation was silent and smooth.

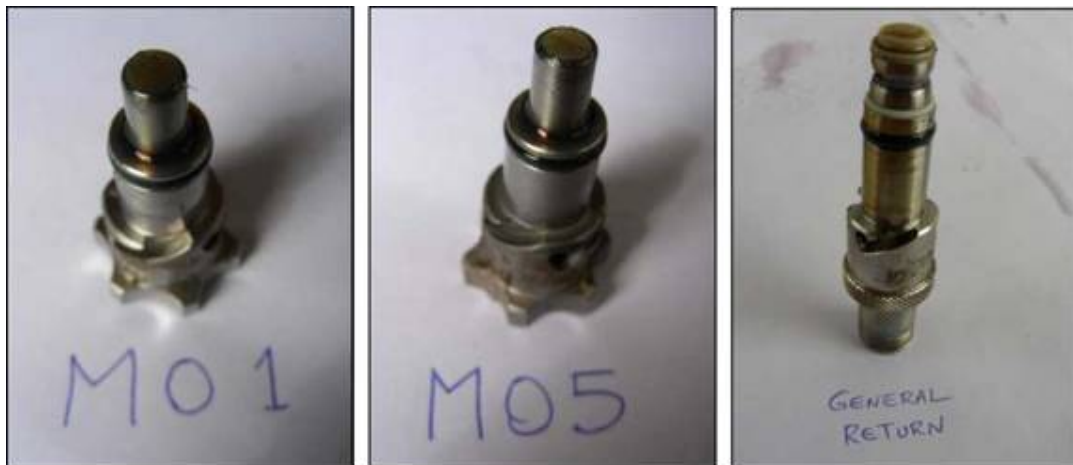
**Figure 14: Magnetic plugs**

All three magnetic plugs were checked. One filament like particle was found on the MO1 (accessories gear box) magnetic plug. Such an isolated particle does not represent any advanced stage of damage and it may have been released as a consequence of the accident. No other particle was found on the other magnetic plugs.

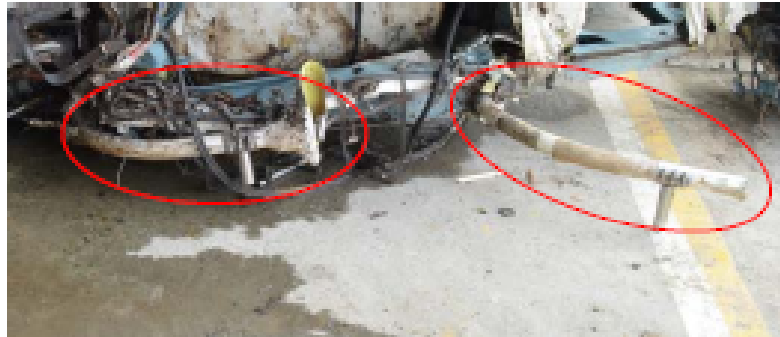
The skid landing gear exhibits some damages which are consistent with a significant longitudinal velocity. Indeed, both cross tubes don't present deformation due to vertical load but have swiveled backward conducting to the failure at the junction with the horizontal tubes which are missing.

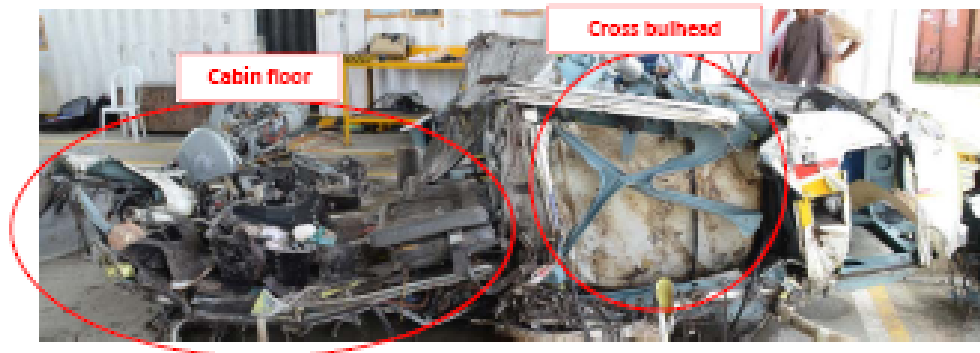
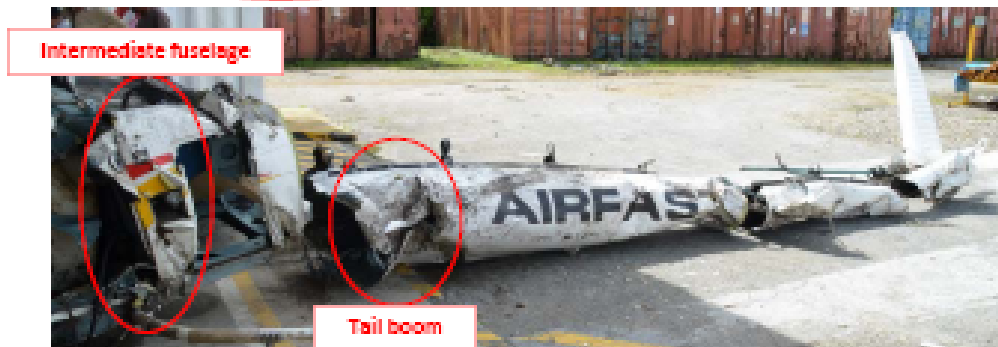
Main structure is highly damaged but exhibits some evidences of a significant longitudinal speed like deformation of the cabin floor, the lateral cross bulkhead deformation of the fuel surrounding structure, the lateral skin buckling of the intermediate fuselage and the tail boom

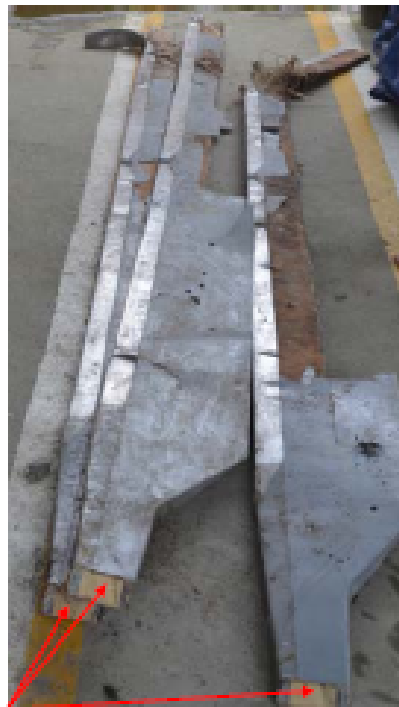
Blades cut for wreckage recovery

The main rotor blades are severely damaged due to the contact with the trees & the ground. These findings are consistent with a presence of significant rotor speed during the impact.

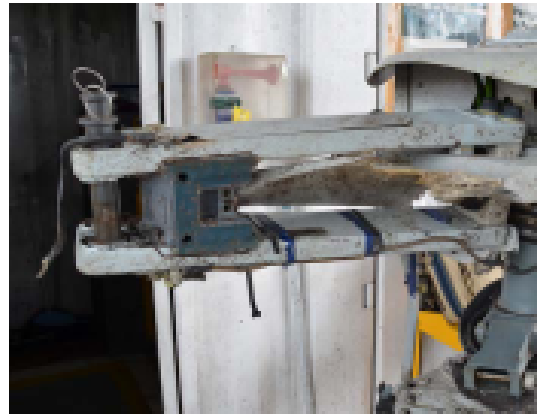
The Main Rotor Head exhibits significant damages resulting from the crash.

The three Star arms (rep 1) are broken with an angle of about 45° which is representative of a significant drag resulting from the ground contact.

The star arms exhibit also damages resulting from flapping.

Moreover, the drop restrainer/restraining ring exhibits high contact and deformation which is also consistent with the flapping damages observed on the star arms.

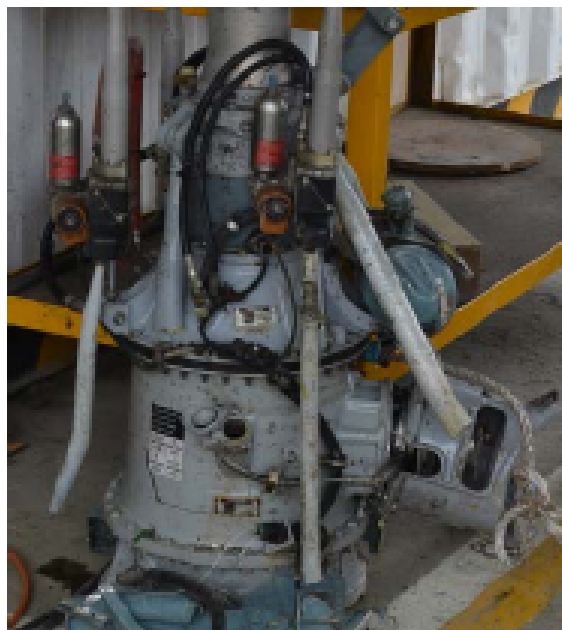
It was not possible to confirm the free rotation of the main rotor head likely due to the post-crash mechanical damage and deformation but no pre-crash damage or failure has been identified on this assembly (no overheating or distress evidence) and no particle has been found on the magnetic plug.

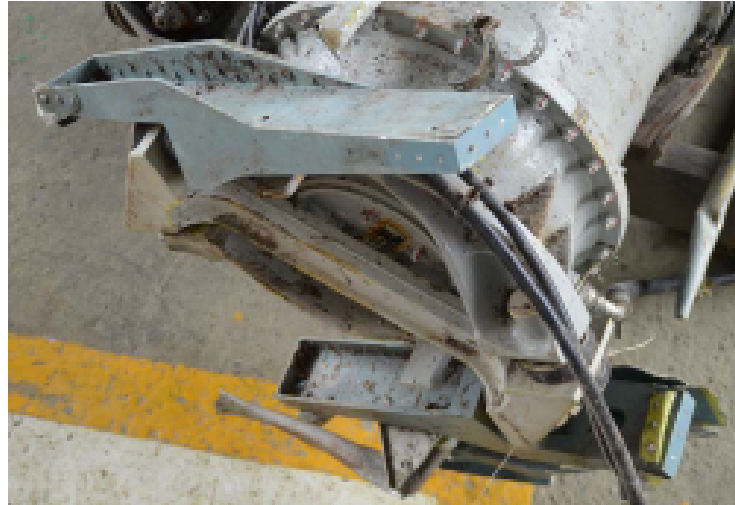
The main gearbox suspension exhibits overload failures and damages which are consistent with the result of the crash sequence.

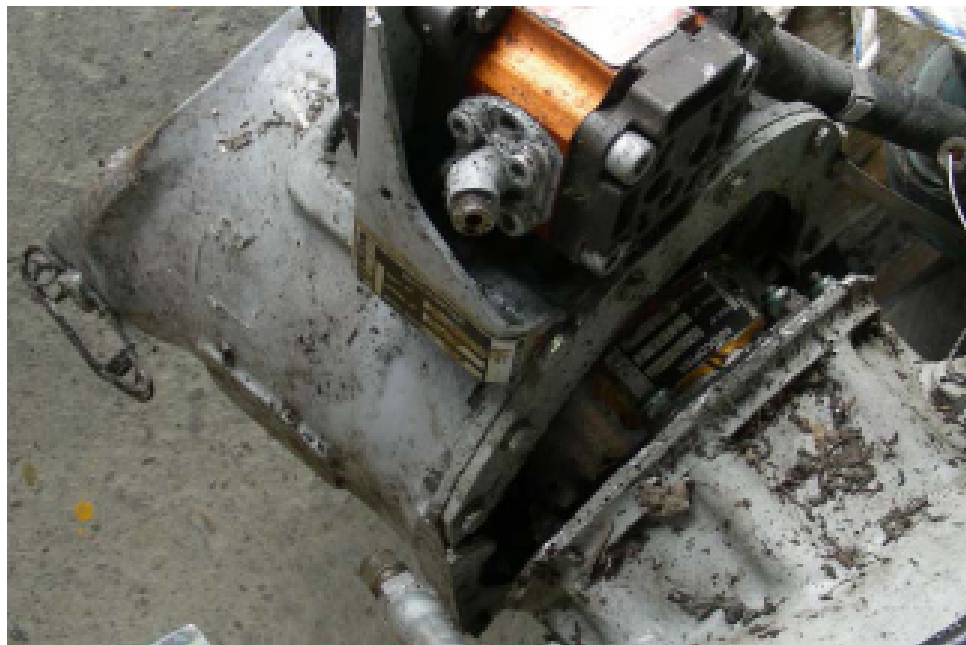
Connecting casing junction with MGB failure

The Engine to MGB coupling tube to Connecting casing coupling is broken due to overload at the gimbal ring area with evidence of mechanical interference with the rotating coupling shaft.

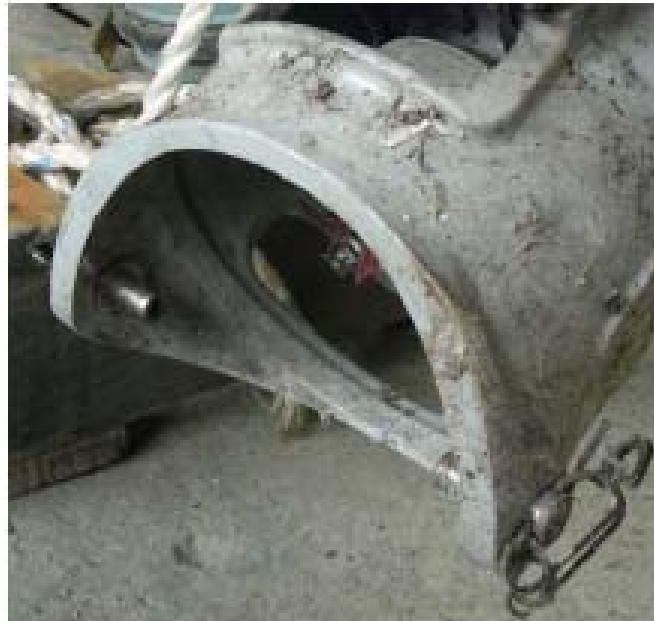
Connecting casing junction with missing Gimbal ring

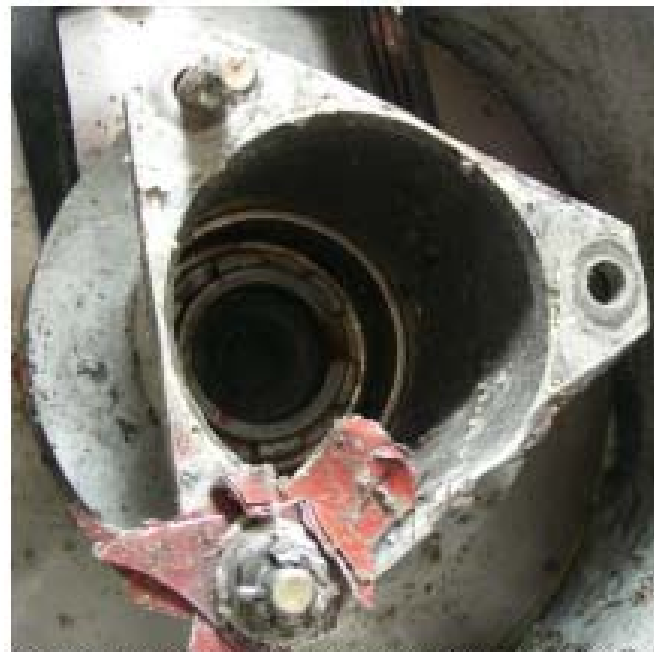
Failure of the drive shaft to MGE input flange Flexible coupling

The drive shaft to MGB input flexible coupling is broken at the MGB side.

One coupling bolt is missing, one coupling bolt exhibits significant shearing/bending deformation with elongation of the coupling hole and one is in position with part of flexible coupling destroyed due to overloads.

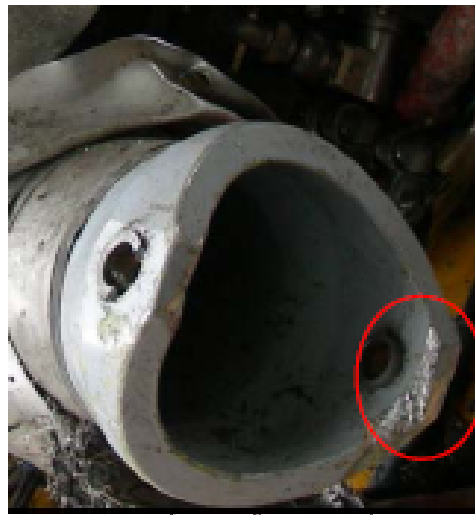
Evidence of mechanical interference with the rotating drive shaft

The coupling tube exhibits evidence of mechanical interferences with the rotating drive shaft flange which indicates that the drive shaft was still turning after the overload flexible coupling failure. The gimbal ring is missing.

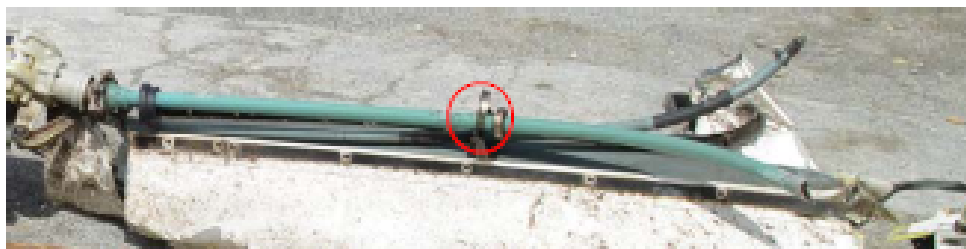
Only the aftward part of the rear light alloy drive shaft is available

Rear light alloy drive shaft

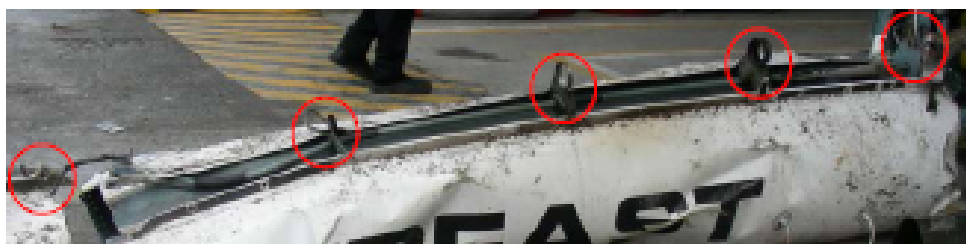
Rear light alloy drive shaft (missing parts)

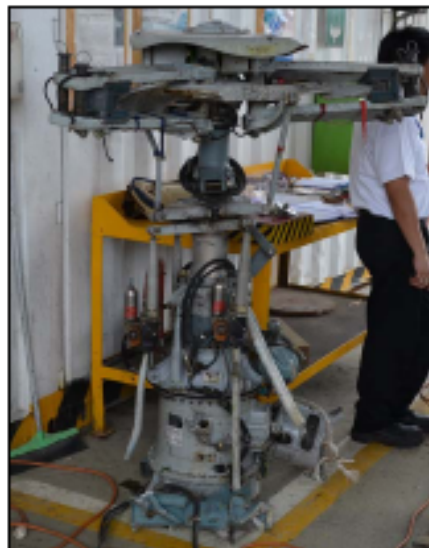
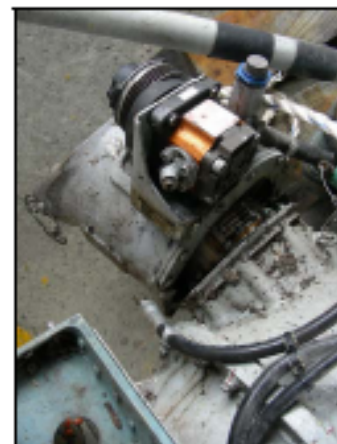
- The MGB's flange that holds the connecting casing was sheared all around its base resulting in the connecting casing hanging loose. Rubbing marks on the connecting casing indicated that the rupture probably occurred as a consequence of the crash.

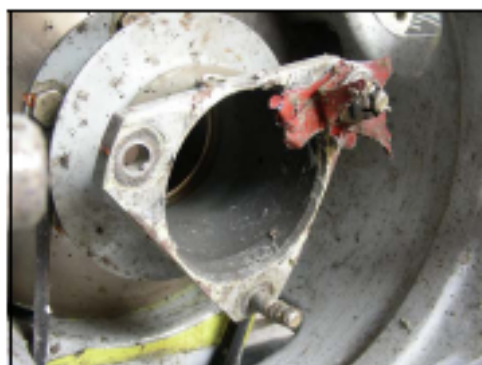
- Damage to the MGB and its supports indicate that it rotated counter-clockwise at the time of the crash. This was a result of the resistant effort generated by the blades hitting solid obstacles. This indicates that the engine was delivering power at the time of the crash.
- The outer flange of the MGB input pinion was in place. The flexor coupling normally connected to it was missing with only a small portion of it remaining around one of the fixing screws. This may have resulted from a combination of high torque levels and misalignment between the MGB and the engine at the time of the crash..

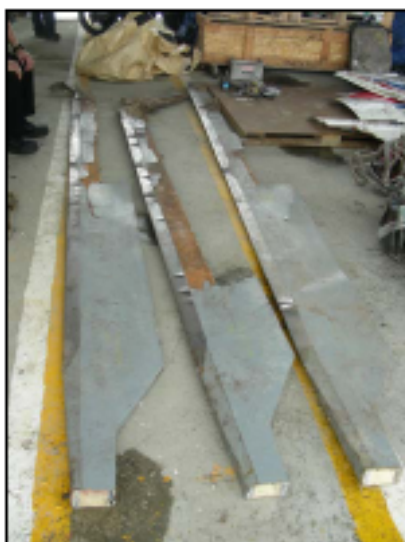
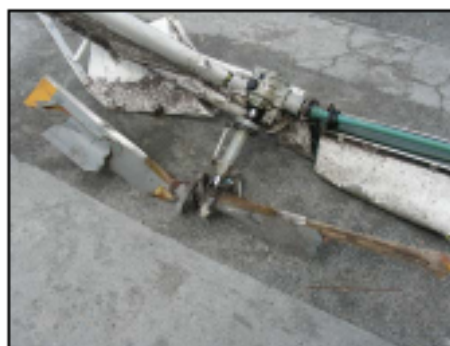
- All rotor blades sustained significant damages thus indicating the presence of power at the time they impacted obstacles (ground and/or trees).

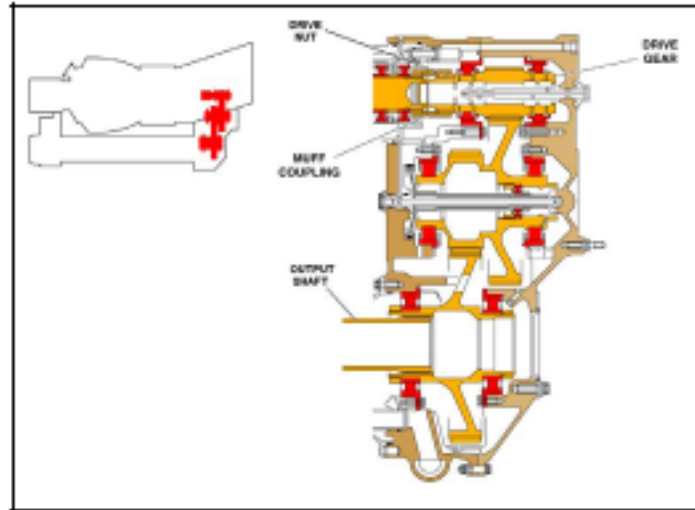
A close examination revealed that the nut had rotated on its shaft by approximately 0.5mm to 1mm.

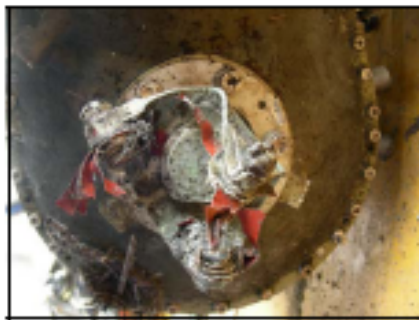
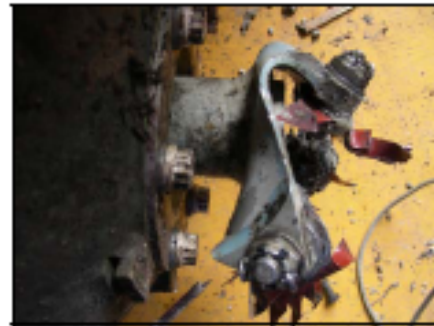
The three wings of the rear output shaft's flange were bent and twisted away from the engine and indicate that it was subjected to a high longitudinal force at the time of the crash. The drive shaft that links the engine to the tail gear box was not recovered.

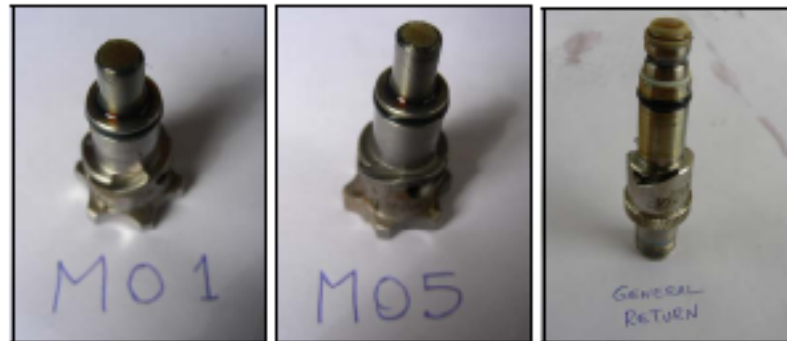
The magnetic plugs were checked. One filament like particle was found on the MO1 magnetic plug. Such an isolated particle does not represent any advanced stage of damage and it may have been released as a consequence of the accident. No other particle was found on the other magnetic plugs.
