AN OBSERVATION ON THE ACCIDENT OF NON-CONVENTION VESSELS CARRYING PASSENGER SANK IN INDONESIAN WATERS

T Sastrodiwongso and Aleik Nurwahyudy, National Transportation Safety Committee, Indonesia

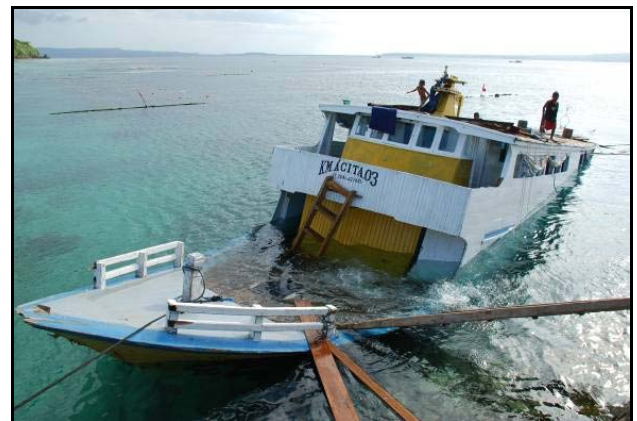
Figure 3: *KM. Acita-03* after evacuated to the Lakebau shore, Bau-bau.

It is concluded that the capsized of the vessel was caused by the loss of stability due to the movement of the passengers to one side of the vessel and accumulated at the Starboard Side of the top deck. The contributing factors of the accident are related to the construction of the ship and the stability.

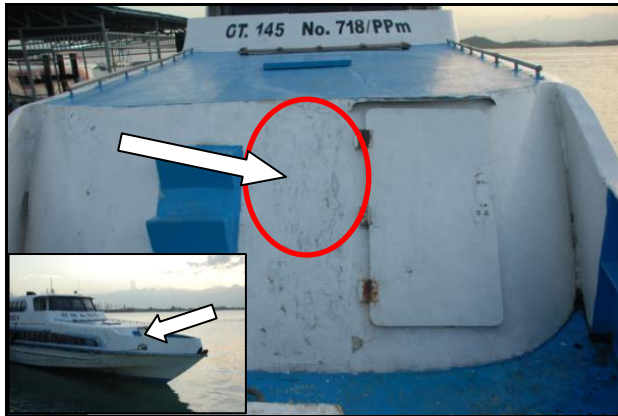
The superstructure's front wall was a position that gets direct pressure with waves of sea water, both arising from the movement of the ship or from the wave coming. Investigation found that the construction of rigid fore bulwark and freeing port installed in the bow structure was not sufficient to let the large volume of sea water escaped freely. According to the statement provided by the master, before the accident, the ship's bow was submerged

According to the information from the shipyard, the thickness of the superstructure front wall which fully made from FRP was only 4 mm and reinforced by 500 mm spacing stiffeners. At the time the ship was constructed, there was no material testing nor any inspection ever performed. The FRP layer constructions were built by the experience from the ship builder.

Following the water ingress from the breached superstructures front wall, the water was trapped inside the foreside of the accommodation area as there were no opening or freeing port on the deck. This condition has worsened the ship buoyancy as there was no escape point for the seawater.

Figure 5: the breached position of 4 mm superstructure's front wall as indicated by white arrow
