KNKT/99.06/02.04.008

AIRCRAFT ACCIDENT REPORT

Mandala Airlines MDL493

Boeing B737-200 Adv PK-RIL

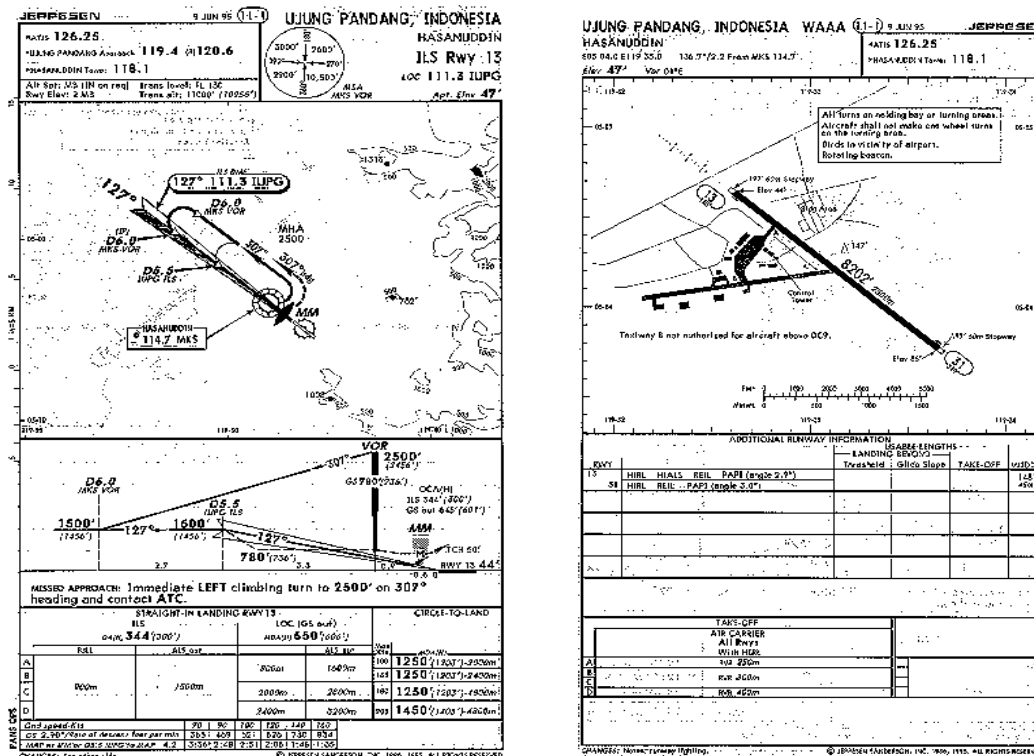
**Figure 1. Airport lay out and ILS approach chart R/W 13 (Current Jeppesen approach chart information)**

The airport has been known to be a difficult for approaches in the months of November to April, which is the rainy season for the region. Westerly winds and turbulence are expected to be encountered on short final to R/W 13.

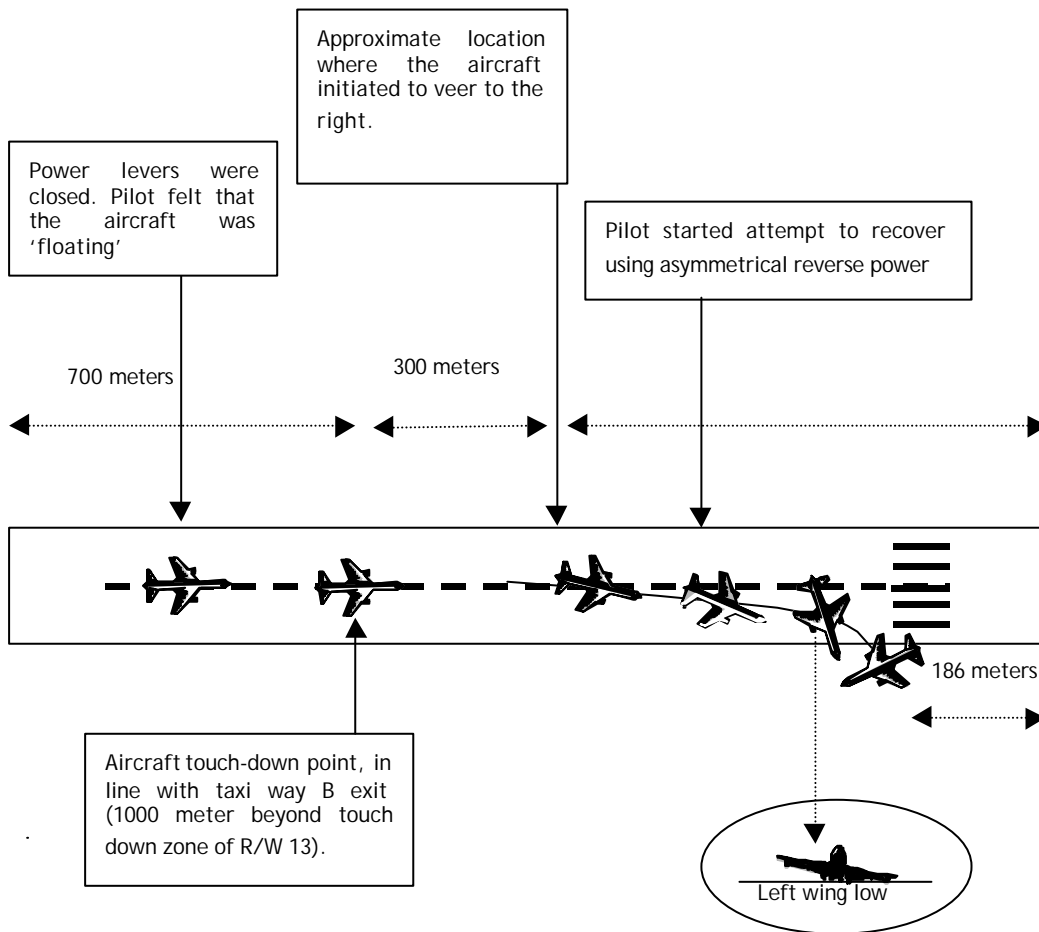
**Figure 2. Aircraft ground roll trajectory (sketch)**

The final position of the aircraft was at 186 meters from the R/W 13/31 threshold. No tire markings of first touch down were found on the runway, although it was reported that the approximate touch-down point was in line with the taxiway B exit, approximately 1000 meters beyond the R/W 13 touch down zone.

No tire brake markings were found along the approximate ground roll trajectory. Rubber deposits were found on R/W 13 at the point where the aircraft started veering to the right, which was at approximately 75 meters before the location where aircraft went off the runway. The significant facts and findings gathered were analyzed. The SHEL concept approach was used in the analysis. The analysis of the events and circumstances which may have contributed to the occurrence were weather conditions, wind measuring equipment, aircraft systems, flight and ground operations procedural deficiencies.

5. REC/99.06.04.02/I/14 (ref. Preliminary recommendation no. R.14/AAIC/99) - The rubber deposit at both ends of the runway must be removed before the rainy season.

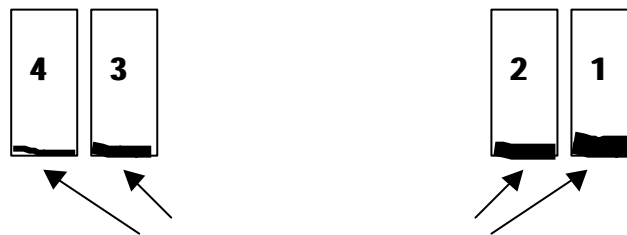
**Figure 3. The tire damage on the main wheel surfaces (worn spots on each main wheel) - front view**

One worn spot in line on all main tires were found and the #1 tire had the worst and followed linearly by #2 tire and #3 tire. The #4 tire was identified having a smaller worn spot mark than the others.

- 6) **Landing gear**. All landing gear tires showed worn out spots. The worst damage was found on the landing gear #1 tire, linearly diminishing in size, the worst or the largest worn out areas were found on landing gear tire #1 gradually diminishing in size on tires #2, #3 and #4. The worn out spot sizes were approximately 20x30 sq cm and less. The #1 landing gear damage is most likely due to high loading during the high speed right turn of the aircraft, which was also evidenced by the separation of the #1 engine.

- The damage to the tire surfaces indicates that the #1 tire experienced the highest loads during the landing maneuver, evidenced also by the separation of the #1 engine during the landing. The existing airport infrastructure was not sufficient to make instrument approaches on R/W 31. The only approach procedures published are ILS and VOR approaches for R/W 13 only. Note that at the time of the occurrence it was raining and the wind velocities and direction were northerly with gusts of up to 20 kts, while the aircraft operation manual procedures stated a tailwind limit of 20 kts during landings. It is noted that the weather monitoring system equipment is located near the tower at about 50 meters distance from the runway. During the landing maneuver, the approach control communicated with, and controlled the aircraft until touch-down.

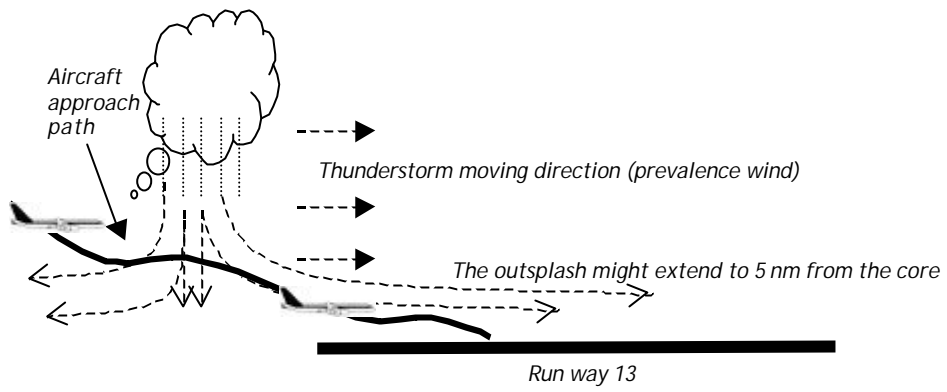
**Figure 4. The aircraft approach path illustration**

Note that these weather data may well point to wind changes that has the characteristics of wind bursts in the Hasanuddin Airport surrounding areas, resulting the aircraft touching down at approximately 3,000 ft beyond the target touchdown point.
