**Aircraft Accident Preliminary Investigation Report**

**KNKT/09.16.04.05**

**DORNIER 328-100**

**PK-TXN**

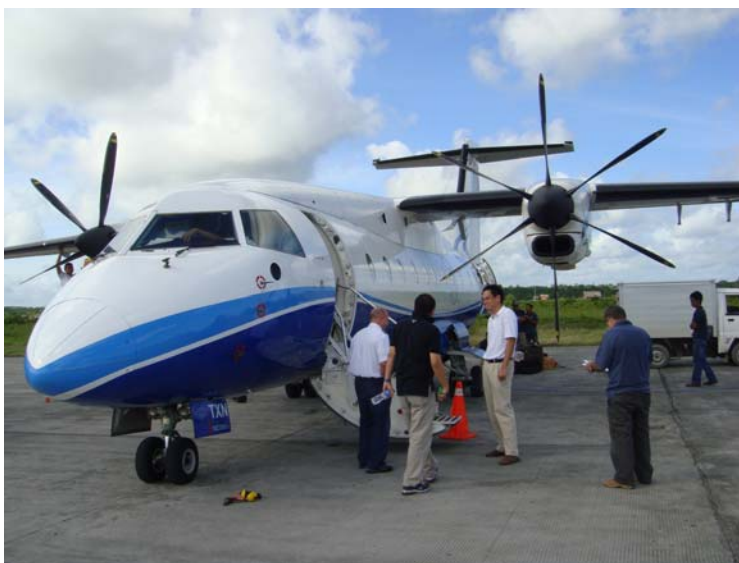
**Figure 1: PK-TXN, Dornier 328-100 at Sentani Airport on 14 June 2009**

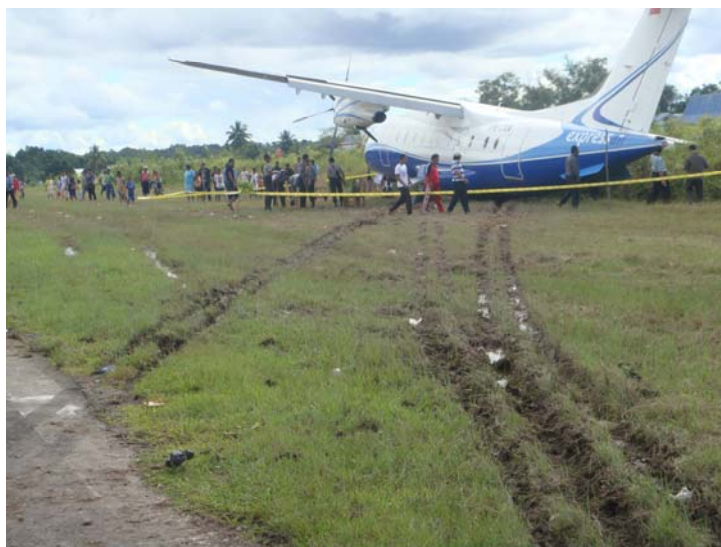
**Figure 2: Wheel marks on the muddy runway shoulder**

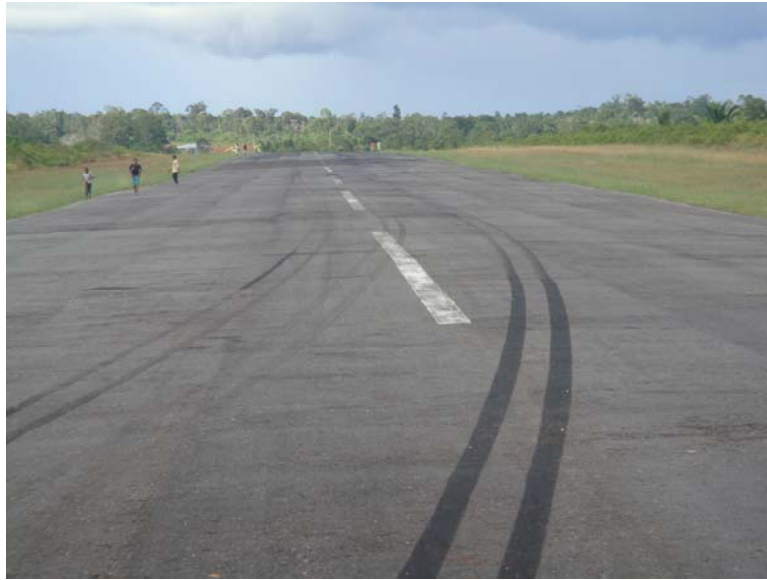
**Figure 3: Tire marks on runway starting to roll to right**

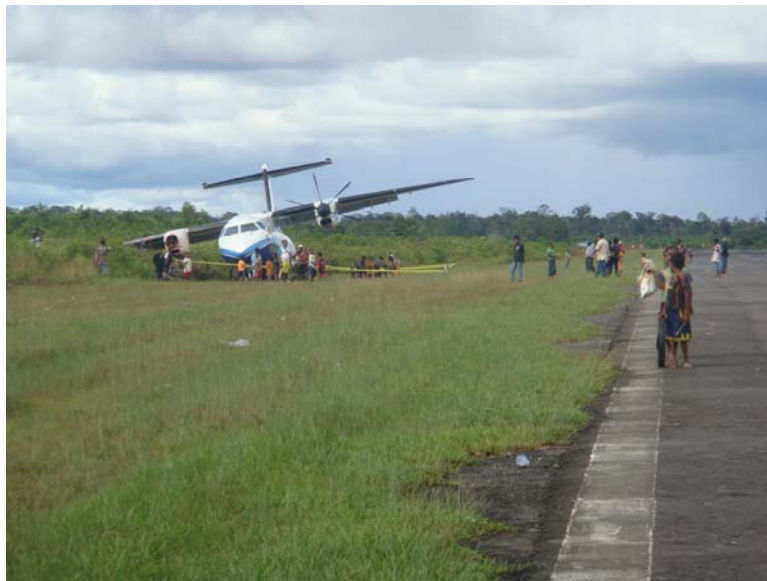
**Figure 4: Final position of the aircraft**

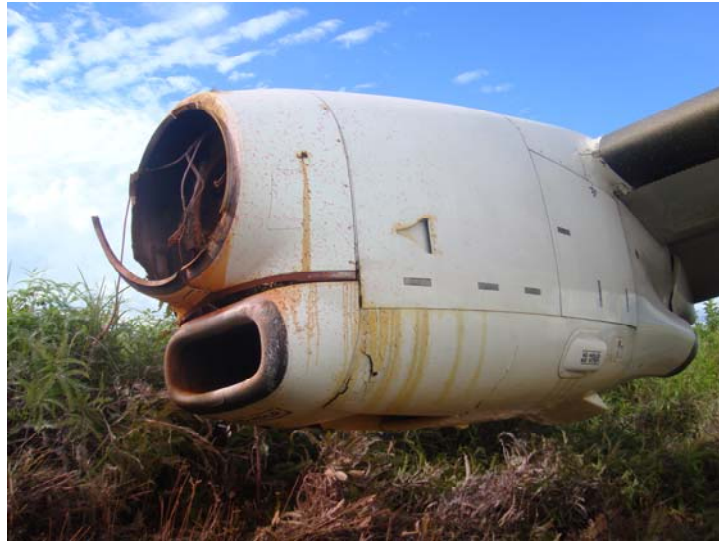
The right engine and propeller were substantially damaged and the right wing tip was resting on the ground.

**Figure 5: Right engine without propeller**

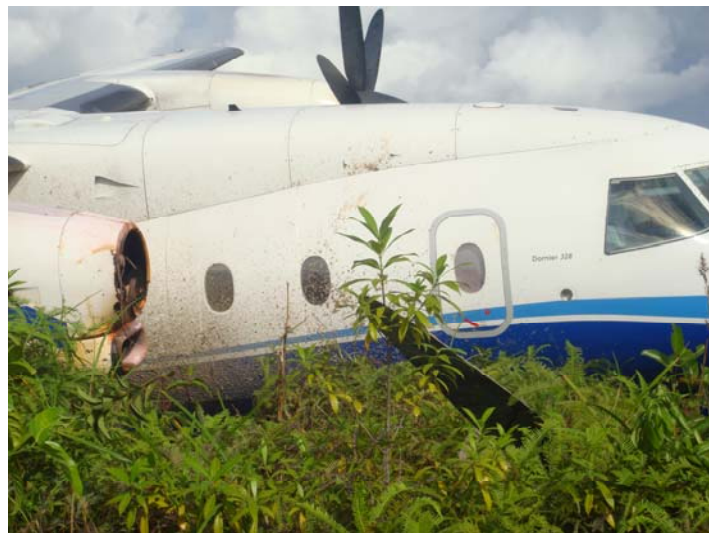
The right wheels sank into the soft ground of the runway shoulder, and the left wheels and the nose wheels were on the shoulder. The right propeller blades fractured as they struck the ground and the propeller assembly was torn from the engine and came to rest approximately 4.5 meters from the right engine. The right engine was substantially damaged.

**Figure 6: Propeller position 4.5 meters away from the engine**

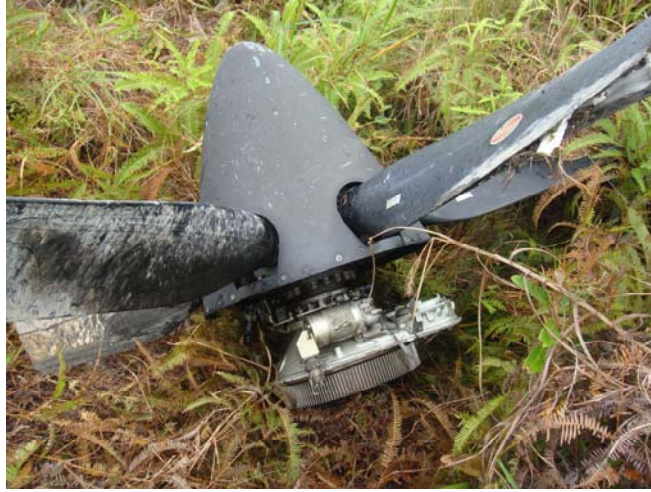
**Figure 7: Right propeller and section of the propeller gear box**

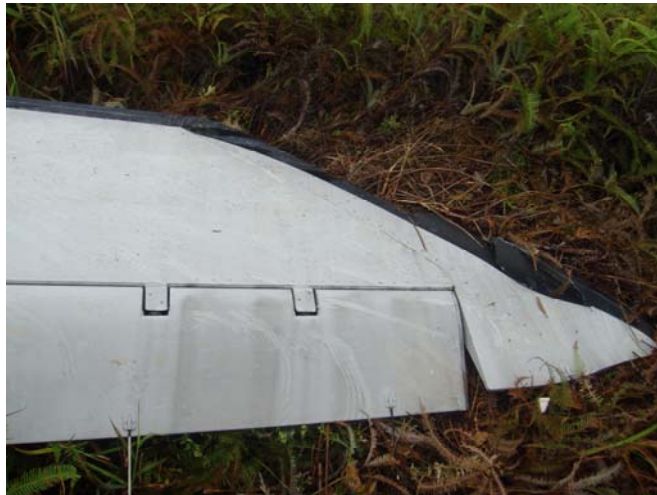
**Figure 8: Right wing tip damage, no wrinkles on wing**

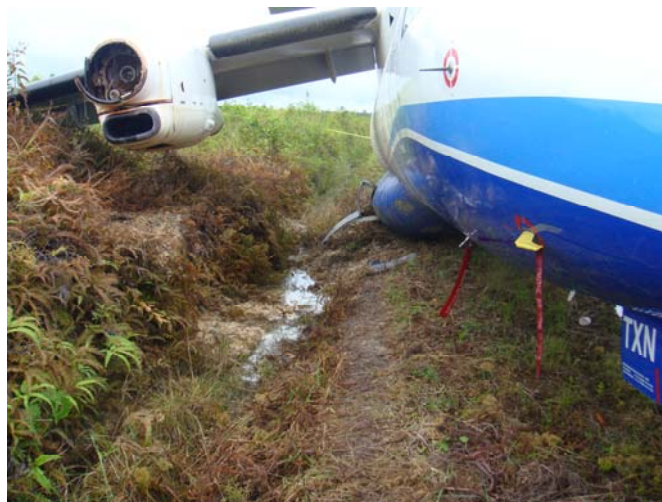
**Figure 9: Right side of the aircraft**

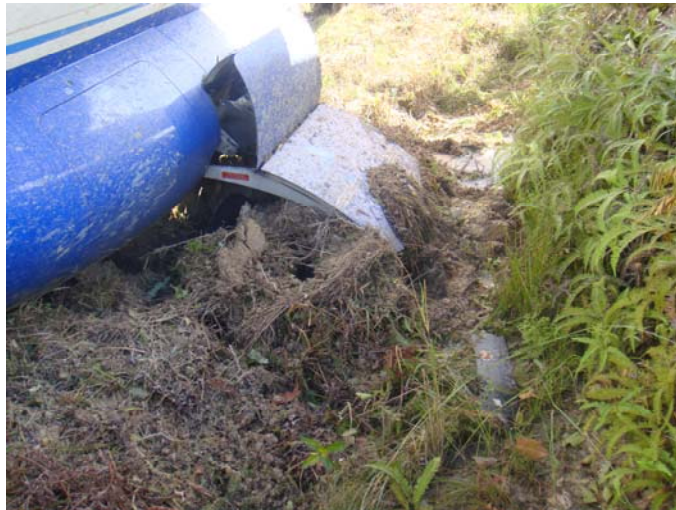
**Figure 10: Propeller hit an earth hump (underneath the front of RH gear)**

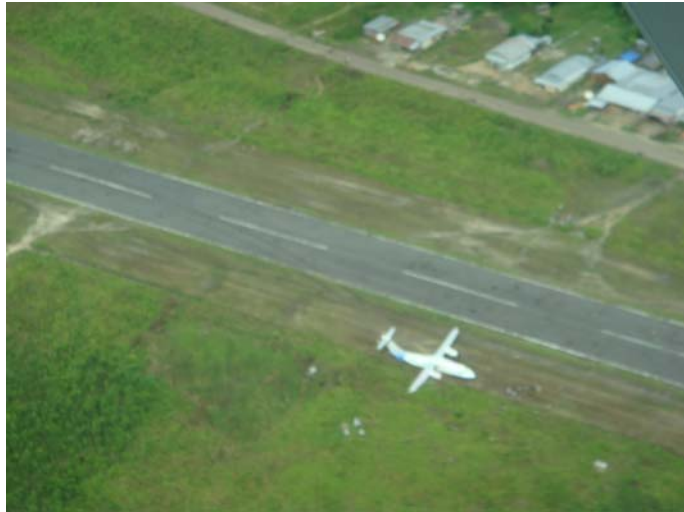
**Figure 11: Wreckage taken from the air**

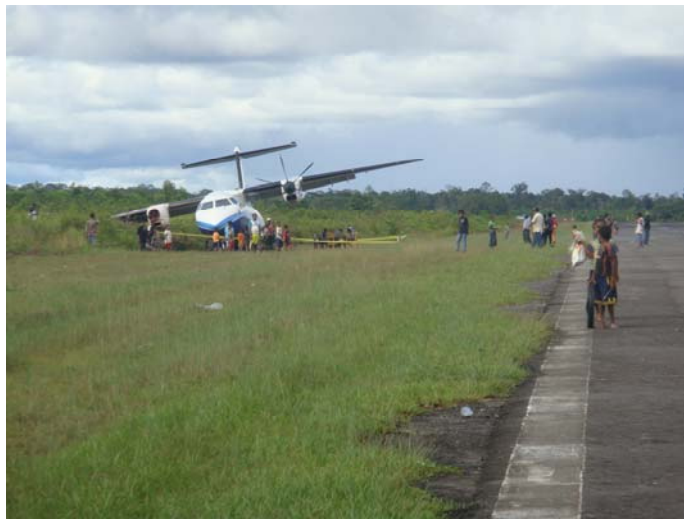
**Figure 12: Final position 600 meters from touch down area**
