**HISTORY OF TAIL ROTOR SHAFT**  
**part number 330A.33.3165 E1, serial number M1941**

**THE DAMAGED TAIL ROTOR SHAFT WITH GEARBOX S/N 187  
AFTER REMOVAL FROM G-PUMH**

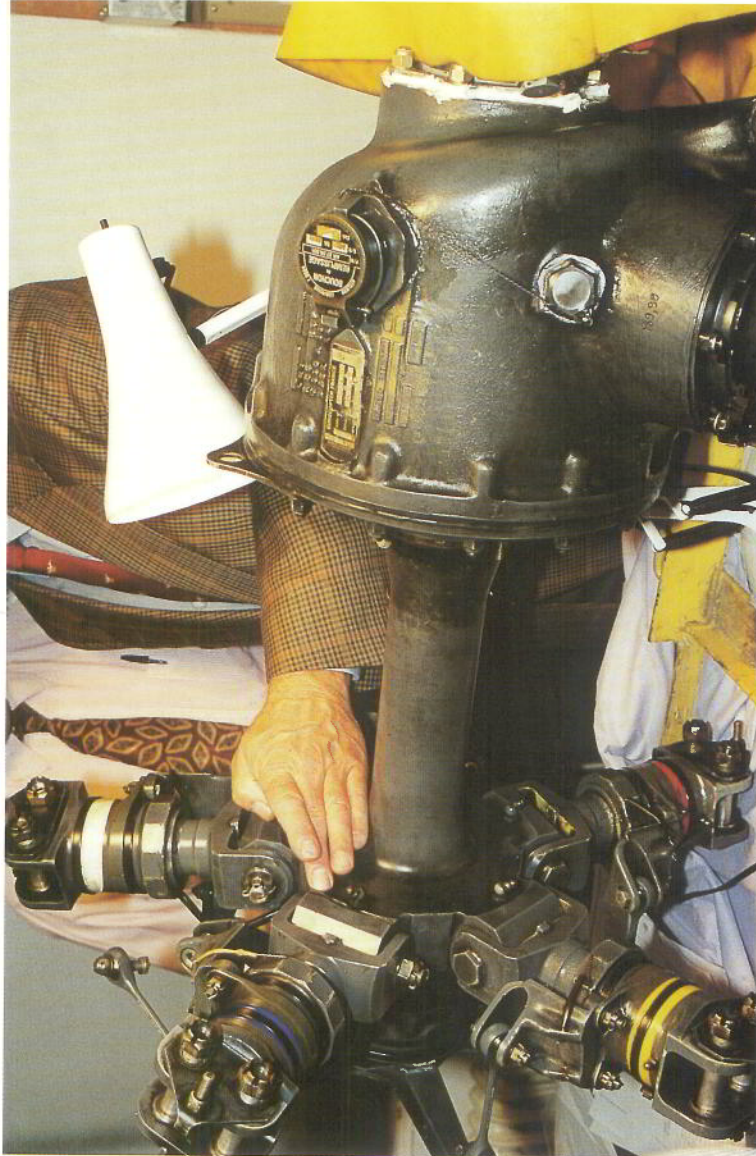
The crack, clearly visible at the grease point, is being indicated

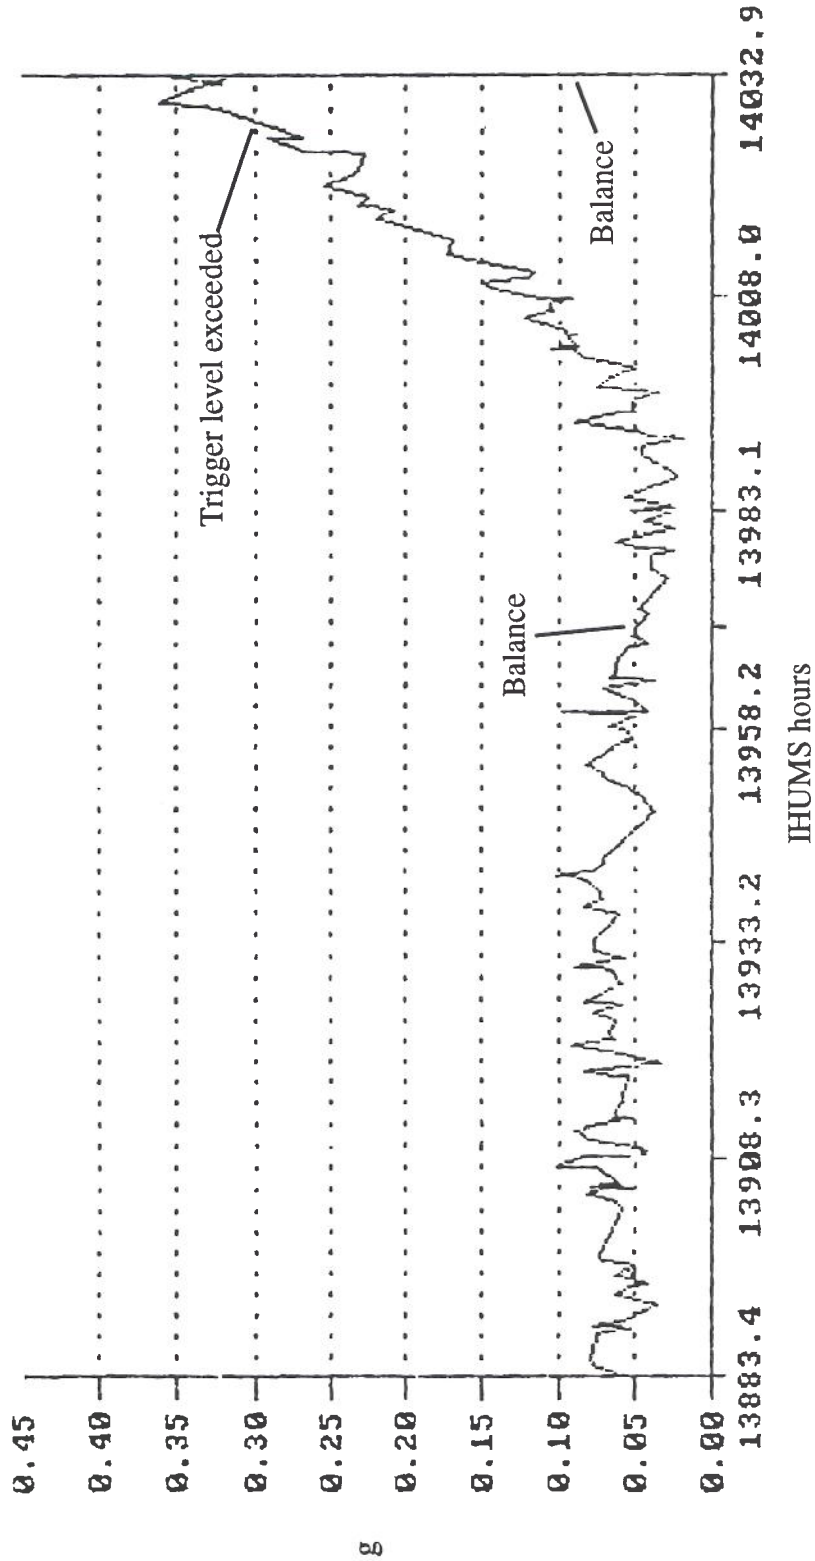
IHUMS TRACE  
TAIL ROTOR GEARBOX OUTPUT, G-PUMH

Fundamental shaft order  
(showing 8% of points)

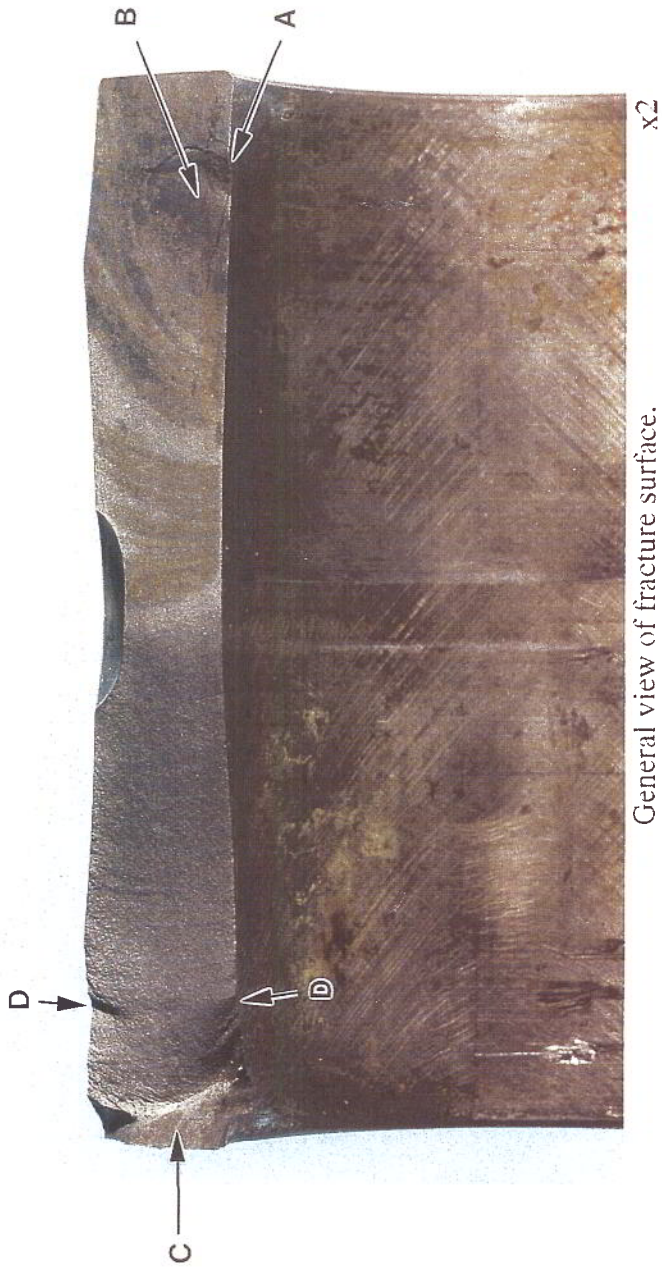
**FRACTURE FACE**

This photograph of the fracture face is taken from the DRA metallurgical report DRA/SMC2/R51AP027/E2144

- A crack initiation
- B stained area
- C ductile rupture zone
- D "ripple" marks at edges of fracture.

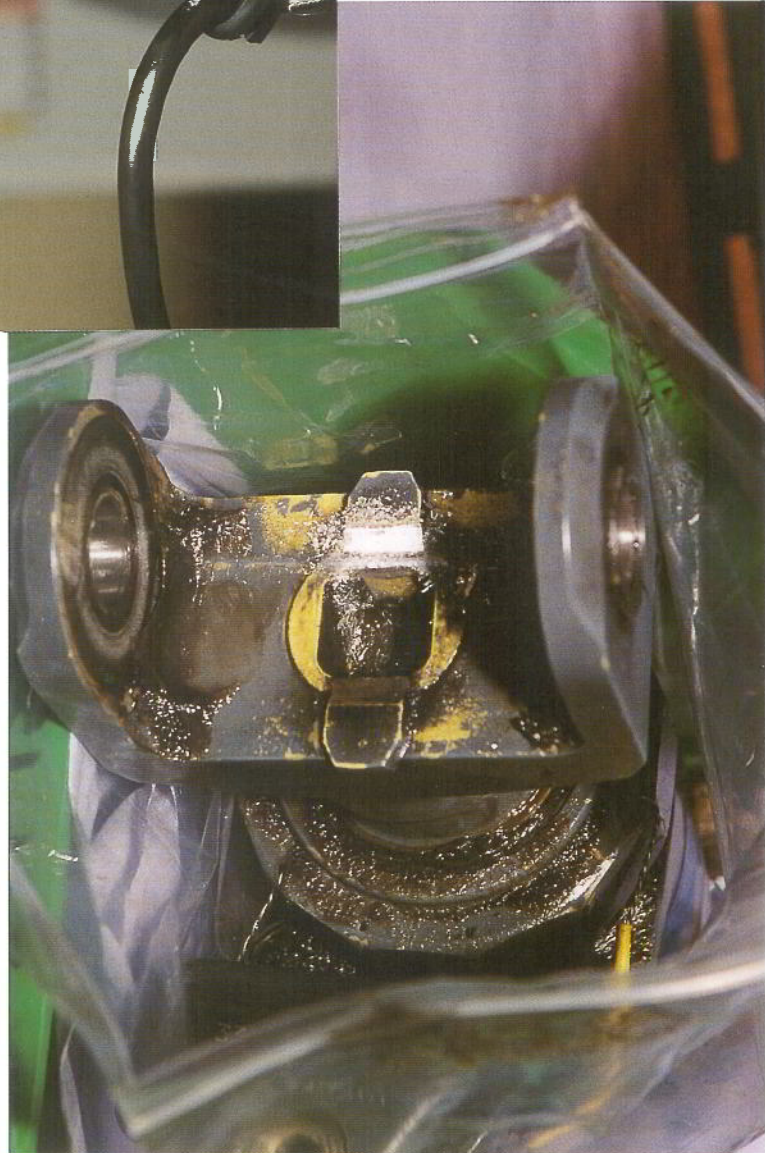
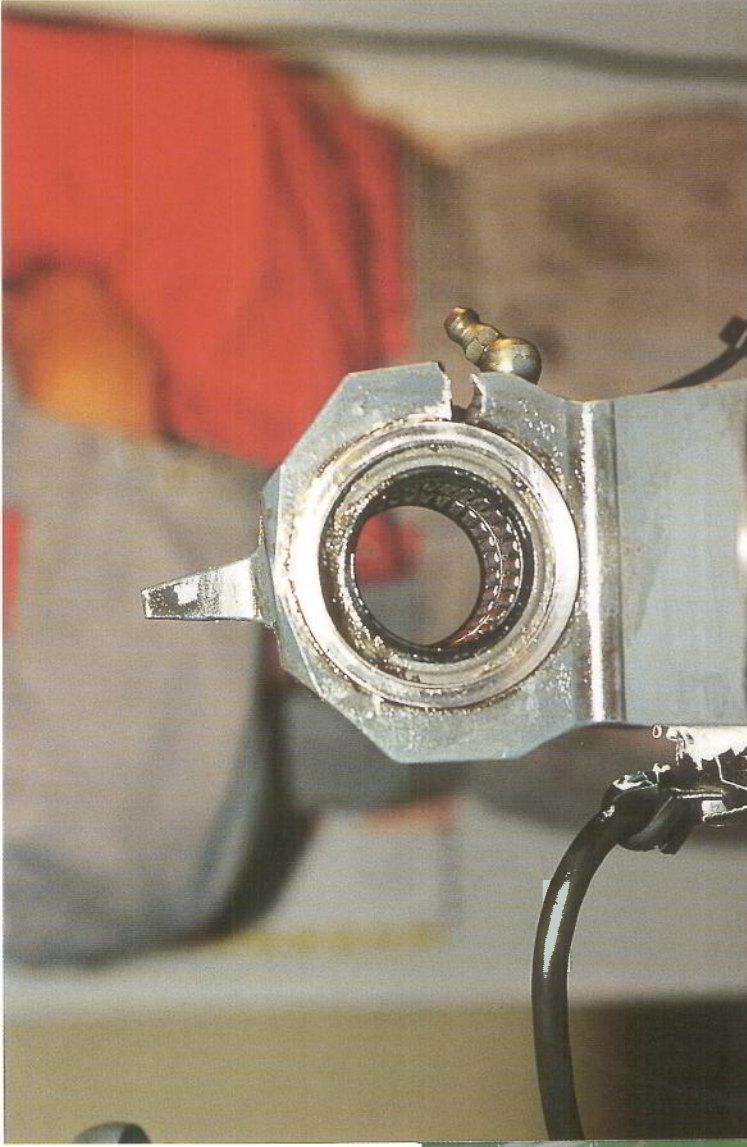
FLAP STOP DAMAGE

Below - the aluminium insert in the blade spindle has sustained heavy wear as a result of repeated contact with the flap stop. Note the aluminium debris generated by this process

Above - with the blade and inner race of the flap bearing removed, the extent to which the crack has opened up can be seen. Note also the angle made by the flap stop, causing contact between the blade spindle and the flap stop with the attendant relief of the bending moment in the flapping hinge retainer.

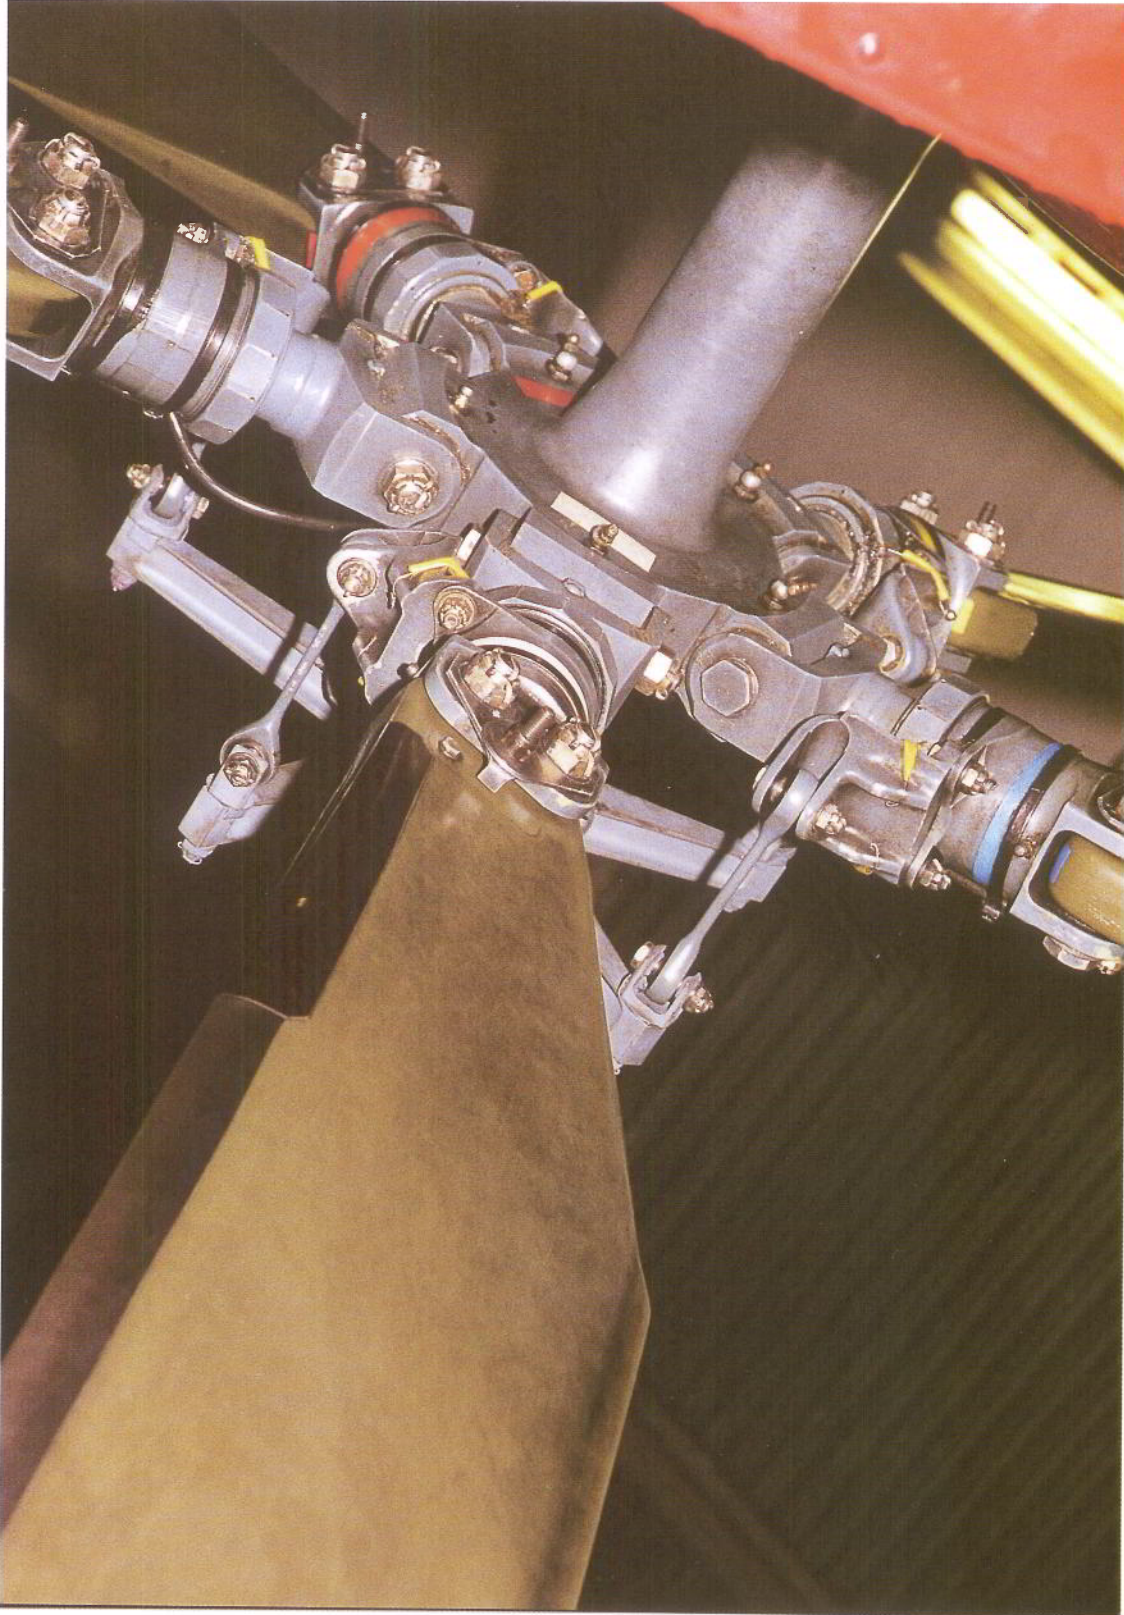
**TYPICAL VIEW OF TAIL ROTOR AVAILABLE  
TO ENGINEER FROM STAGING**

Note that the crack location on the nearest blade is completely obscured,  
and partly obscured on the more distant blades

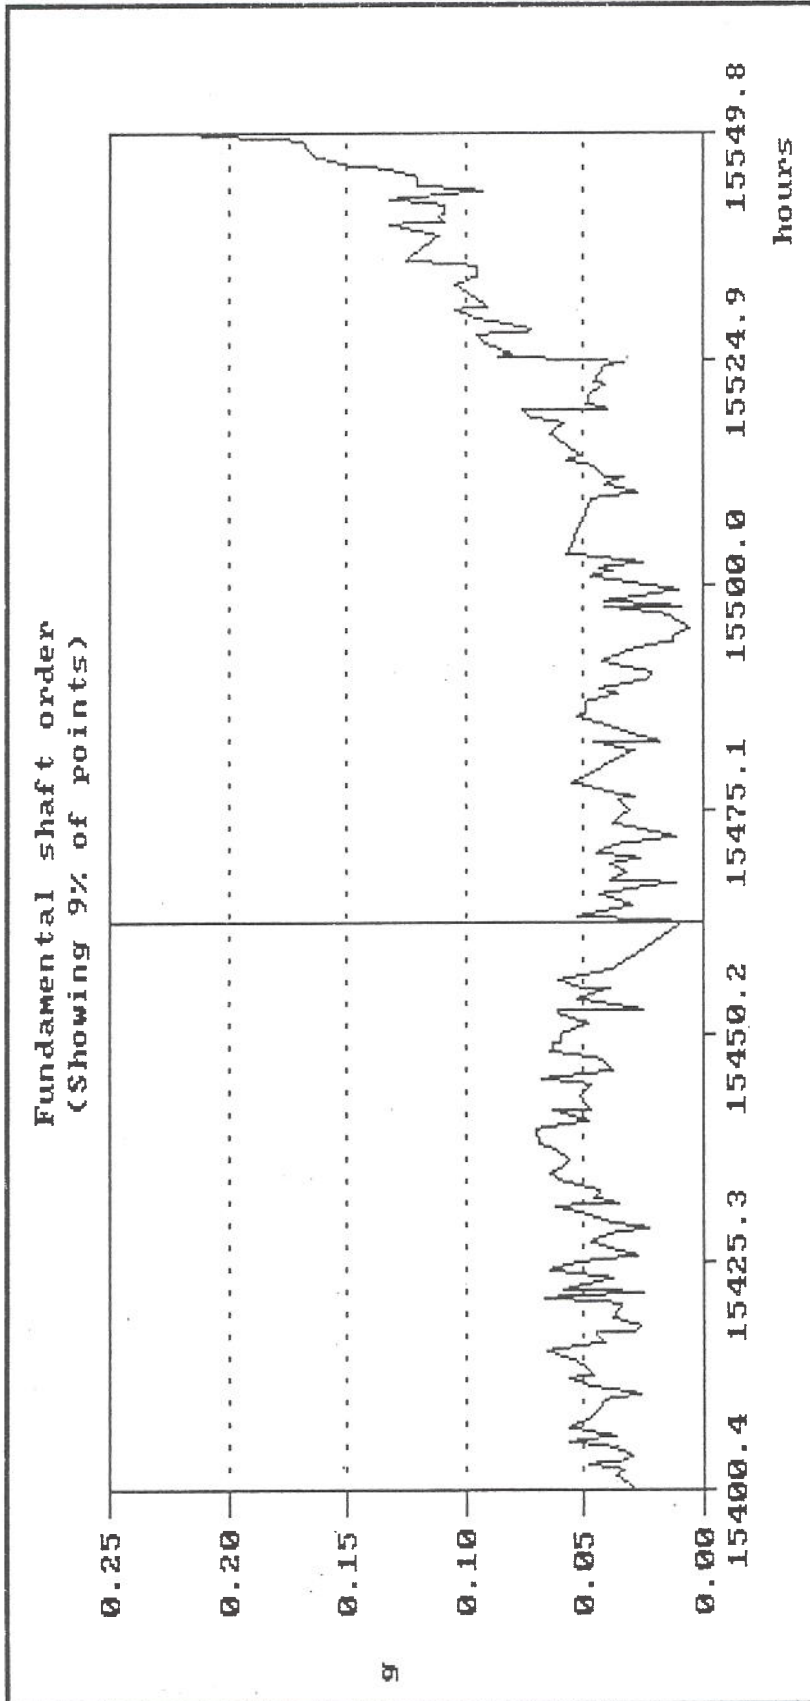
**G-PUMB IHUMS TRACE**

This trace, from another AS332L, is visually very similar to that of G-PUMH, however the cause was found to be a steadily deteriorating flap hinge bearing.
