# AIRCRAFT ACCIDENT REPORT 2/2018

Report on the serious incident to  
**Boeing 737-86J, C-FWGH**  
Belfast International Airport  
on 21 July 2017

**Air Accidents Investigation Branch**

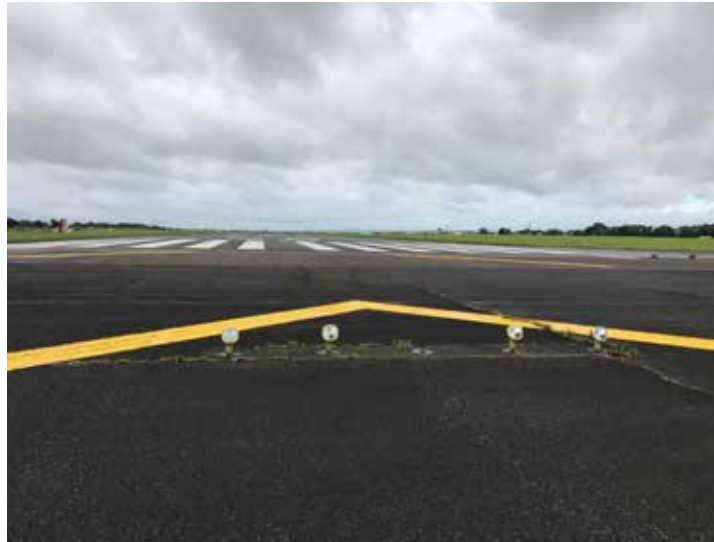
**Figure 6**

Within the stopway were two sets of supplementary approach lights for Runway 25. Each of these sets had thirteen lights set out in three groups across the tarmac. These lights were positioned 36 cm above the stopway surface. The first set of lights was 29 m beyond the end of Runway 07, with the stopway ending 60 m beyond the end of Runway 07. The aircraft struck the centre light within the first set of supplementary approach lights. Figure 5 shows the layout of the lights, together with the dimensions of the stopway and indicates the direction of travel of the aircraft and the light the aircraft struck. Figure 6 shows the view from the stopway with the centre light missing.

The view from the stopway showing the centre light missing

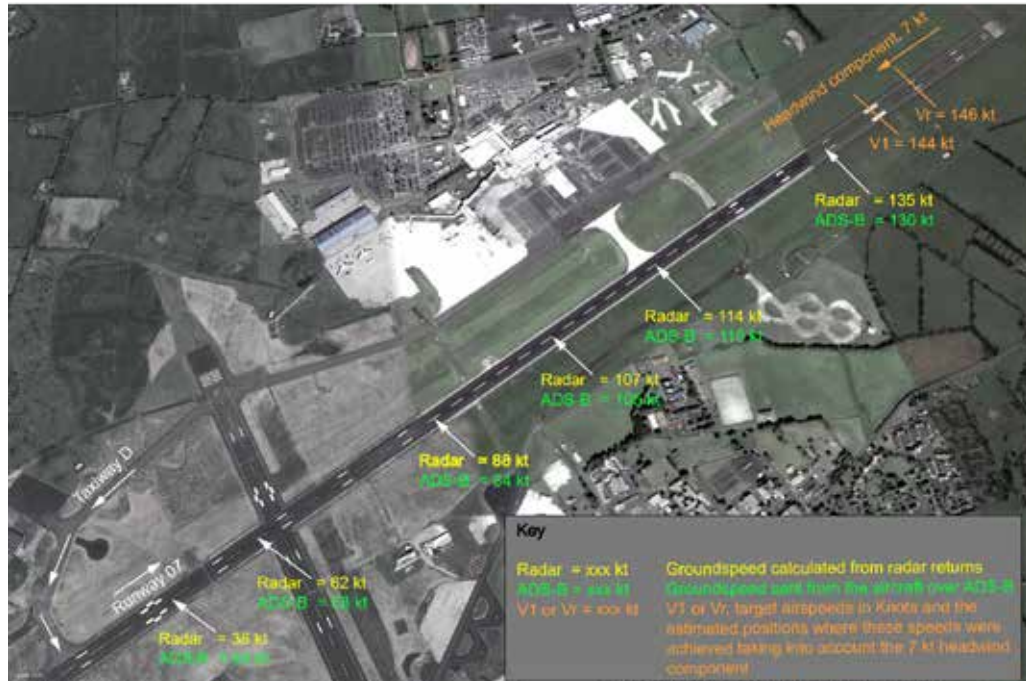
**Figure 10**

The radar installation at Belfast International Airport tracked C-FWGH along Runway 07 and during initial climb-out, when altitude data also became available from the aircraft's transponder. The radar returns allowed groundspeed for the aircraft to be calculated which was supplemented by both groundspeed and altitude data transmitted from the aircraft over its Automatic Dependent Surveillance – Broadcast (ADS-B) datalink. This data is shown in Figure 10 for the ground roll, where the text in yellow represents calculated groundspeed data from the radar track and, in green, the received ADS-B groundspeeds. Orange lines show the approximate position where the aircraft achieved airspeeds equivalent to the EFB-calculated  $V_1$  and  $V_R$ , considering the 7 kt headwind component.  $V_R$  would have been achieved approximately 300 m from the end of the runway.

Groundspeed data for the takeoff in relation to the EFB calculated  $V_1$  and  $V_R$   
 © 2017 Google, Image © 2017 DigitalGlobe

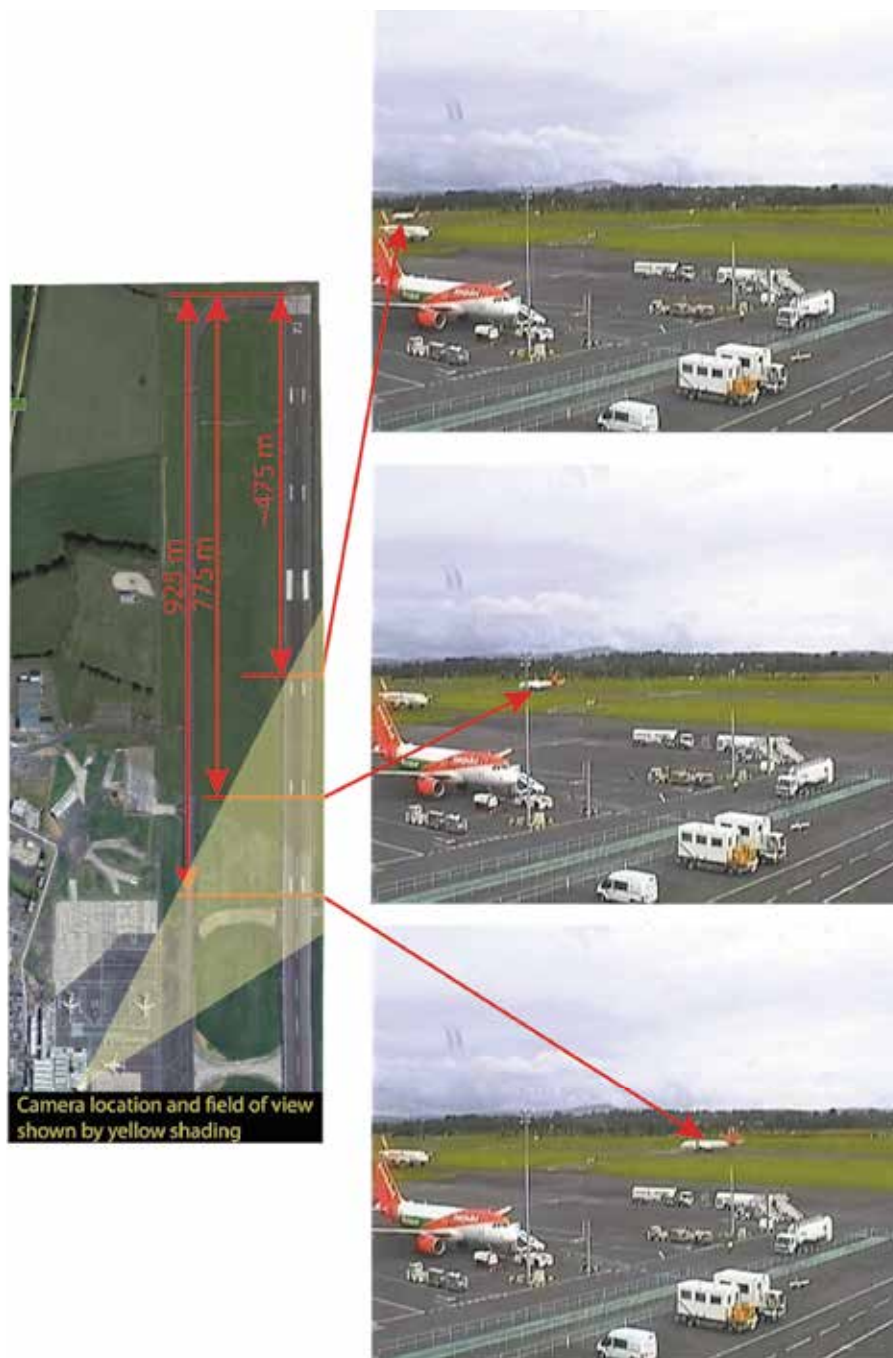
Figure 12

The airport operator provided the AAIB with closed-circuit television (CCTV) recordings of C-FWGH's takeoff from two cameras. The first camera's field of view recorded the segment between 1,000 m and 475 m from the departure end of Runway 07. At the end of this segment, C-FWGH had not rotated (Figure 12).

The first CCTV recording showing C-FWGH's takeoff

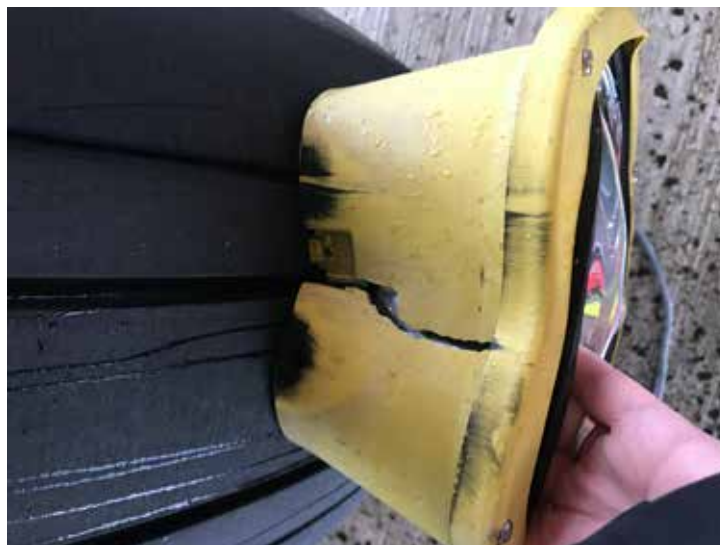
**Figure 16**

One of the supplementary approach lights within the Runway 07 stopway was found lying on the ground during the runway inspection. Closer examination revealed that the light had significant impact damage with evidence of black rubber deposits.

When compared with the tread on the tyres on C-FWGH, the pattern of rubber deposits indicated that the light had probably been struck by one of the main gear tyres. Chemical analysis of the rubber deposit was unable to confirm whether a main or nose landing gear tyre struck the light (Figure 16).

Aerodrome lights are designed to be frangible. If struck by an aircraft they are to break causing minimal or no damage to the aircraft. The crew were unaware that they had struck a runway light and there was no damage to the aircraft structure or tyre from striking the light.

Tread pattern comparison with main gear tyre
