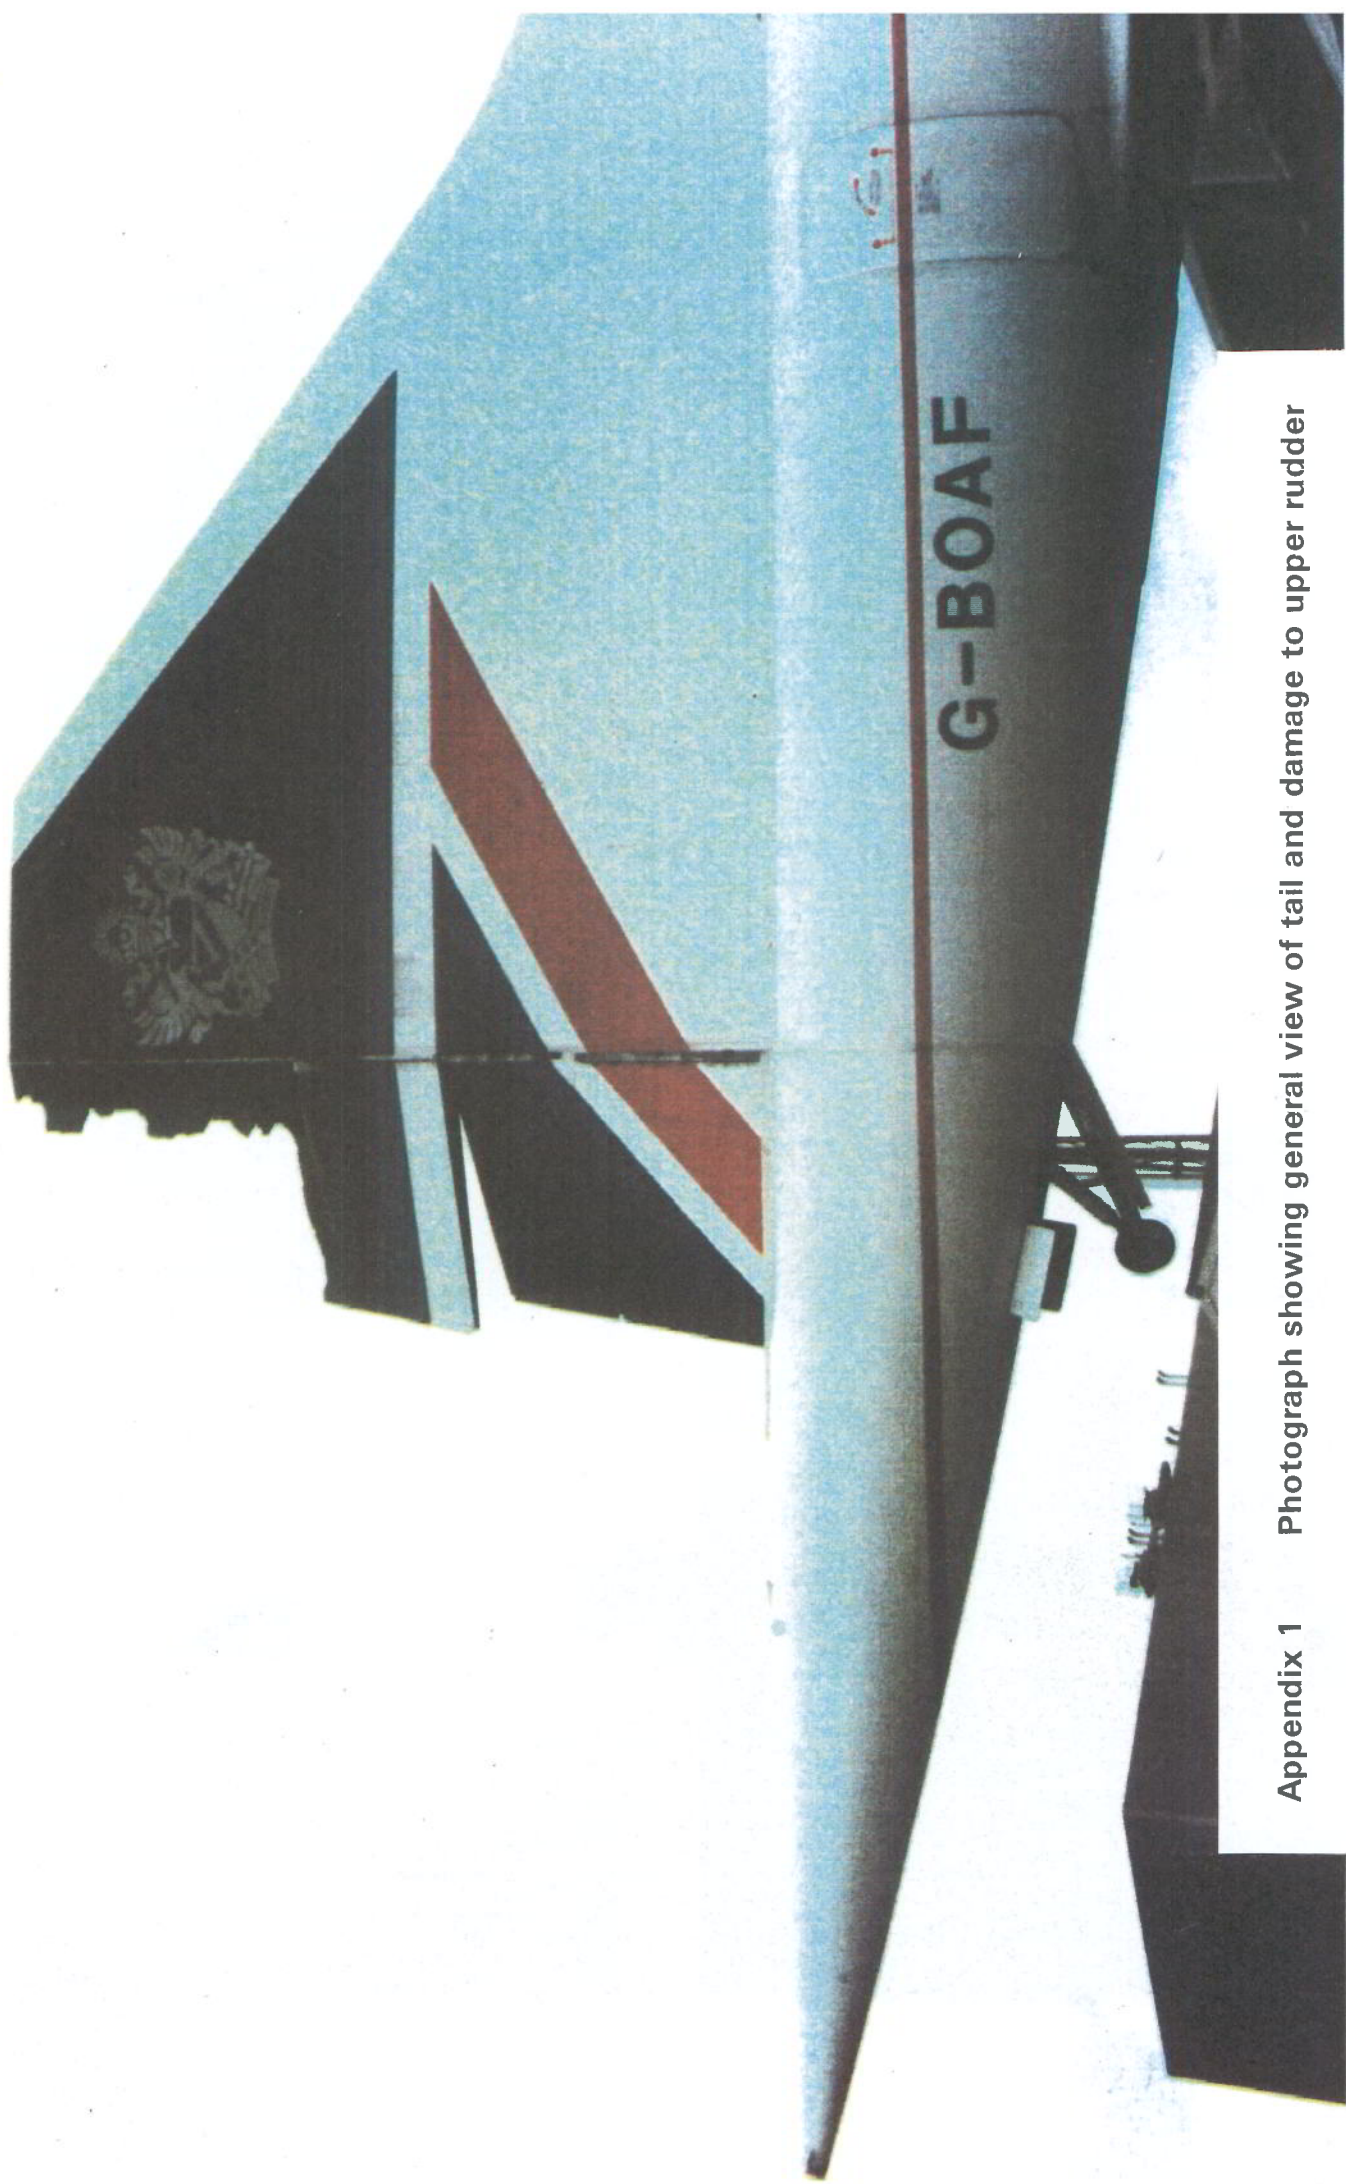
Appendix 1 Photograph showing general view of tail and damage to upper rudder

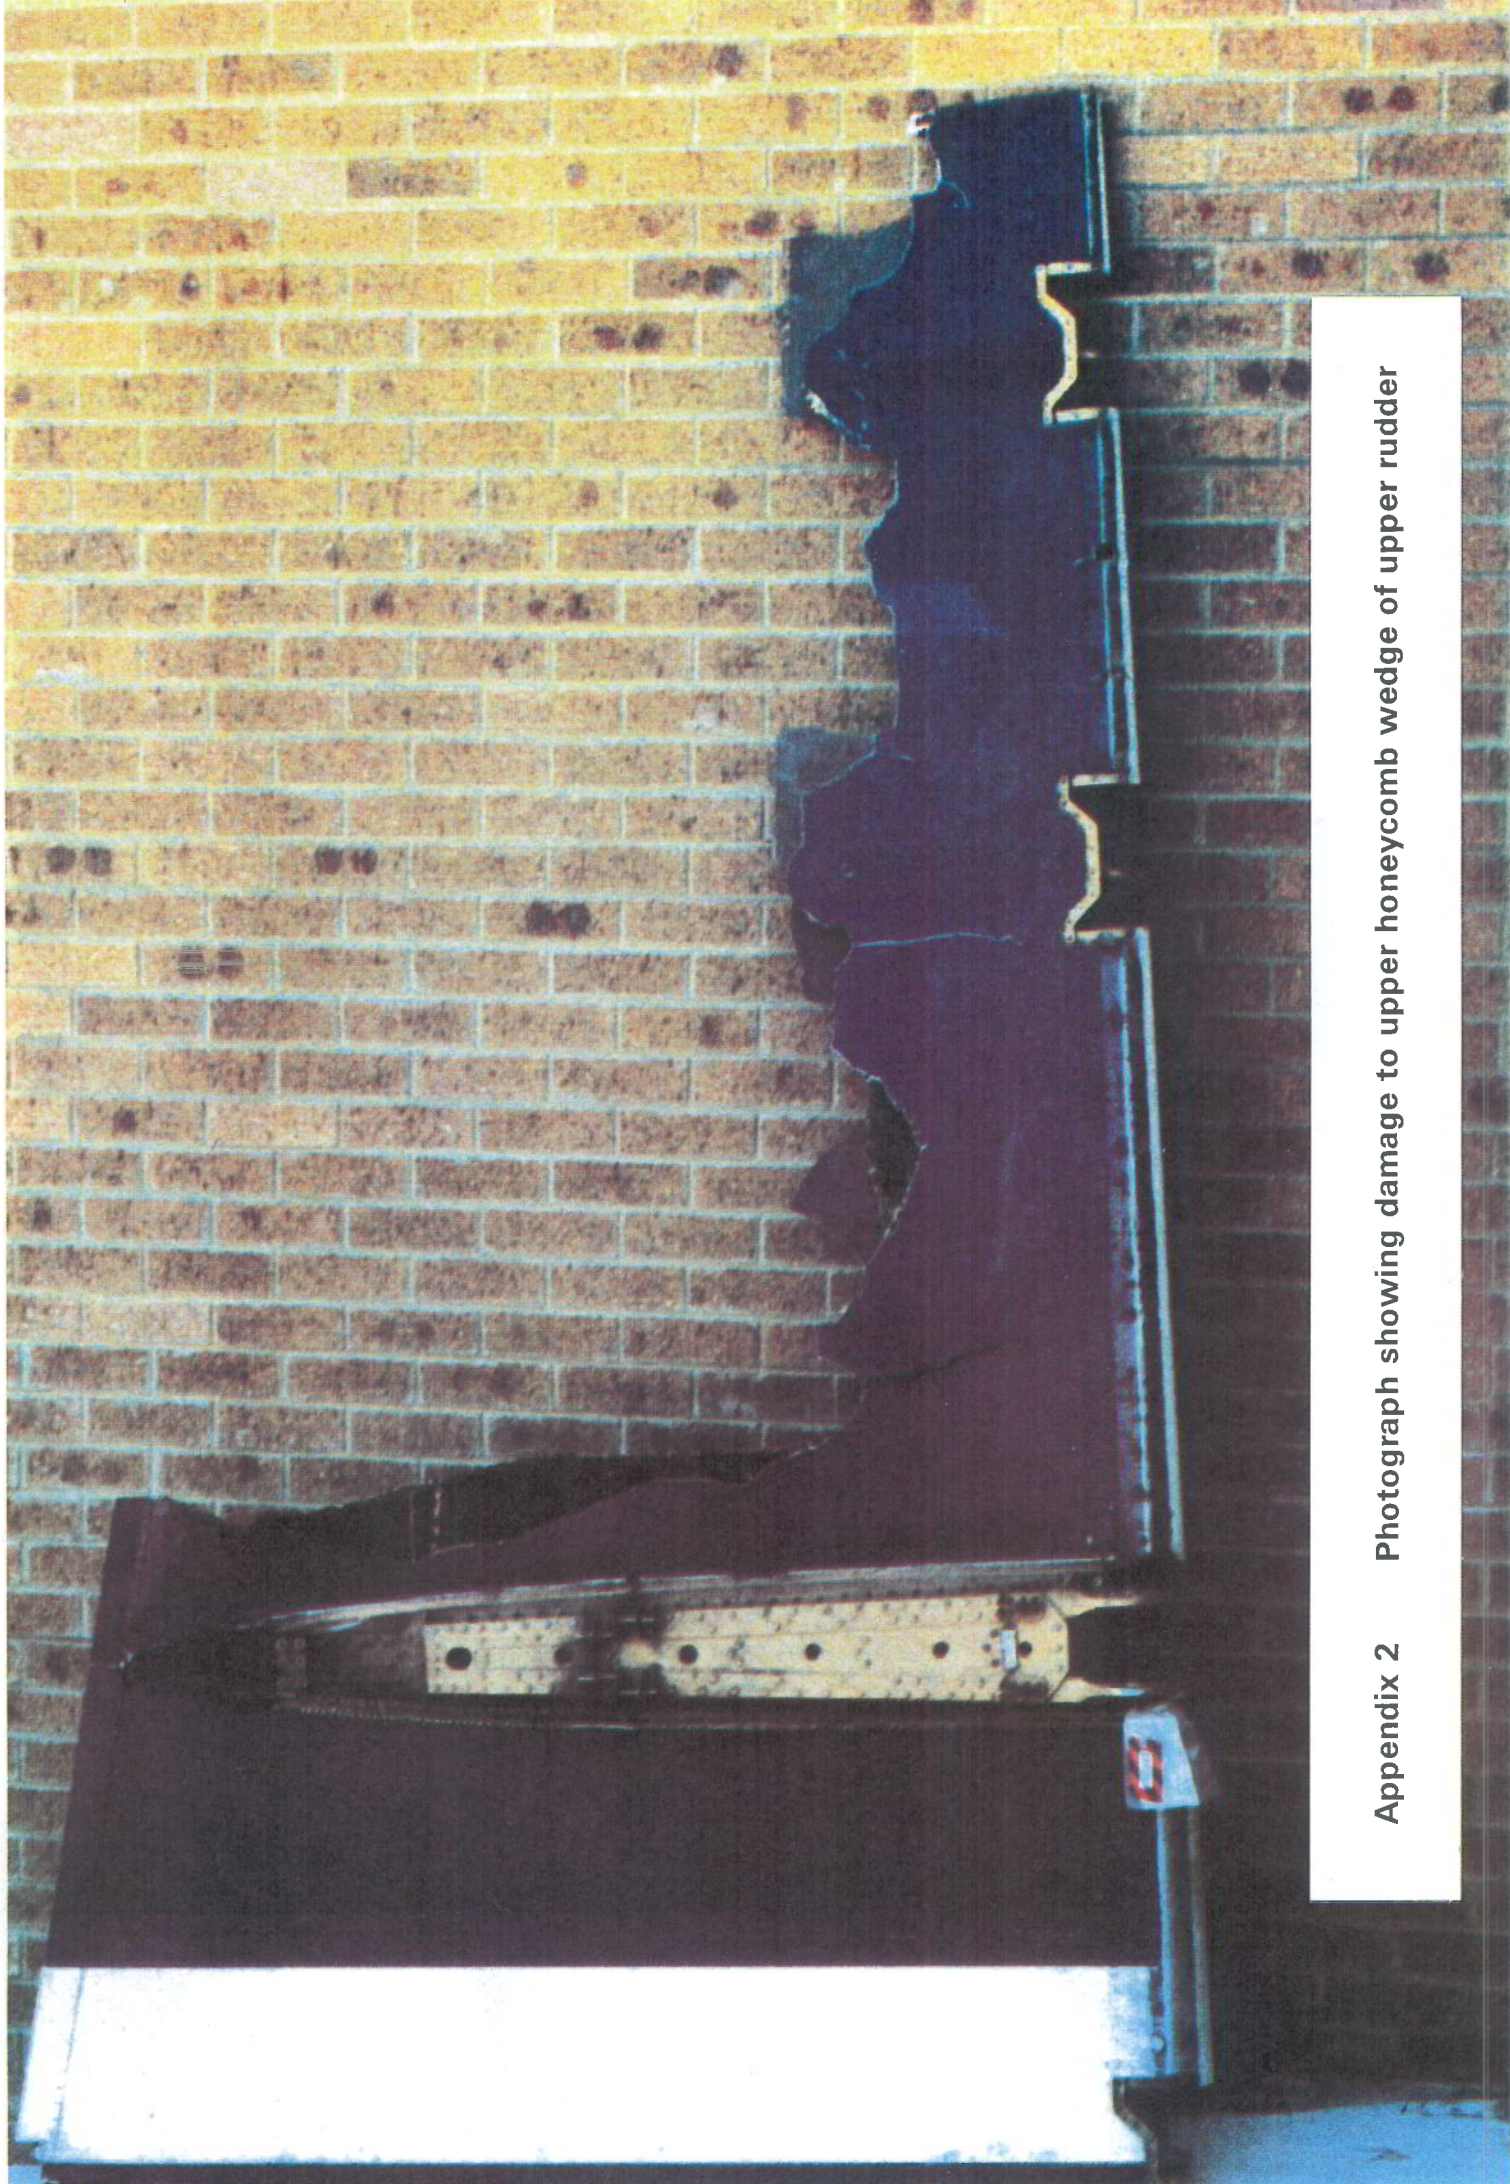
Appendix 2 Photograph showing damage to upper honeycomb wedge of upper rudder

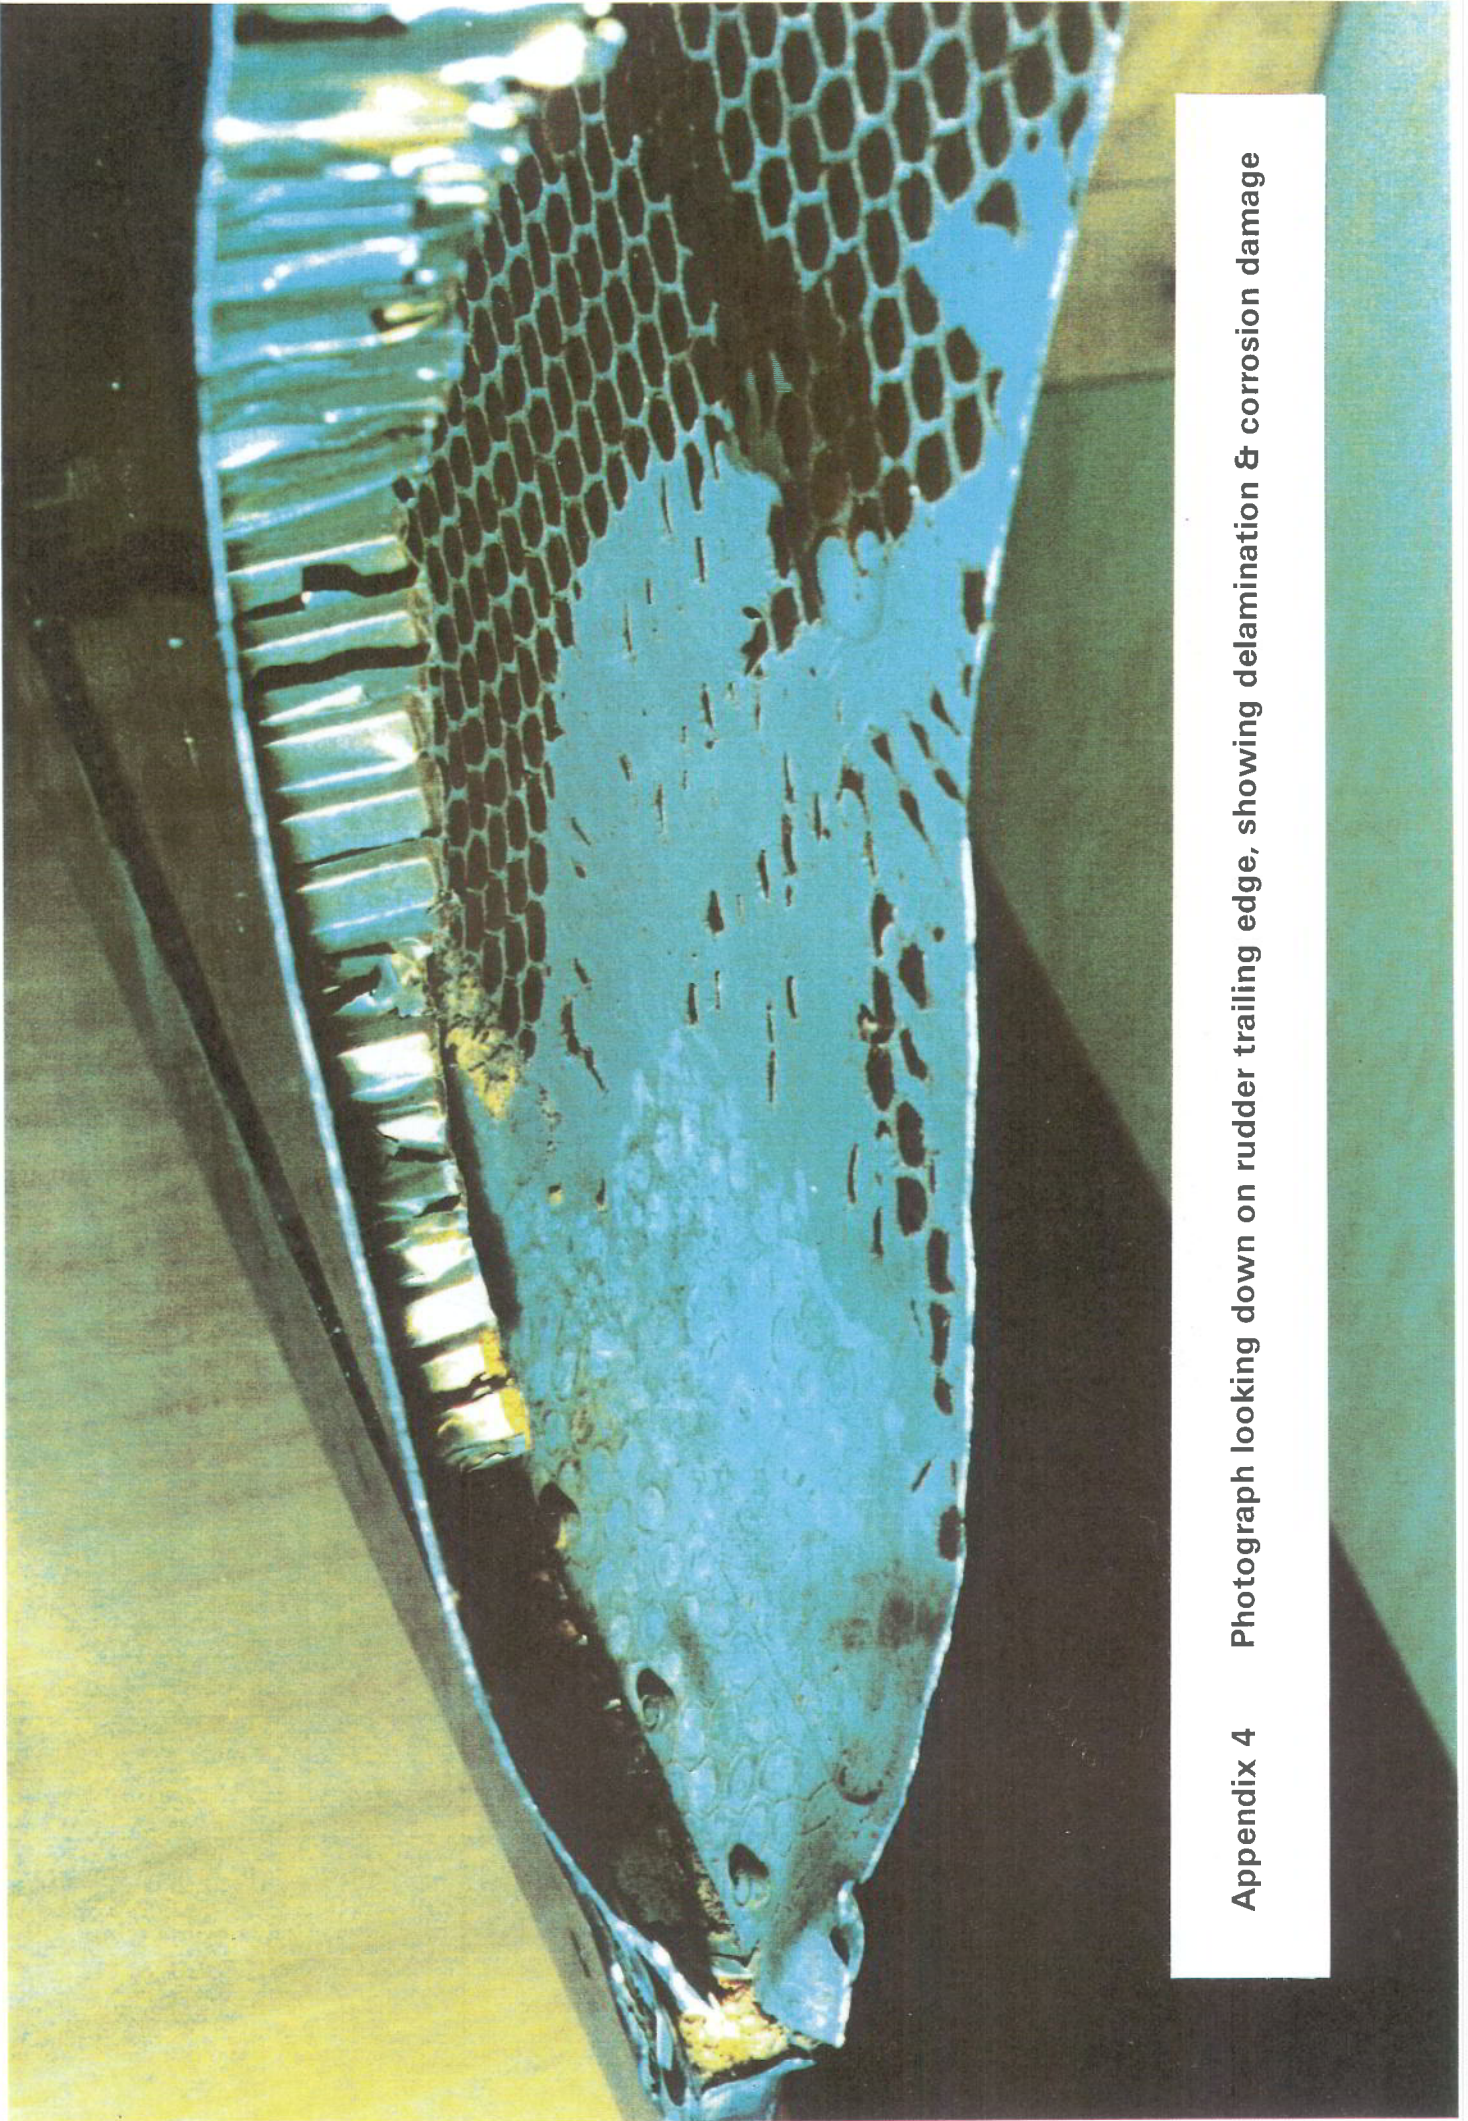
Appendix 4 Photograph looking down on rudder trailing edge, showing delamination & corrosion damage

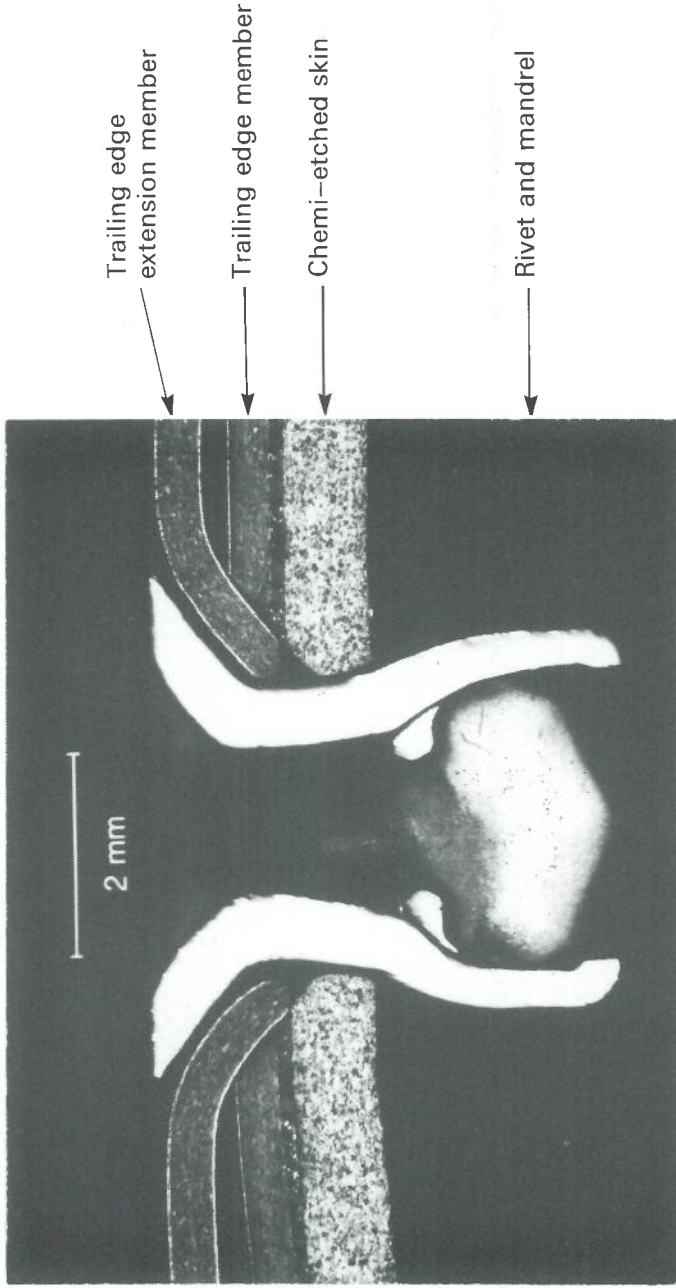
Appendix 5 Section through a rivet in the trailing edge extension of the upper wedge of the upper rudder, serial no. VW25, removed from G-BOAF

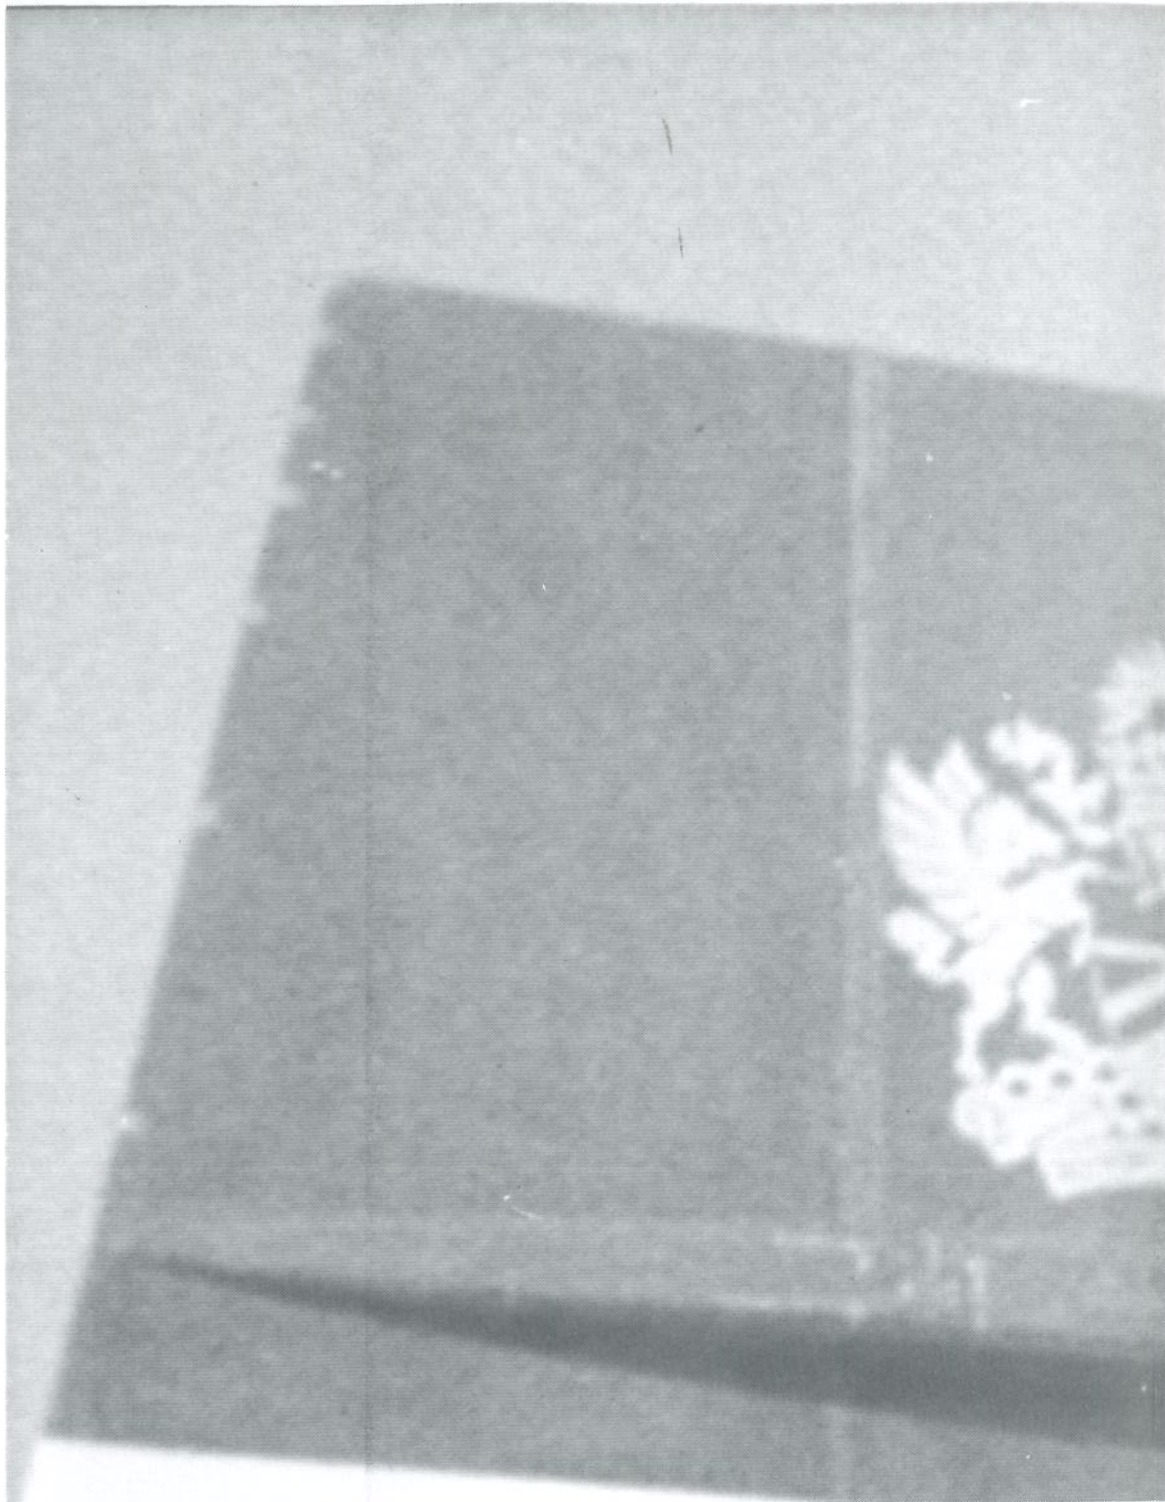
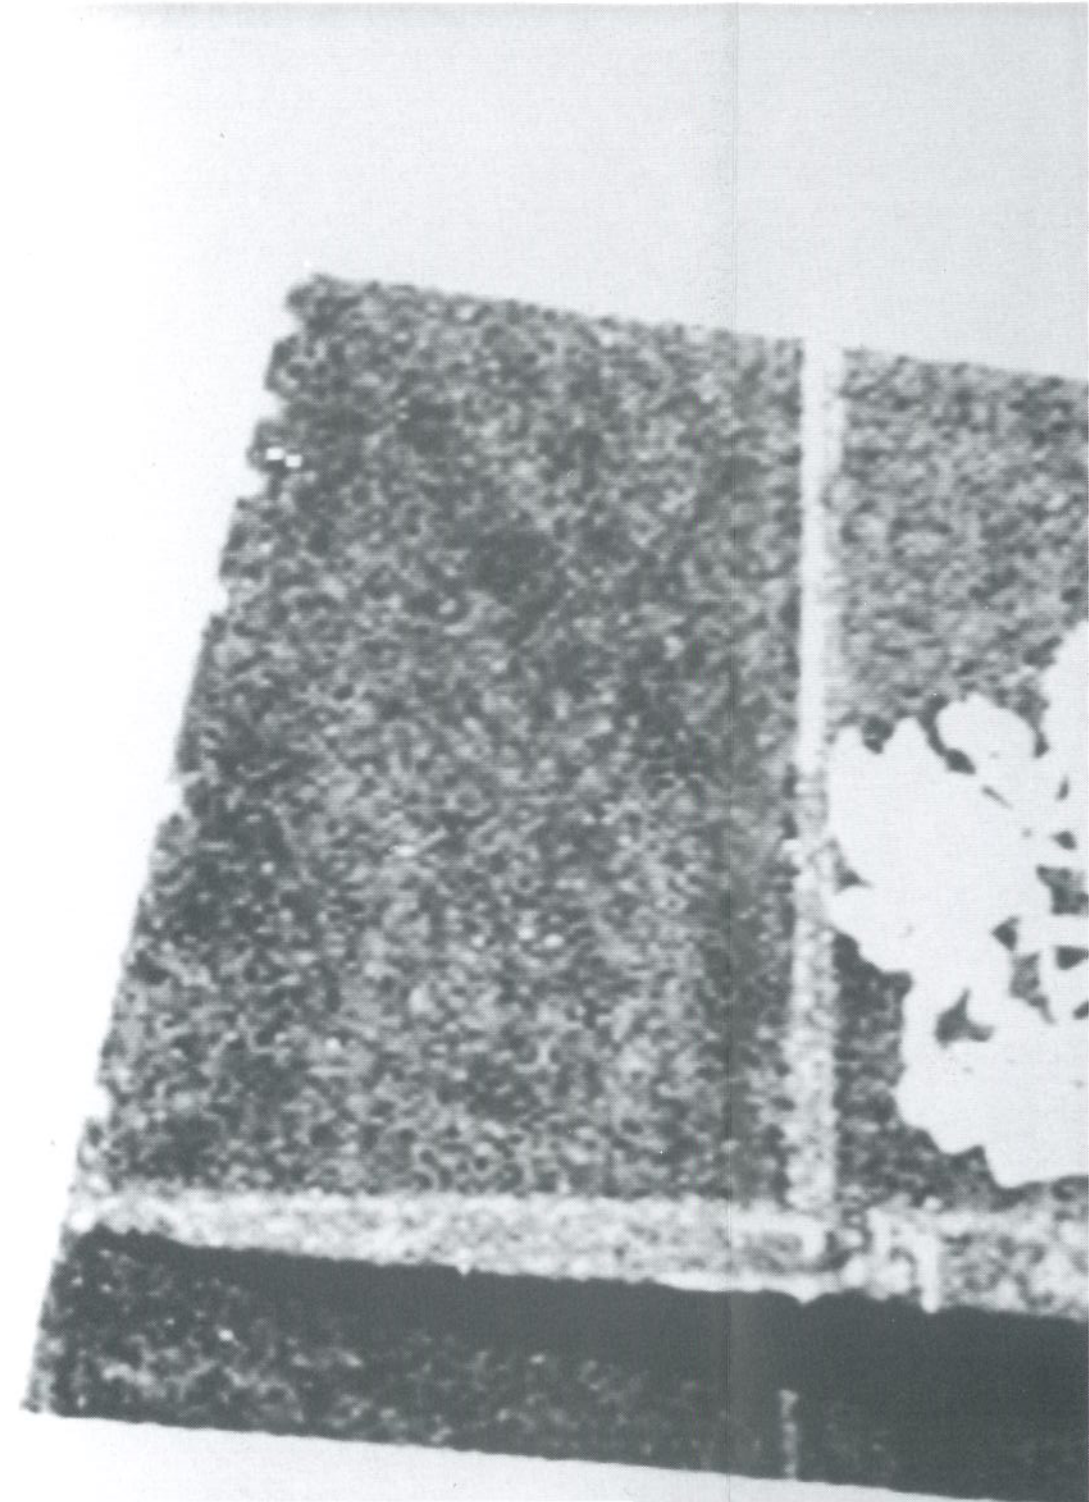
Appendix 6

Enlargement and computer enhancement of a photograph taken prior to departure from Christchurch.

The barely visible variations in colour on the left, when enhanced by increasing the contrast, show a large and distinct curved feature on the rudder skin.

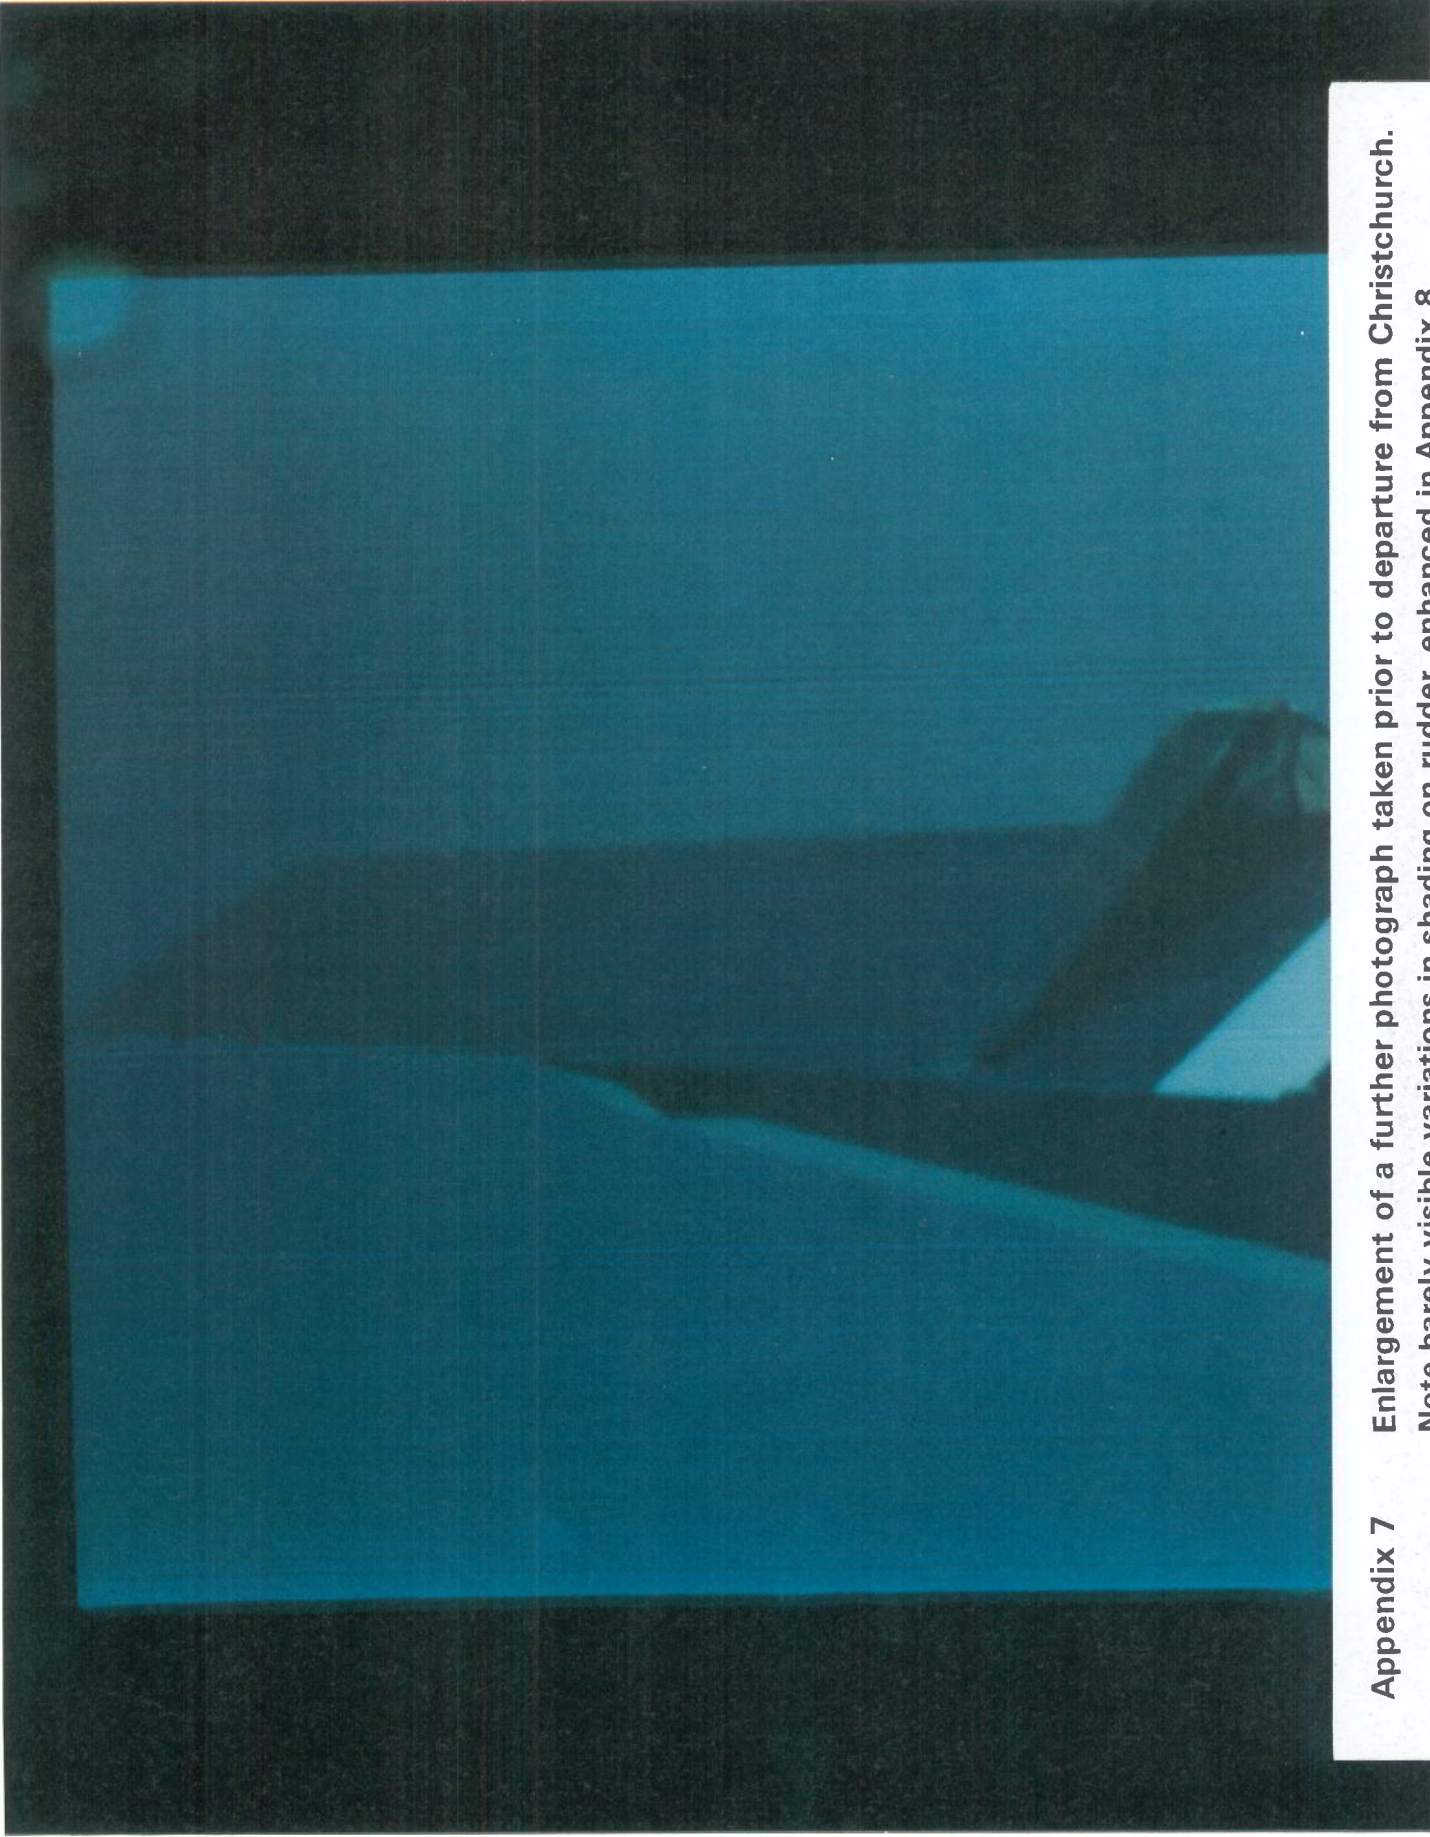
Appendix 7 **Enlargement of a further photograph taken prior to departure from Christchurch.**
Note barely visible variations in shading on rudder, enhanced in Appendix 8

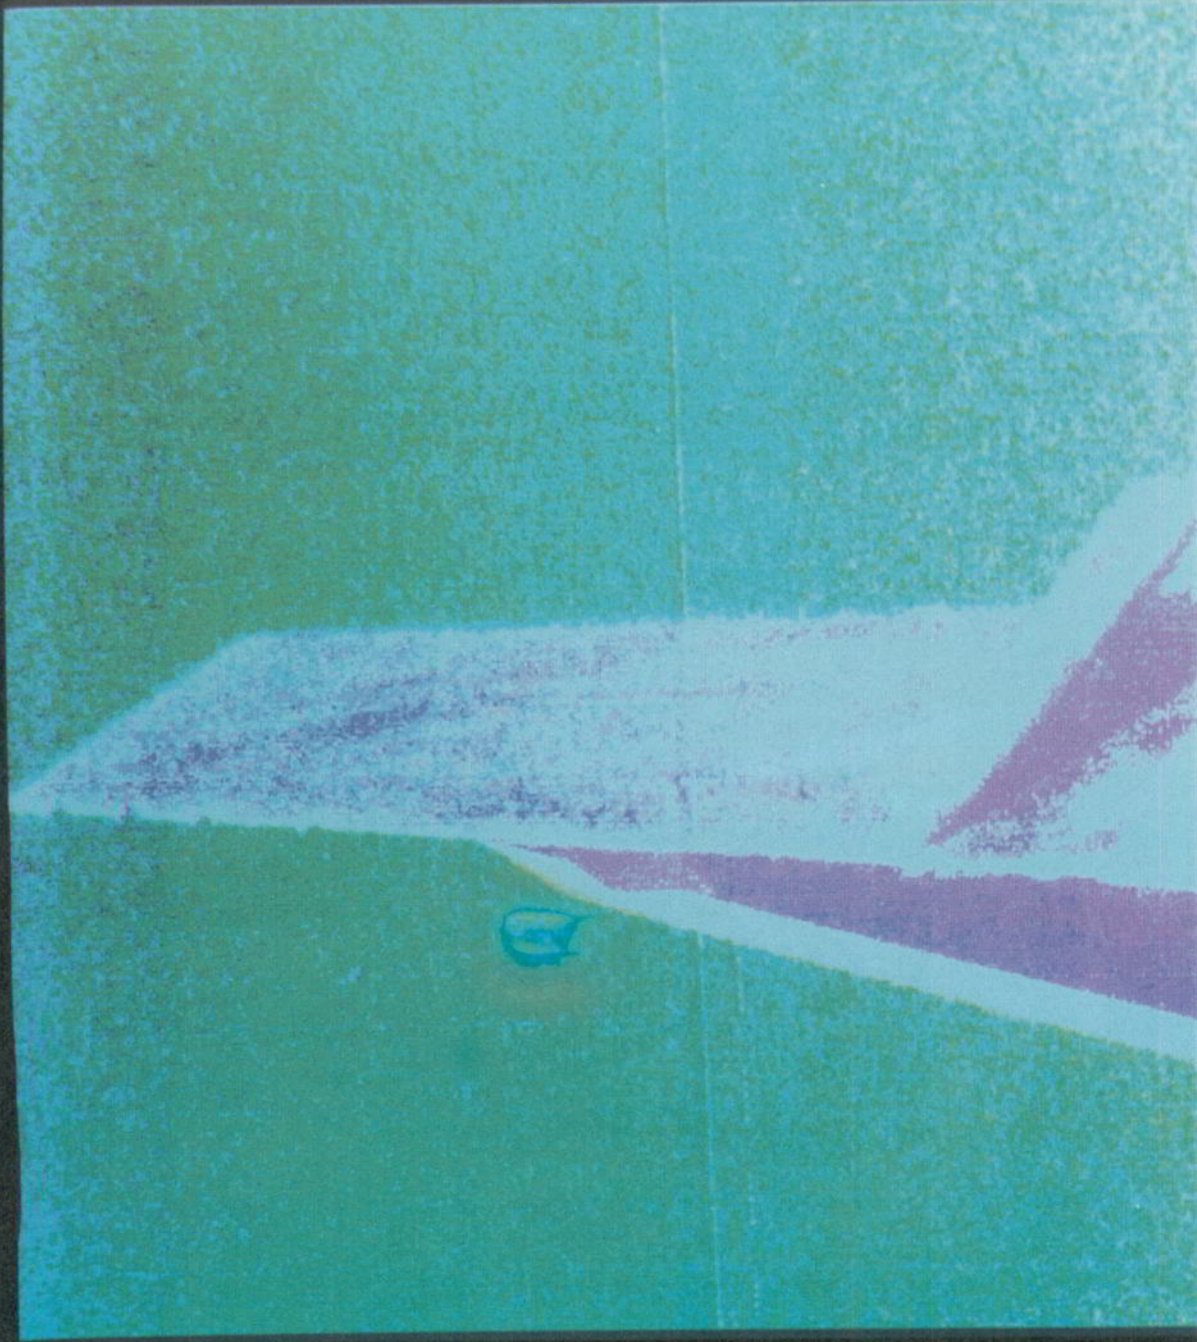
Appendix 8 Computer enhancement of photograph at Appendix 7, showing darker curved area running diagonally across the upper wedge.

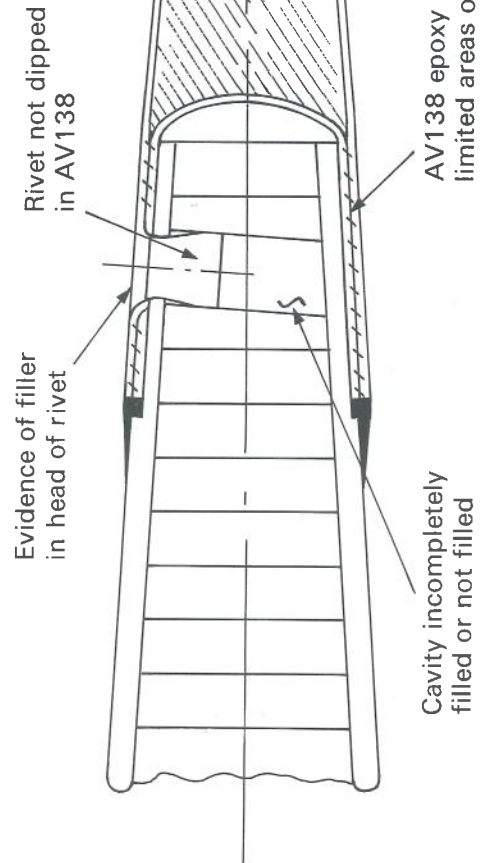
c) Trailing edge extension modification as carried out on G-BOAF

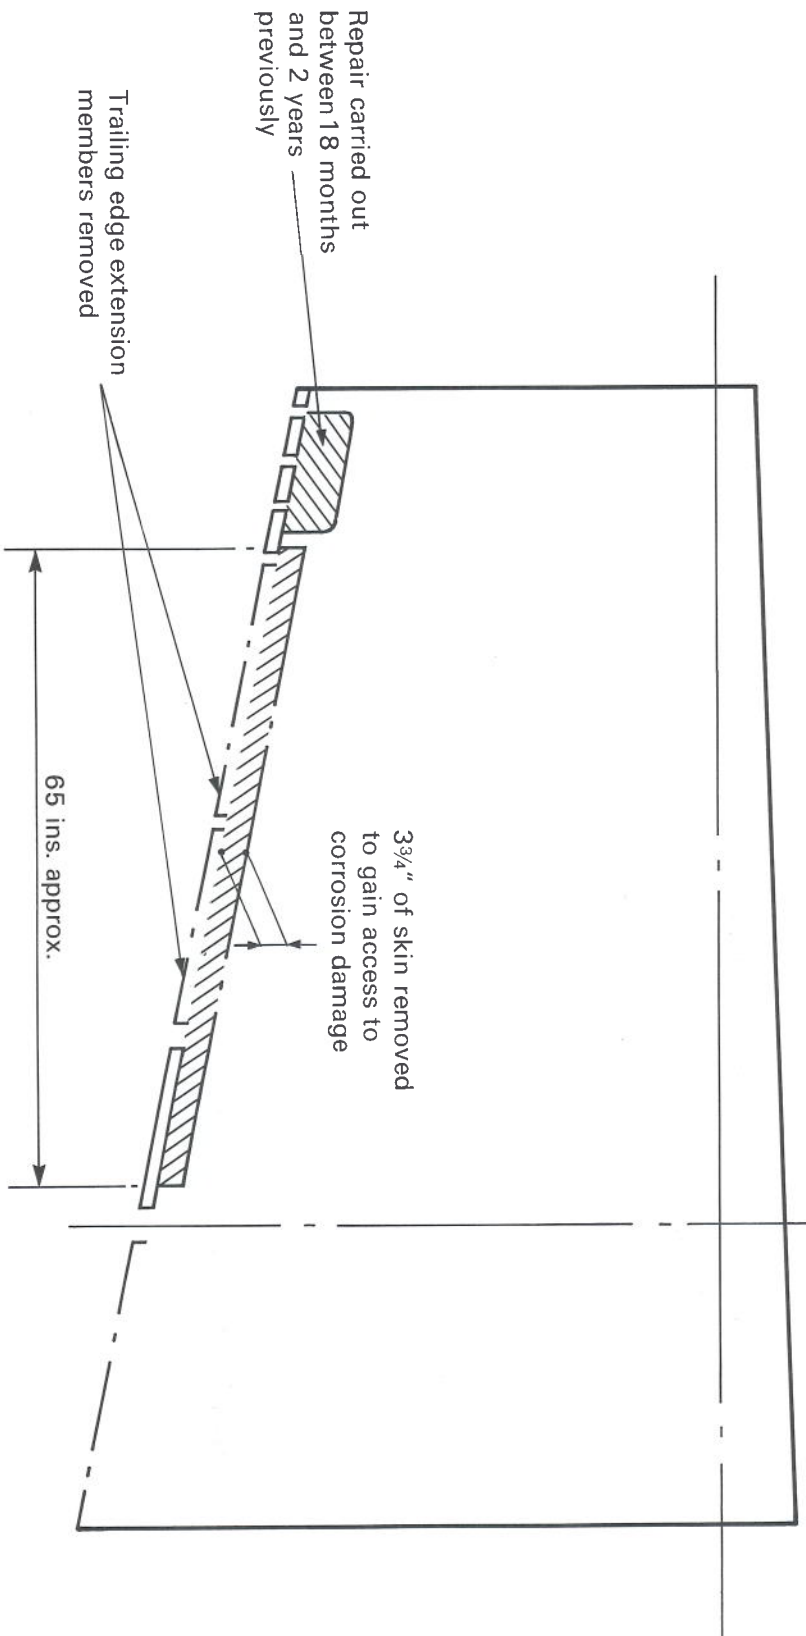
Appendix 10 Diagram of damage found on upper rudder VW22 removed from G-BOAB

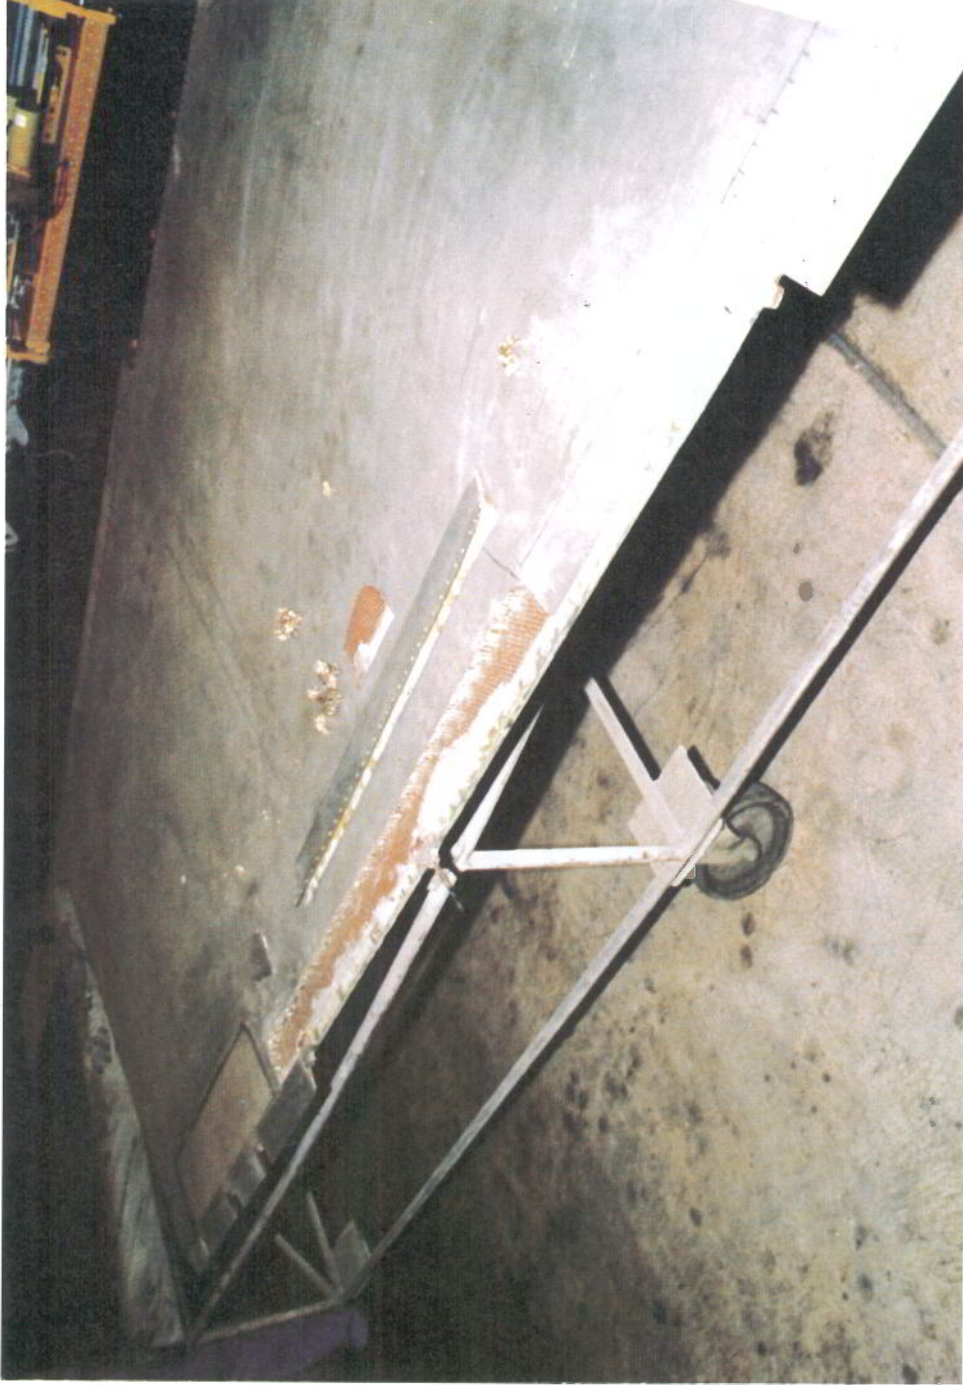
Appendix 11 Upper rudder VW22 removed from G-BOAB

General view of damage to trailing edge (skin on one side cut away locally and trailing edge extension partly removed)

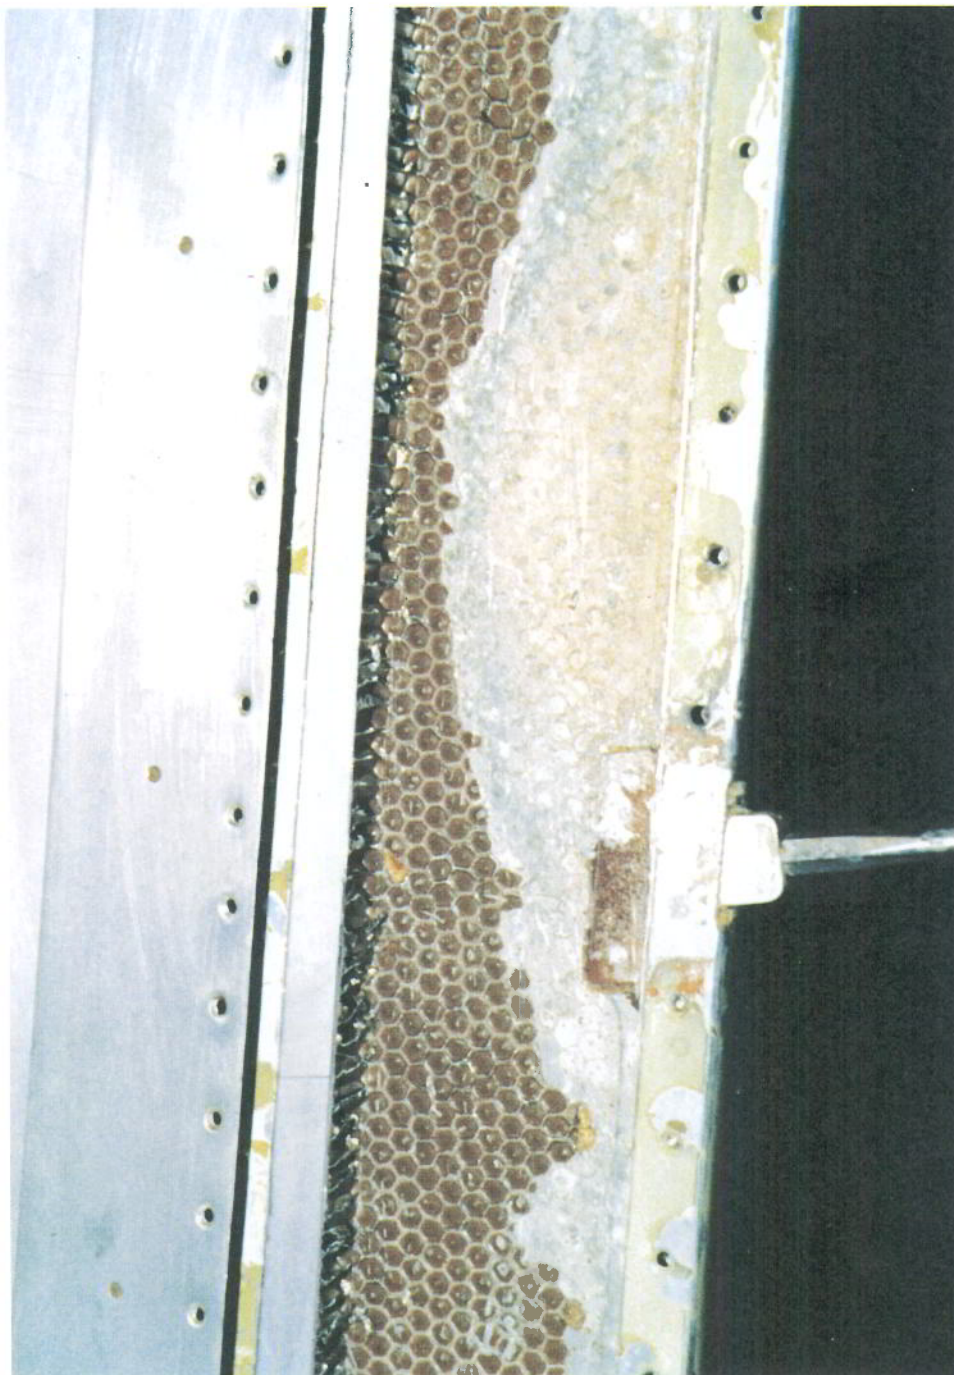
Appendix 12 **Upper rudder VW22 removed from G-BOAB**

Close up view of typical damage inside trailing edge.
