No: 10/90

Ref: EW/C1159

| <b>Aircraft Type and Registration:</b> | Aerospatiale AS332L, G-PUMA | |
| <b>Nature of Damage:</b> | Fire damage to rotor brake, transmission bay and sliding cowling | |

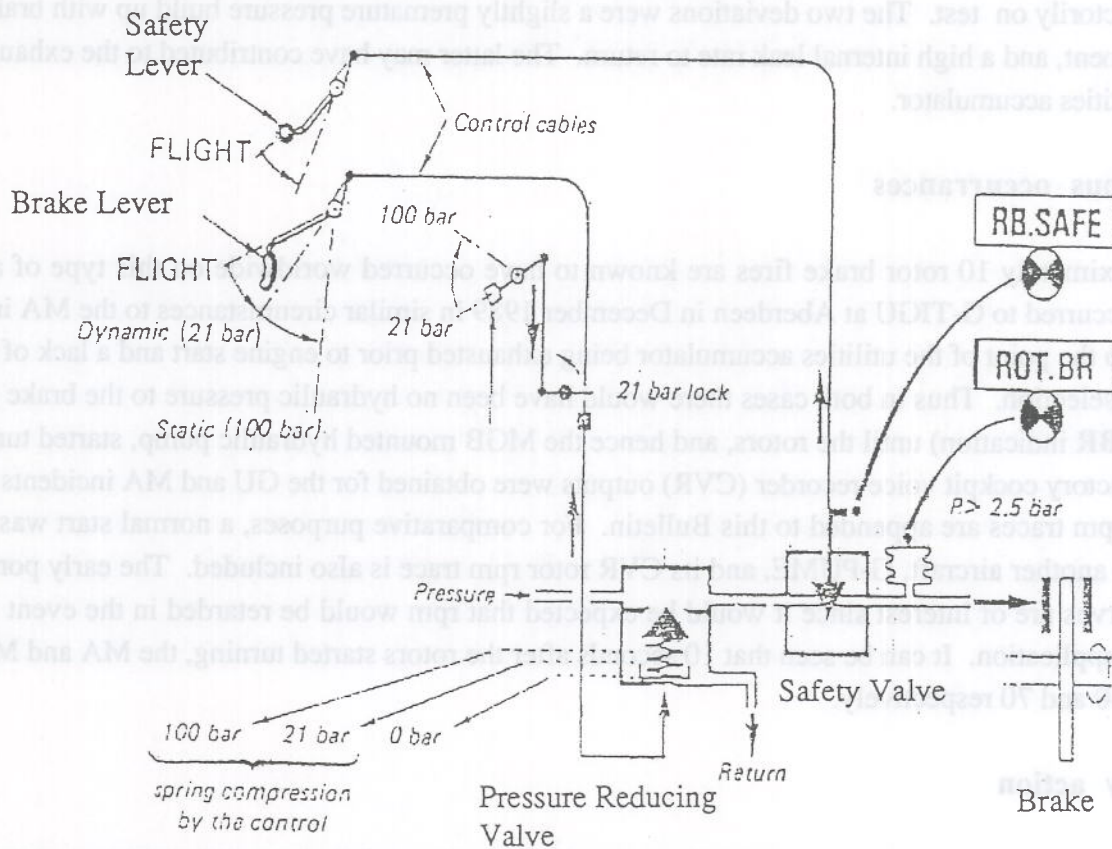
AS332 Brake System Schematic

The brake unit consists of a calliper bolted to the MGB above the tail rotor drive shaft. A fixed pad is attached to one side of the calliper, with opposing pads attached to hydraulically operated pistons on the other. Return springs pull the pistons, and hence the pads, away from the disc when hydraulic pressure is removed. A carbon disc is located between the pads and is attached to the tail rotor drive shaft. Hydraulic power is provided from the left hand pump on the MGB. When the rotors are stationary, the system is supplied from an electric pump. Pressure is maintained via the utilities accumulator, which can be recharged if necessary by means of a hand pump.

A schematic of the operating system is shown in the attached Figure and it can be seen that it consists of two levers, mounted on the overhead panel close to the top of the windscreen, operating on a

pressure reducing valve and a safety valve respectively. When the Safety Lever is in the "Flight" (ie fully forward) position, the safety valve is closed which allows no pressure to the brake unit even if the Brake Lever should inadvertently be pulled. When the Safety Lever is in the "Ground" (ie fully back) position, the **RB.SAFE** caption is illuminated, meaning that the Brake Lever can now be applied. Brake pressure progressively increases with lever movement up to the 21 bar detent. Further movement to the 100 bar detent is inhibited by a baulk which can only be removed by operation of an additional lever on the bulkhead behind the pilot. The latter position is used to maintain the rotors stationary whilst both engines are started in high wind conditions; brake release then results in rapid rotor spin-up, reducing the possibility of blade sailing.

A pressure switch illuminates a **ROT.BR** caption when the pressure in the brake line exceeds 2.5 bar.

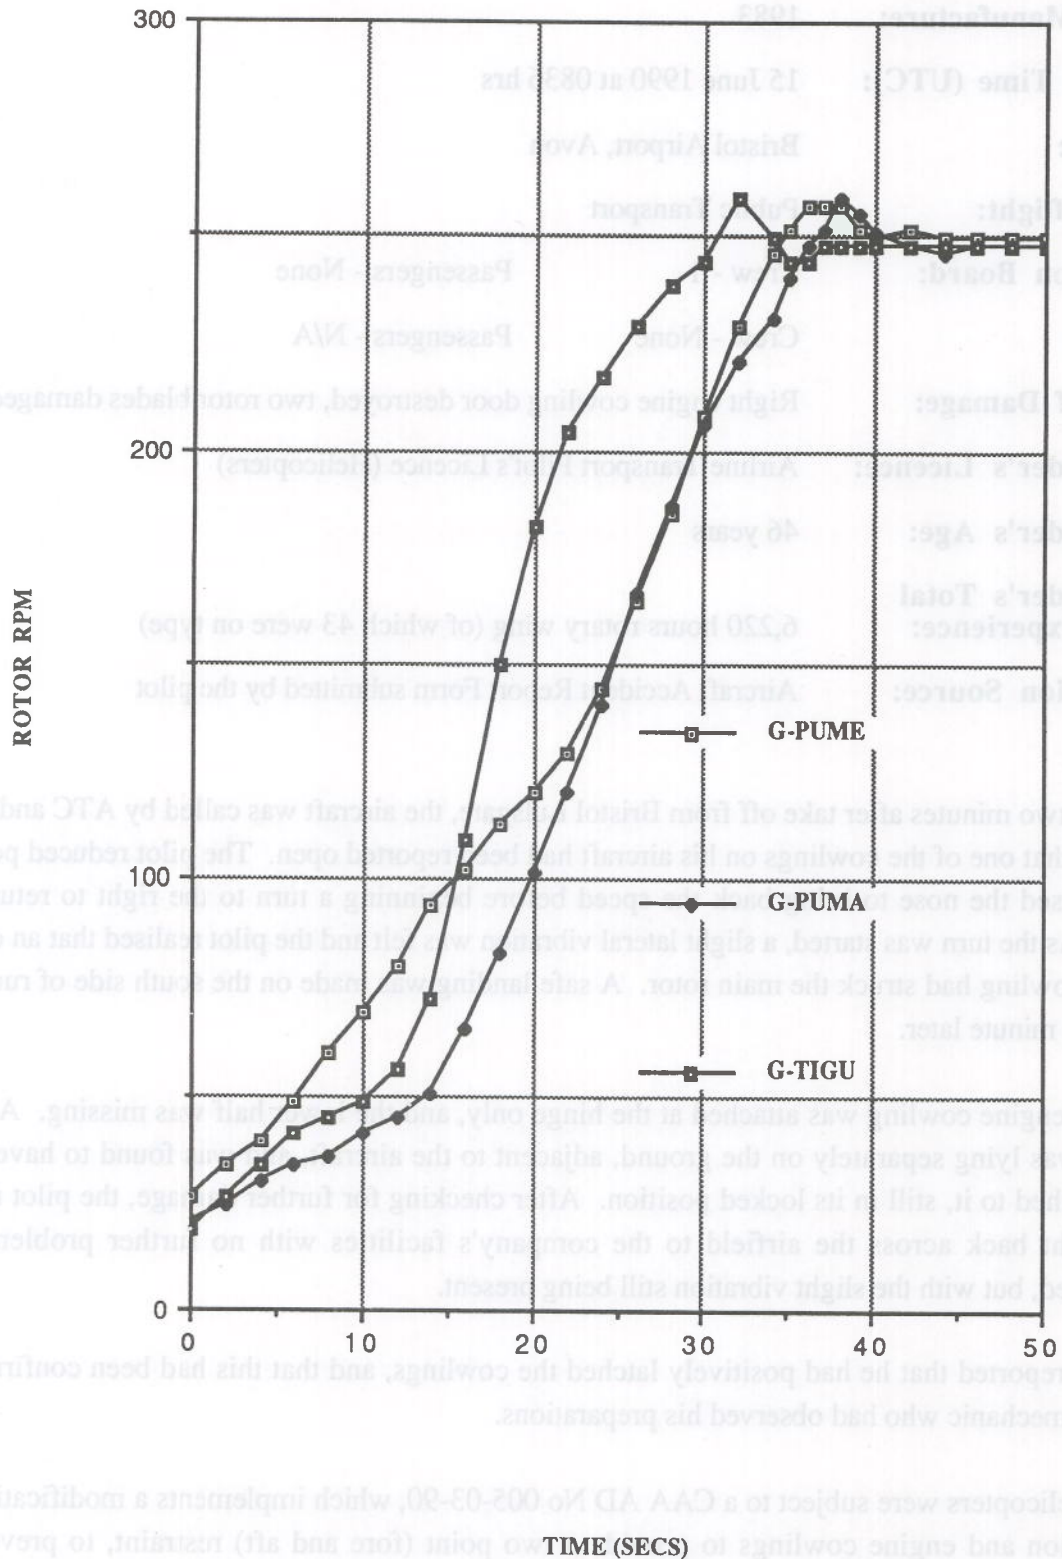
# AS332L SUPERPUMA ROTOR RPM DURING START UP

Approximately 10 rotor brake fires are known to have occurred worldwide on this type of aircraft. One occurred to G-TIGU at Aberdeen in December 1989 in similar circumstances to the MA incident, even to the point of the utilities accumulator being exhausted prior to engine start and a lack of electric pump selection. Thus in both cases there would have been no hydraulic pressure to the brake (and no **ROT.BR** indication) until the rotors, and hence the MGB mounted hydraulic pump, started turning. Satisfactory cockpit voice recorder (CVR) outputs were obtained for the GU and MA incidents and the rotor rpm traces are appended to this Bulletin. For comparative purposes, a normal start was carried out on another aircraft, G-PUME, and its CVR rotor rpm trace is also included. The early portions of the curves are of interest since it would be expected that rpm would be retarded in the event of rotor brake application. It can be seen that 10 seconds after the rotors started turning, the MA and ME rpms were 40 and 70 respectively.
