**AAIB Bulletin No: 5/93**

**Ref: EW/G93/01/02**

| <b>Aircraft Type and Registration:</b> | Aerospatiale AS355-F2 Ecureuil II, G-BOOV | |

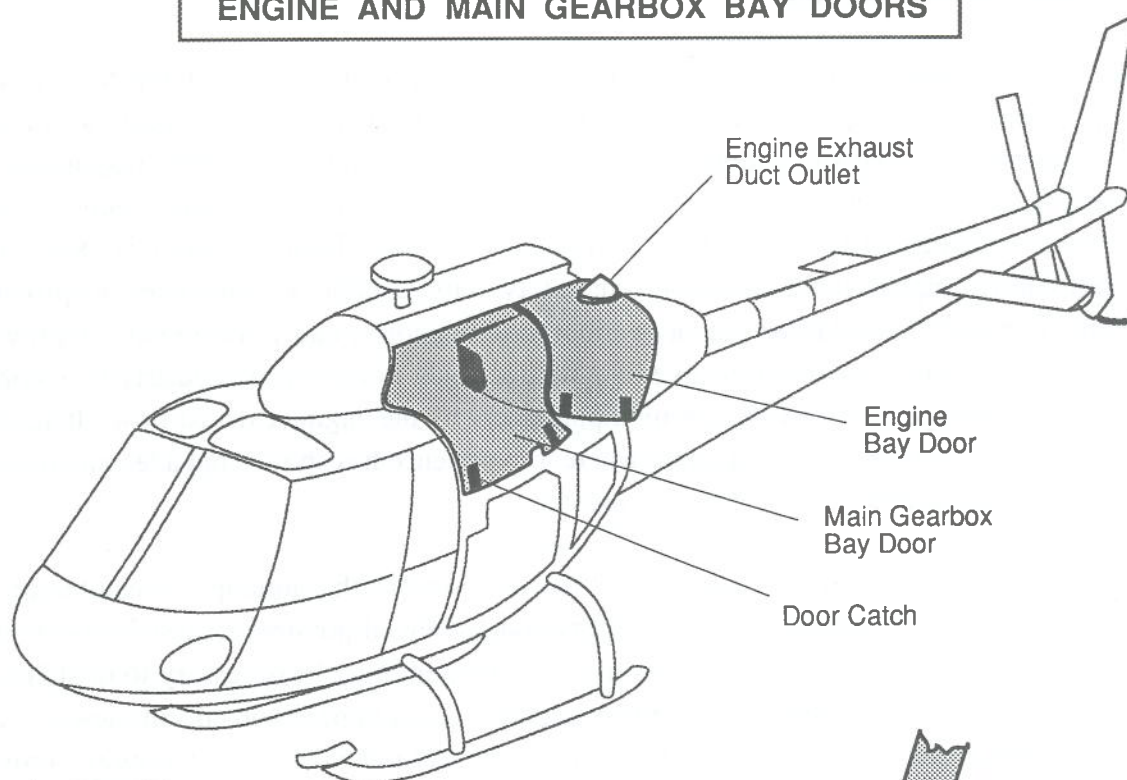
**Fig 1**

The Squirrel is provided with an engine bay door and a main gearbox (MGB) bay door on either side of the aircraft (Fig 1), each attached at its top by a piano hinge fixed parallel to the aircraft longitudinal axis and at its bottom by two overcentre catches locating in latch plates fixed to the floor of the bay. The MGB bay doors also have two auxiliary catches along their trailing edge. Both sets of doors are of composite construction; the engine bay doors are curved, 1.2 metres along the hinge by 0.9 metres along the curve. A rubber stop at each catch position locates in a dished part of the latch plate and this tends to hold the doors closed to some degree even when unlatched. Cockpit warning lights provide indication of a baggage bay door not closed, but there is no cockpit indication of the state of the engine or MGB bay doors or their latches.

## ENGINE AND MAIN GEARBOX BAY DOORS

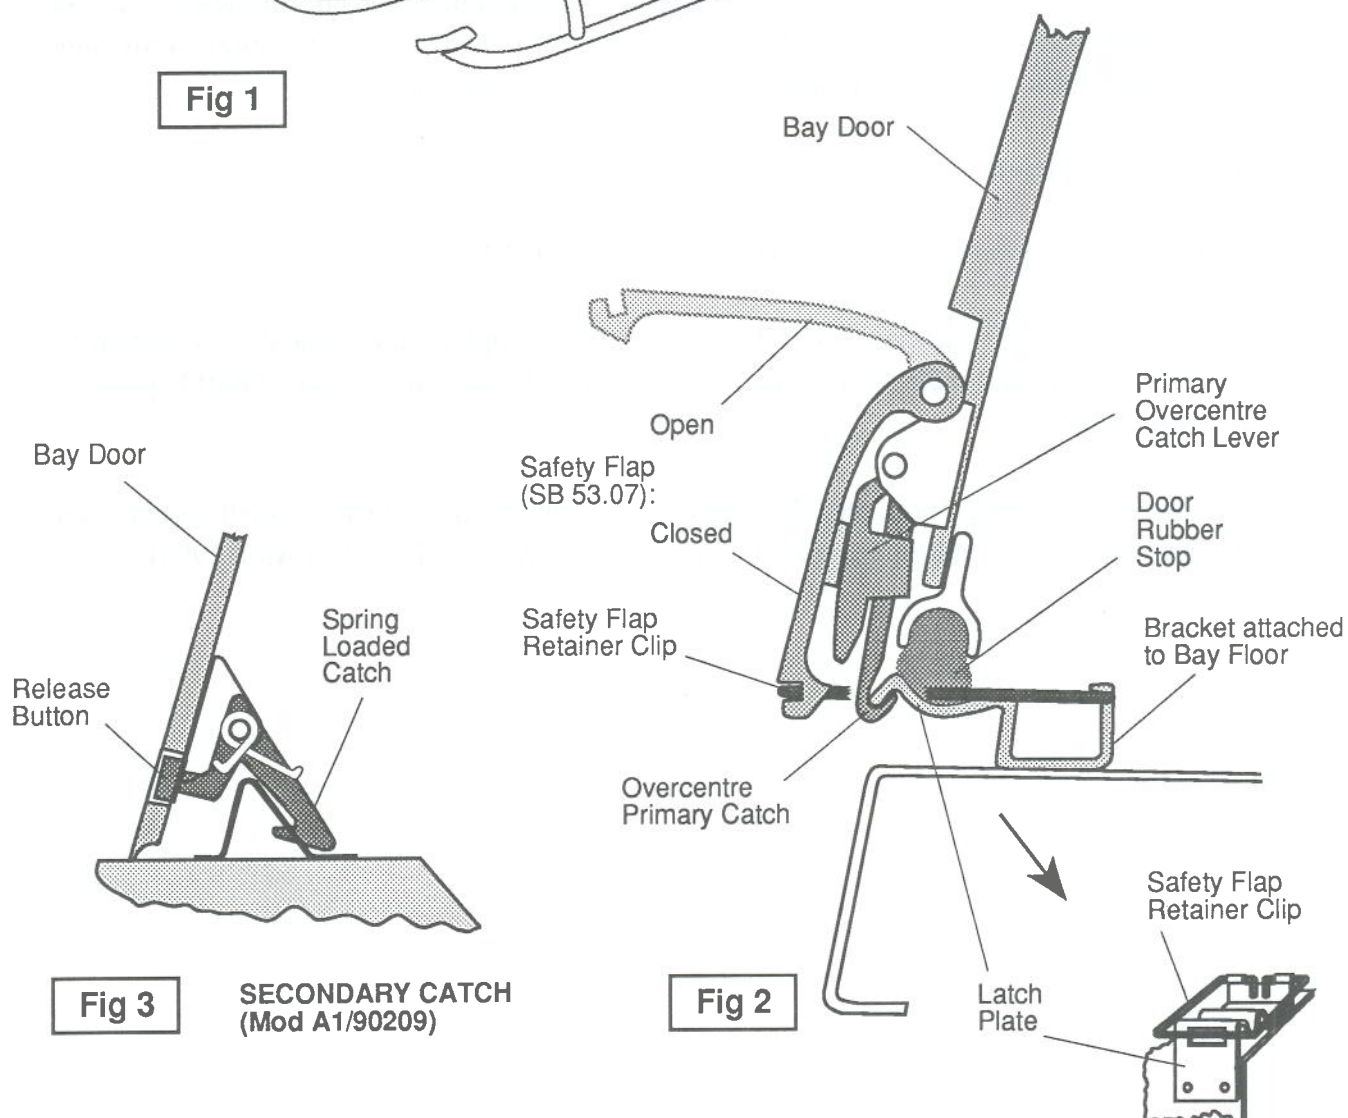
**Fig 3**

A further CAA Approved Modification (McAlpine Helicopters Ltd A1/90209-100) is available that adds a secondary spring-loaded catch for each engine bay door that acts to hold an unlatched door near to the closed position (Fig 3). With the aircraft on the ground with rotors stopped, lowering the door under its own weight causes the catch to engage, and the catch can be manually disengaged for door opening. The helicopter manufacturer considers that previous experience on other types of helicopter has indicated that a slightly open door is likely to be subjected to significant airflow loads that may be beyond the capability of the door to withstand for long when restrained by a single catch. The modification is not mandatory and has not yet been widely installed. It was not present on G-BOOV.

**SECONDARY CATCH  
(Mod A1/90209)**
