**AAIB Bulletin No: 7/95**

**Ref: EW/C95/5/5**

**Aircraft Type and Registration:** De Havilland Canada DHC-8-311 Dash 8, G-BRYJ

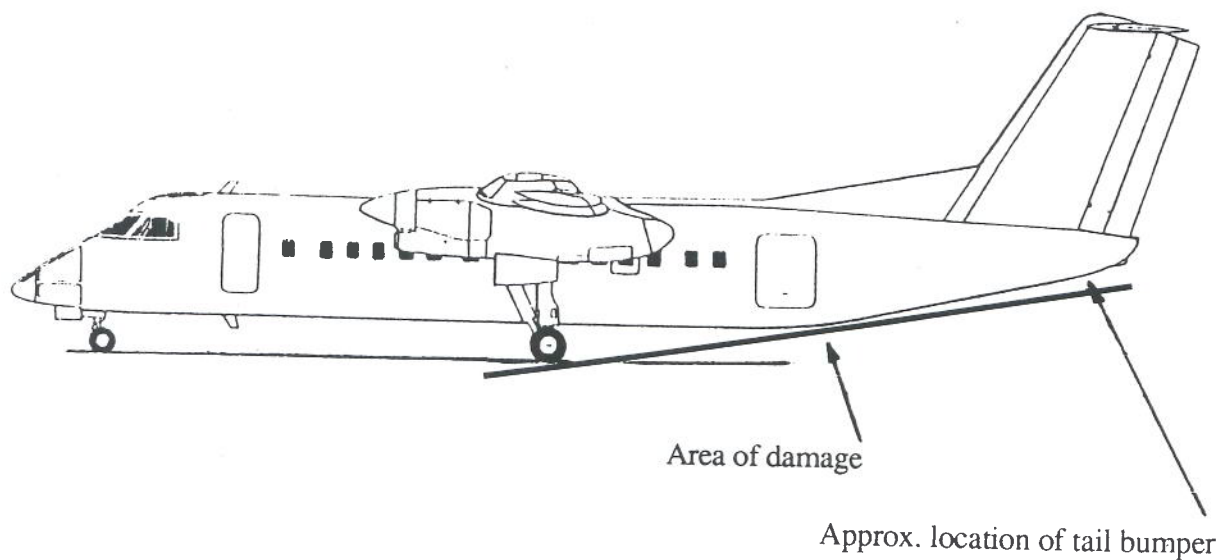
Although the aircraft had been equipped with a tail bumper, the ground/fuselage "contact line", at a high pitch angle whilst landing, passes closer to the fuselage underside than to the tail bumper. The operator has now removed the bumper (and had planned to do so prior to the accident), in accordance with Service Bulletin No 832111.

Diagram showing ground contact line at a high pitch attitude

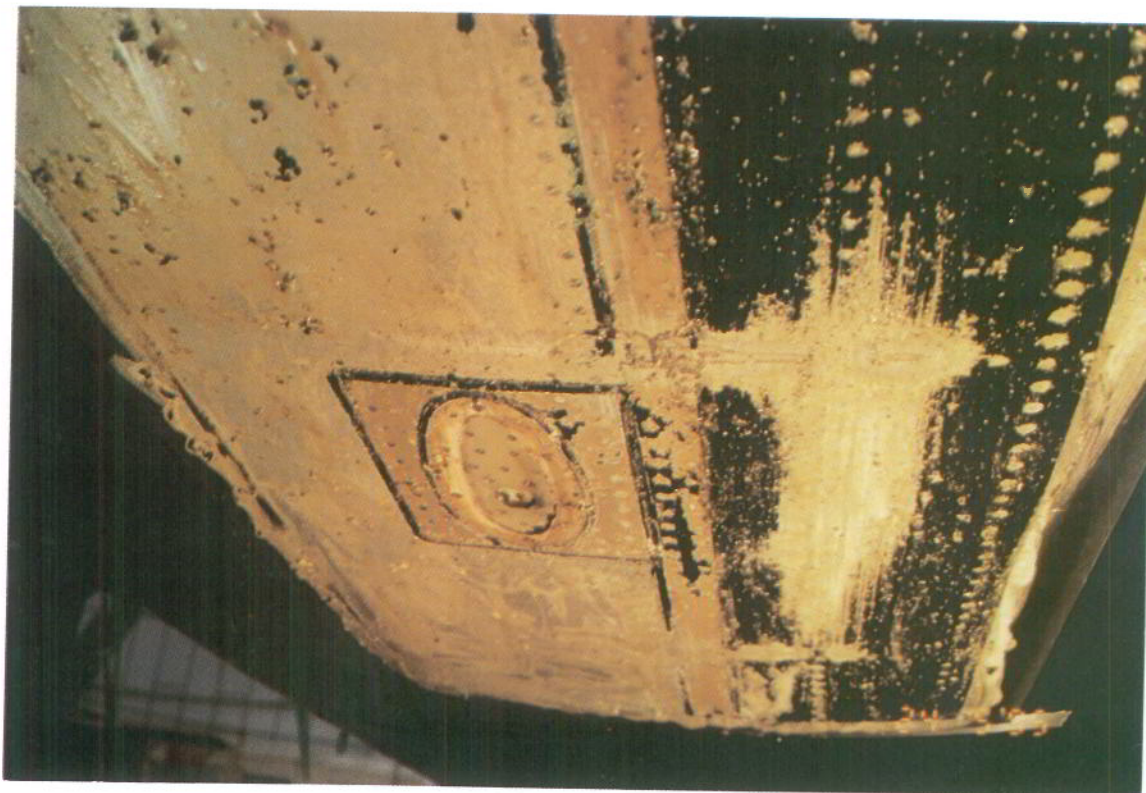
A photograph of the damage is also appended, although it should be noted that at the time of the AAIB inspection, the damaged area had been treated with paint stripper in preparation for the structural repair. The damage would definitely have appeared more superficial when it was inspected immediately after the sectors flown. In particular, it was apparent that the paint quality was such that it was difficult to discern the rivet lines, and in consequence, the locations of the frames and stringers. Inspection of the fuselage interior in the affected area revealed no evidence of damage.

The fuselage skin panels in this area consisted of two alloy sheets bonded together. These in turn were conventionally riveted to the frames and stringers. The left and right panels butted together on the aircraft centreline, the join being covered by internal and external butt straps. The inner strap was considerably wider than the outer, which had been abraded away where it straddled frame No 642.50. The skin either side was also severely abraded, slightly more so on the right-hand side, and the two layers of the skin panel had worn away, exposing the inner butt strap. The skin was scratched as far forward as the next frame, with the damage again being slightly more severe on the right-hand side. The TOUCHED RUNWAY switch mounting plate, mounted to the left of the centreline, and which stood slightly proud of the skin, had been abraded on its rear corners. The frangible disk that covered the switch, together with the external switch components, were missing.

View on underside of G-BRYJ looking forward. Note "touch runway" switch mounting plate to the left of the centreline  
(NB. Surface treated with paint stripper at time of photograph)

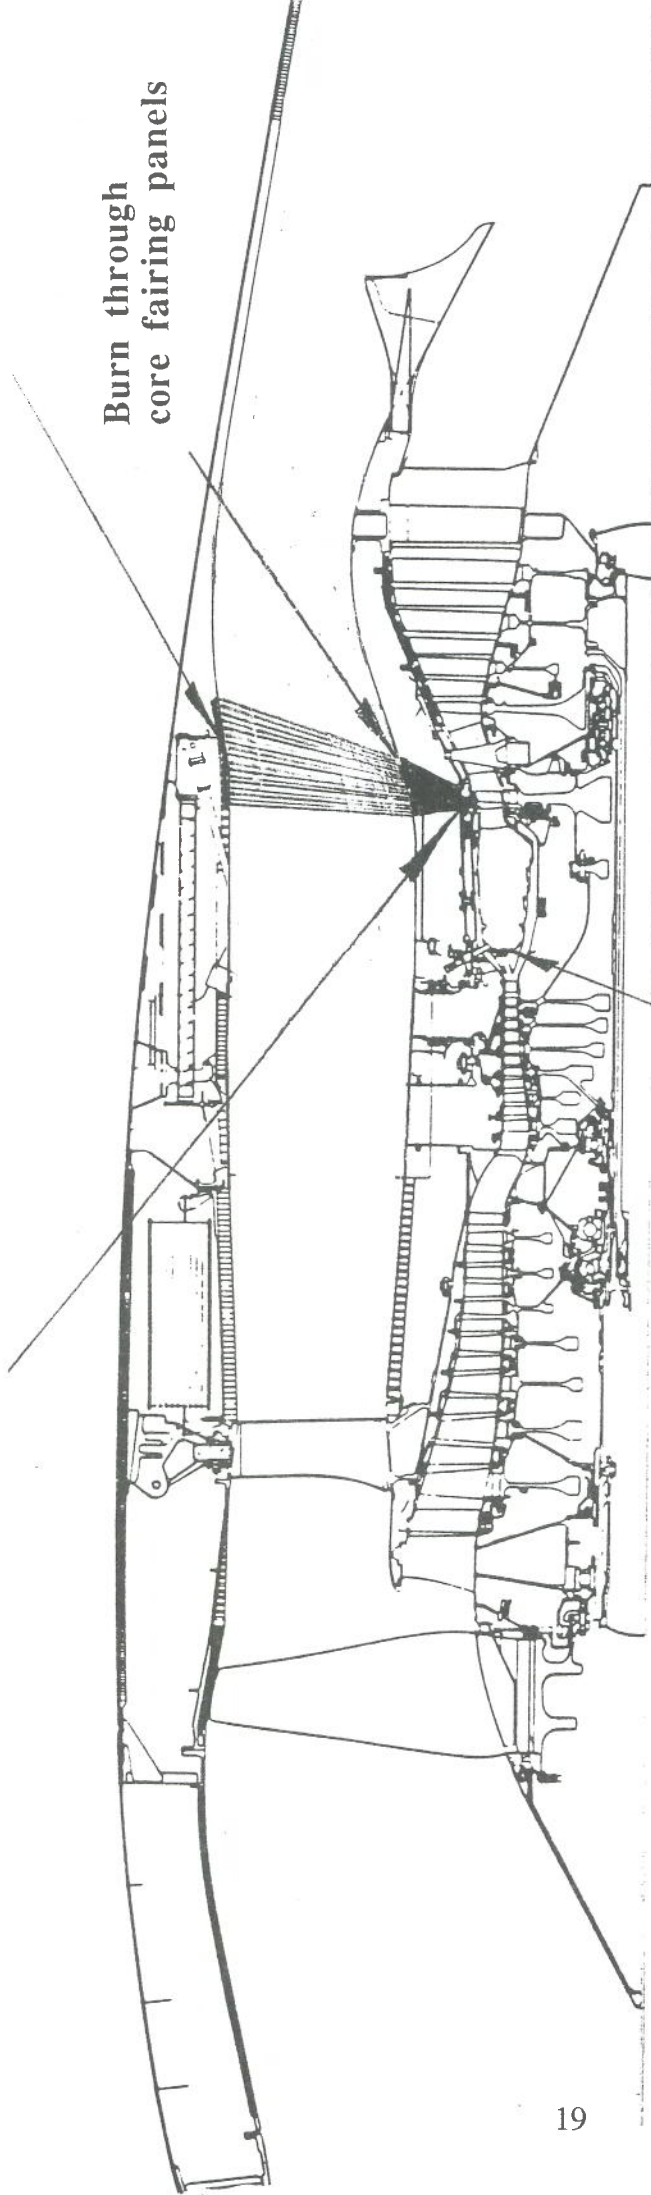
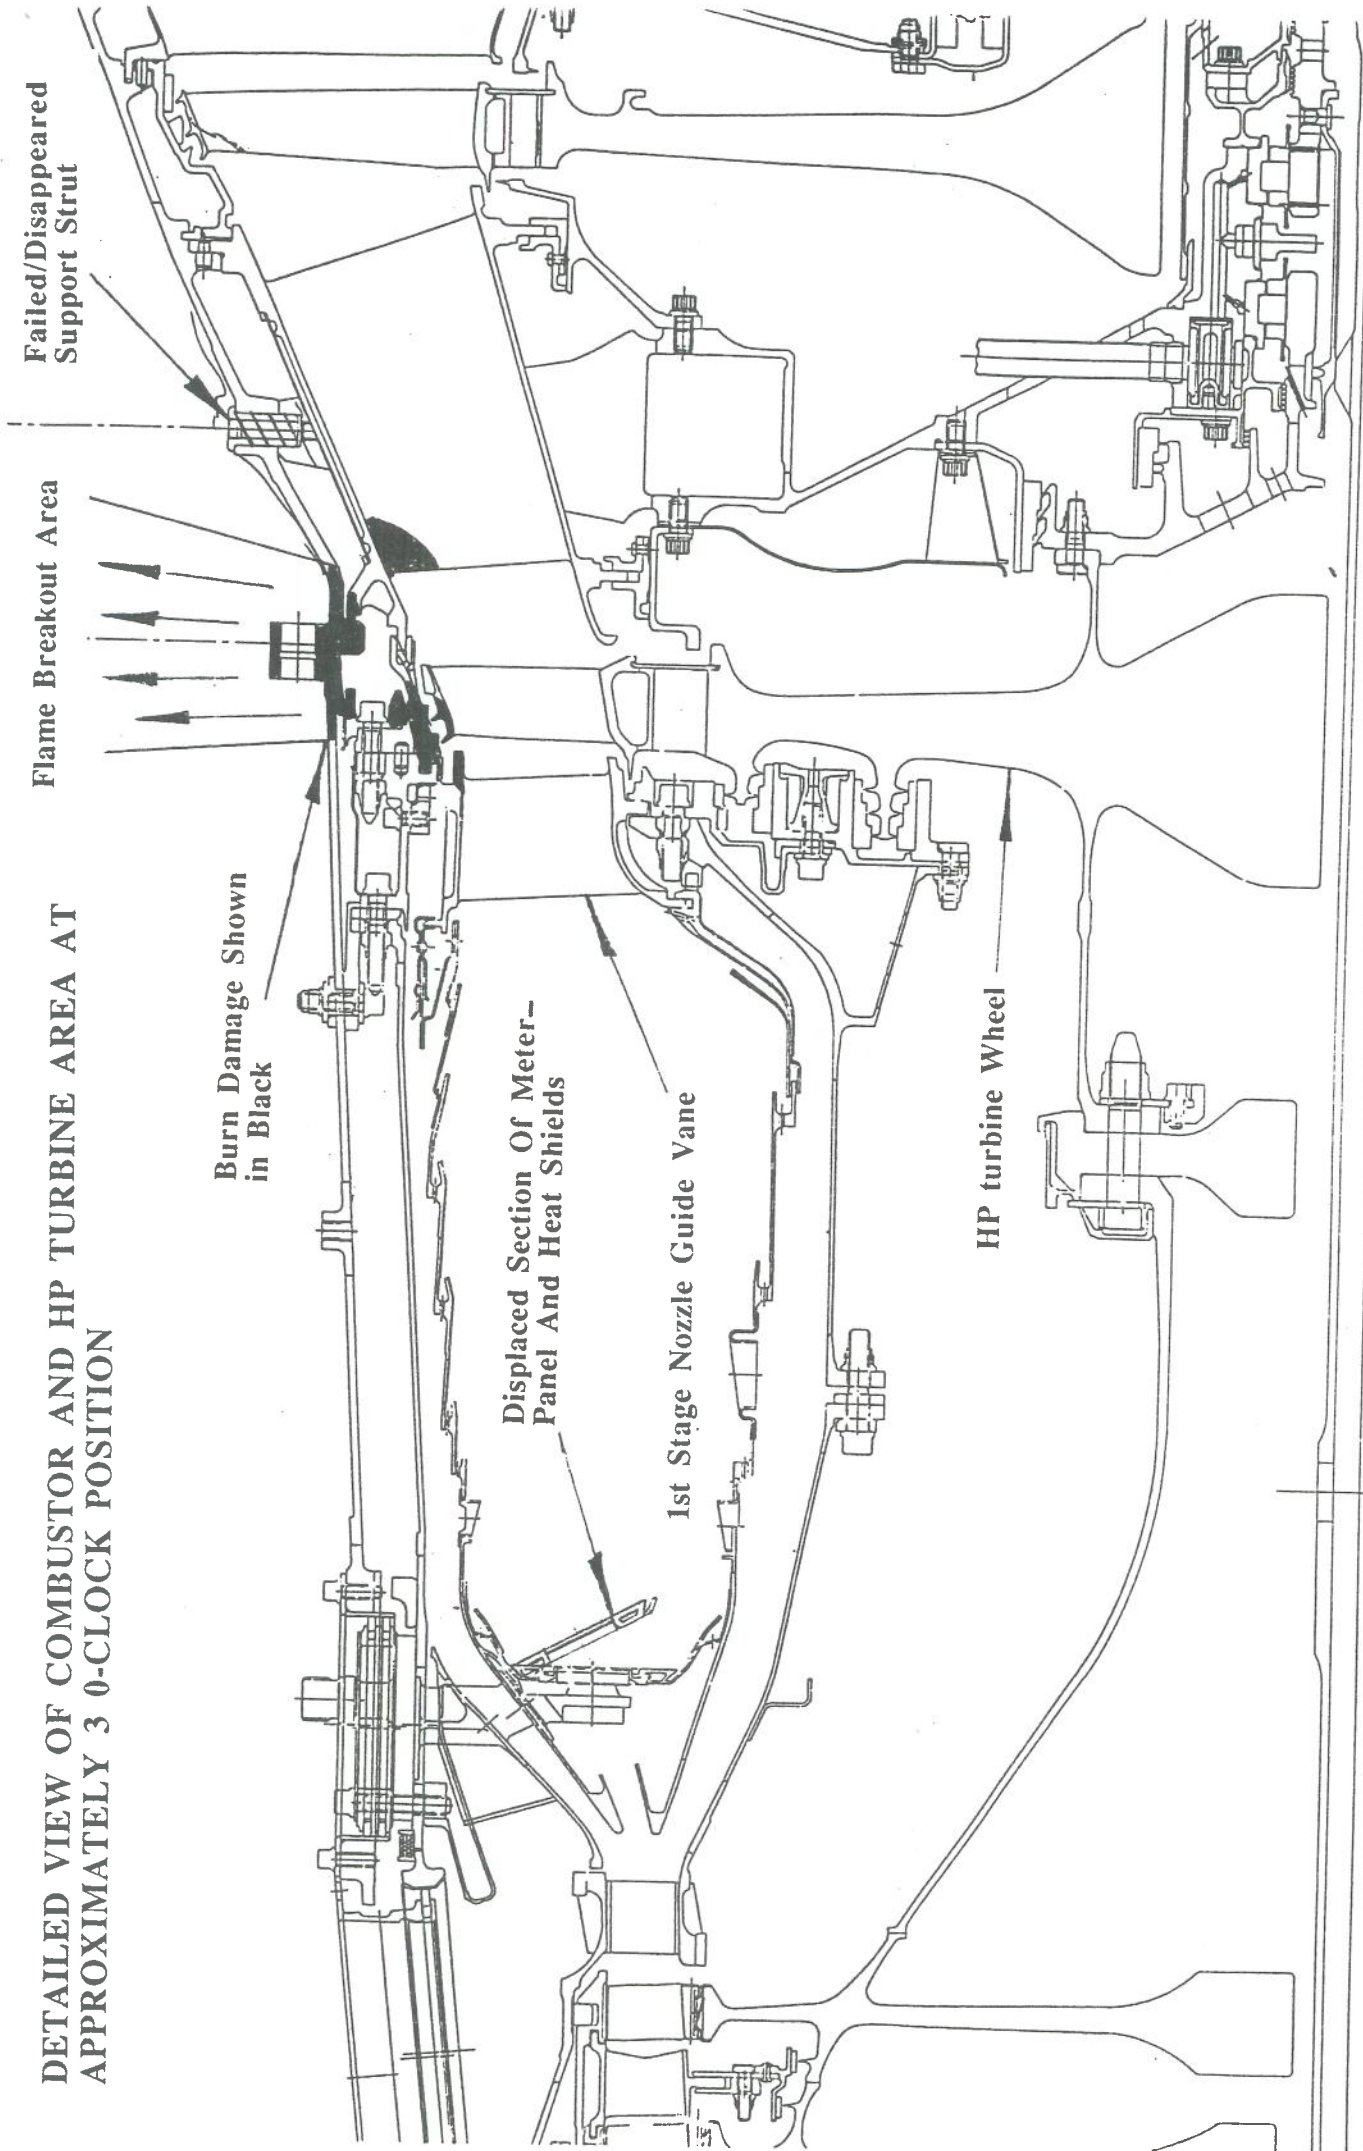
SECTION OF RB 211 524 H ENGINE SHOWING POSITIONS OF  
MAJOR BURN DAMAGE AND DISPLACED METERPANEL

This had initially allowed combustion gases to escape into the cooling air cavity before burning through the outer casing of the engine core and locally destroying the metal panels forming the fairing of the core within the bypass flow. In addition, the inner skin of the cold nozzle and elements of the thrust reverser (ie skins forming the outer boundary of the bypass flow) was locally heat damaged. Severe burning, holing and cracking of the Intermediate Pressure (IP) turbine casing and cooling air manifold had also occurred, together with local damage to the HP/IP support structure. Although extensive mechanical damage to most of the turbine stages was found, it was considered that this was all associated with debris from the original burn through area passing through the turbines and becoming trapped between the blades and the nozzle guide vanes.

Examination of the combustion system revealed that a section of the meterpanel at the upstream end of the combustion liner had become displaced in such a way that the faces of the heat shields were angled towards the outside of the engine rather than lying at right angles to the flow direction. This displacement was the result of circumferential cracking occurring between a group of adjacent cooling air slots at the inner circumference of a section of the meterpanel, allowing the latter to distort under the influence of the gas path load. This resulted in complete or partial disengagement of fuel spray nozzles from positions 3 to 7 and modification of the downstream flow pattern such that the hotter areas near the centre of the flame pattern came into contact with the outer wall of the gas path. This, in turn, resulted in loss of the outer platforms of two HP NGVs and local burn through of HP turbine seal segments.

The damaged section of the meterpanel area was cut away from the combustion liner and was examined by the materials laboratory of the engine manufacturer, as were a number of corresponding sections removed from in-service examples of other engines which exhibited cracking in similar areas. It was determined that the components were all dimensionally and materially correct. It was also established that the cracking phenomenon was the result of a low cycle thermal fatigue effect which, when sufficiently developed, allowed a high-cycle fatigue mechanism to become dominant.

Burn through  
engine core casing

Burn damage on reverser  
panels and cold nozzle

Burn through  
core fairing panels

Meterpanel

**DETAILED VIEW OF COMBUSTOR AND HP TURBINE AREA AT  
APPROXIMATELY 3 O-CLOCK POSITION**

The manufacturer has also recently introduced into production a modified combustor head manufactured from C 263, in place of the existing Nimonic 75 material. The meterpanel, which is attached to the head, is already manufactured from C 263, but the opportunity has also been taken to incorporate within it some minor changes to the arrangement of cooling air holes and some slight geometric alterations. Although this design change, which is detailed in Service Bulletin 72-9764, was made for reasons unrelated to the problem of meterpanel failure, it is thought that the design will reduce the tendency for cracking to occur in the area of the cooling air slots and reduce or eliminate the possibility of this type of failure.

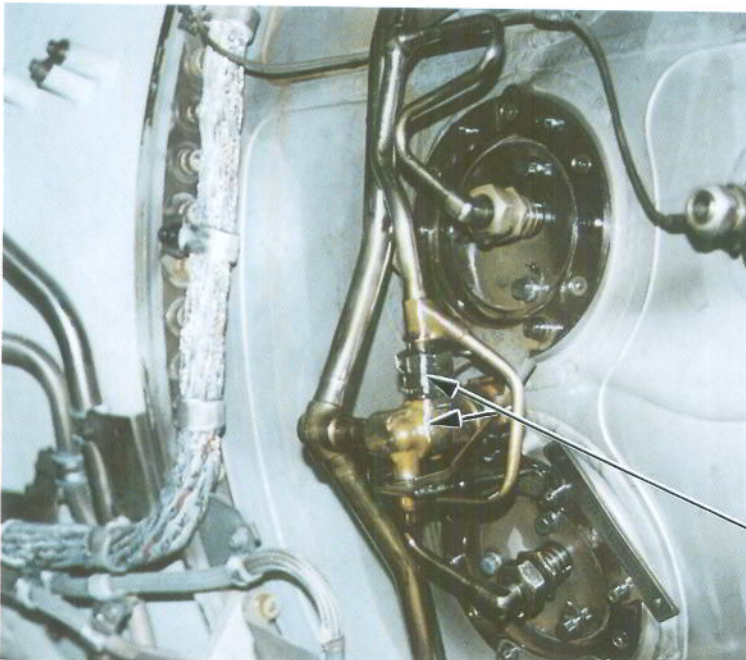
Fig 1a Union nut after tightening to correct torque

The union nut was restored to its position before the torque check was done and a leak test performed. This showed that there was a fuel leak from the joint which started when the pressure was raised above 200 psi. When the joint was tightened up to the correct torque it did not leak, even at the maximum achievable fuel pressure of 1400 psi. This particular pigtail had been changed in May 1993, whilst the engine was on the wing; since when the engine had run 10,369 hours with 1,365 starts.

note changed position of line on nut relative to that on manifold

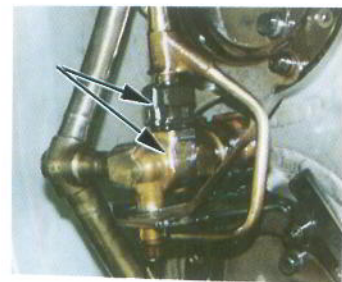
Union nut found to be undertightened

White line on nut and manifold show position of nut as found.
