**ACCIDENT**

| <b>Aircraft Type and Registration:</b> | Aerostar YAK-52, G-CCJK | |
| <b>Date &amp; Time (UTC):</b> | 21 August 2018 at 0915 hrs | |
| <b>Location:</b> | East Hoe Manor private strip, Hambledon, Hampshire | |

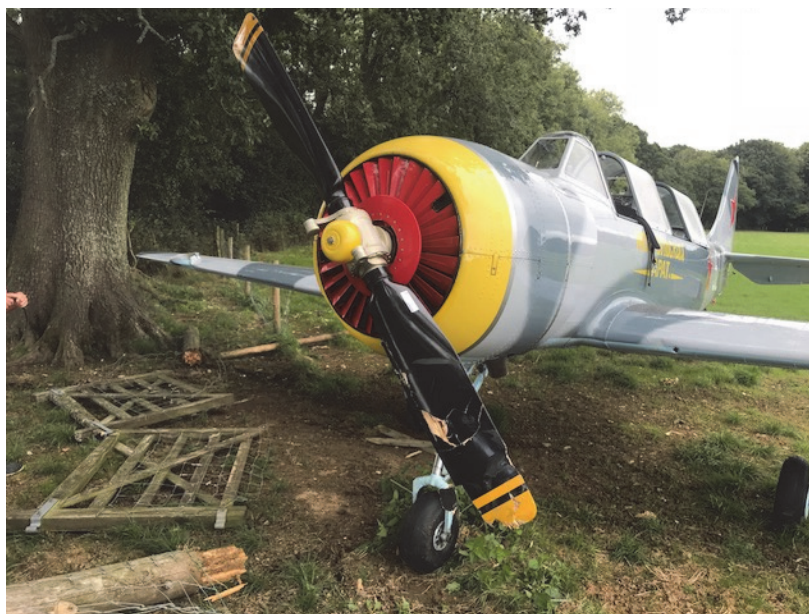
**Figure 1**

continued to rotate. The aircraft overran the runway at approximately 10 mph and collided with a fence. It came to a stop a few metres beyond the fence and the pilot was able to exit the aircraft unaided (Figure 1).

G-CCJK after the accident

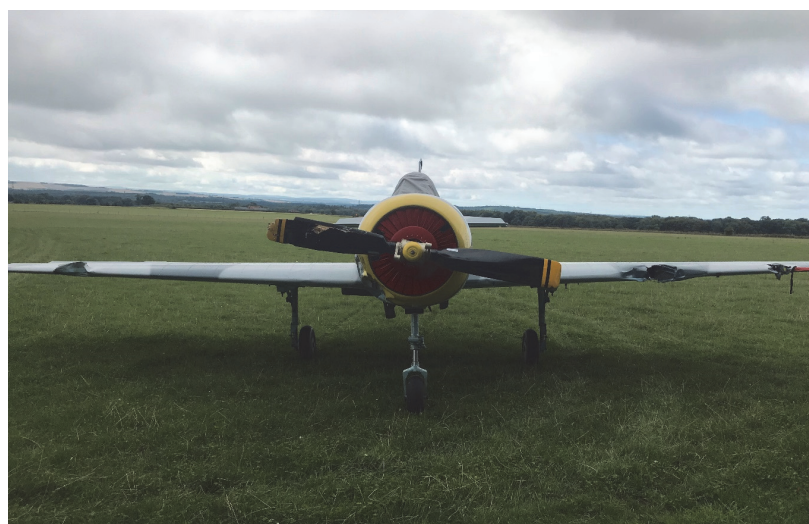
**Figure 2**

The collision with the fence caused damage to both leading edges, the right lower cowling and the propeller (Figure 2).

G-CCJK showing fence post damage to both leading edges and propeller

After the accident the pilot inspected the runway and found the surface was very hard, with new shoots of grass and damp with dew. He believed that this combination of conditions made the surface slippery. He reported that the YAK 52's normal ground roll

was approximately 150 m, but on this occasion it had used over 380 m. He reflected that he should have checked the runway surface conditions before departing.
