**SERIOUS INCIDENT**

| <b>Aircraft Type and Registration:</b> | BAE Systems (Operations) Ltd ATP, SE-MHE | |

**Synopsis**

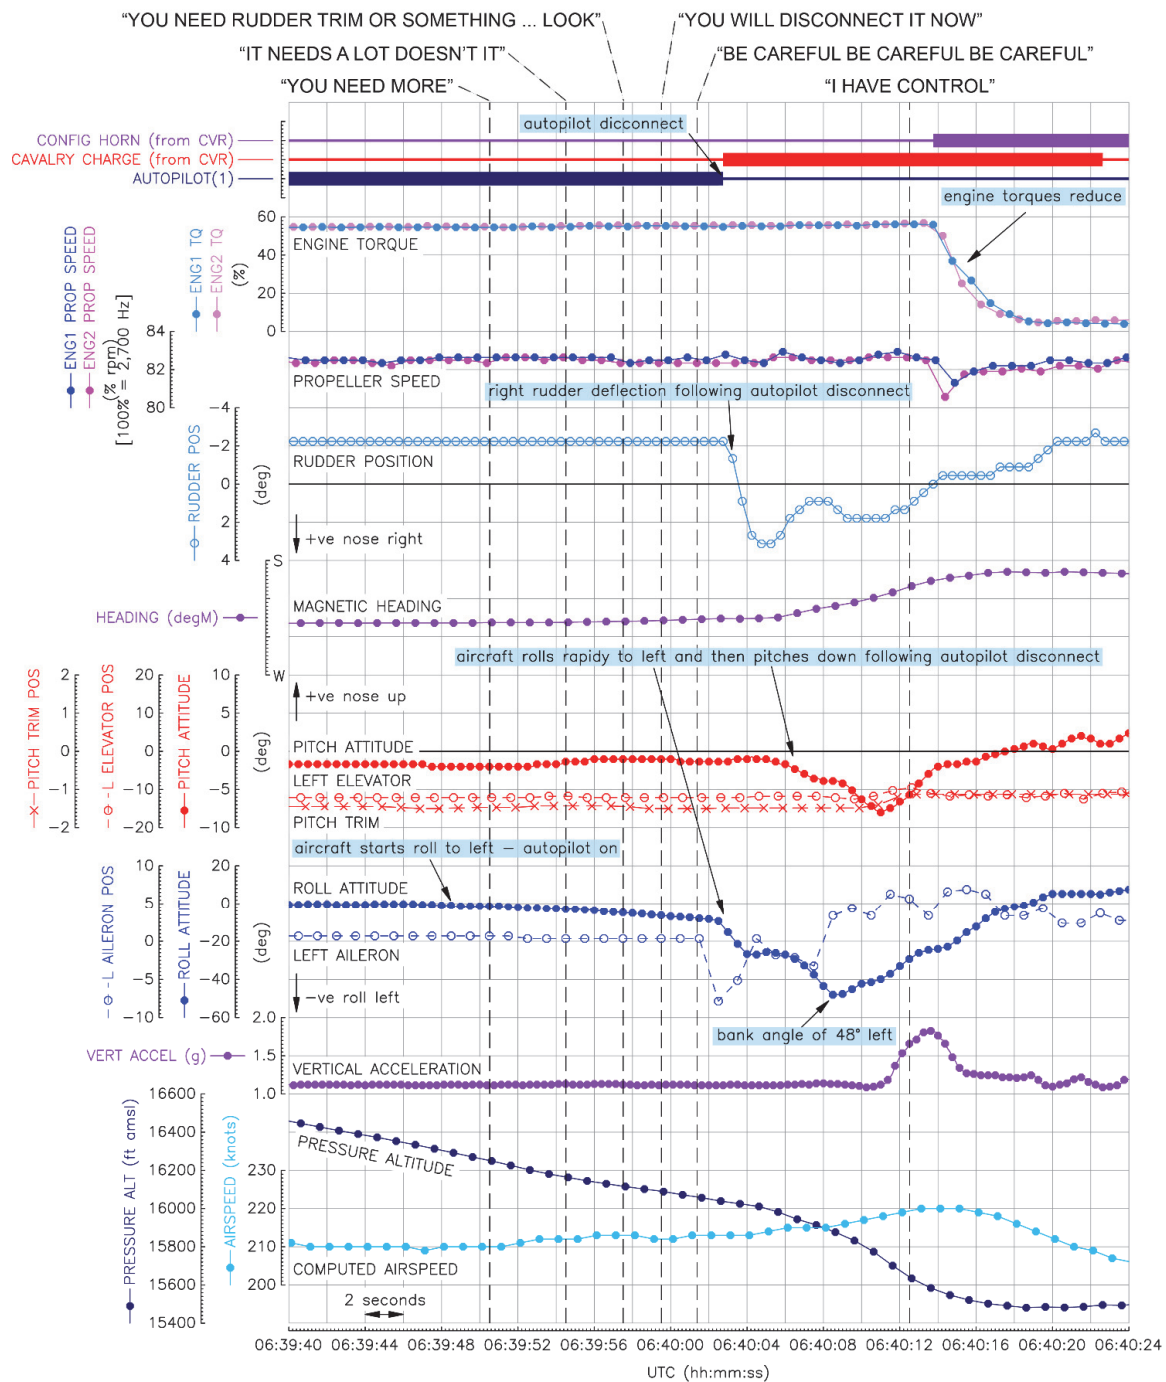
Figure 1 starts with the aircraft stable on descent towards Guernsey, with the autopilot engaged, passing through 16,500 ft amsl, with the propeller speed at about 82% (of the maximum 1,200 rpm), and engine torques of about 55%. In summary, the data indicates the following:

Salient parameters during the event with extracts from the CVR relating to use of trim

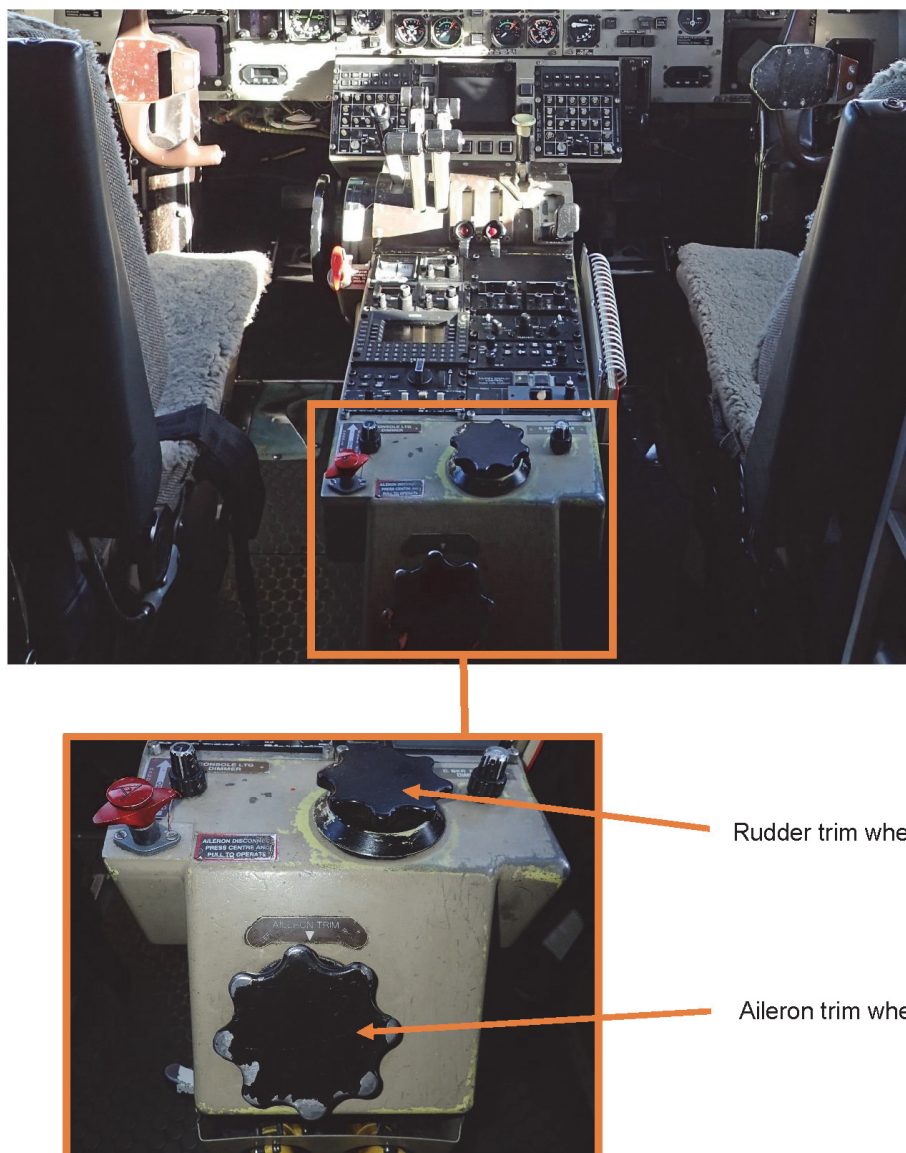
**Figure 2**

Position of the rudder and aileron trim wheels
