**Aircraft type and registration:** Boeing 737 G-BKYP/BAe 1-11 G-AVML

**Date and time (UTC):** 29 July 1986 at 0934 hrs

**Location:** London (Heathrow) Terminal Control Area

# SSR TRACKS FOR AIRMISS 29.7.86

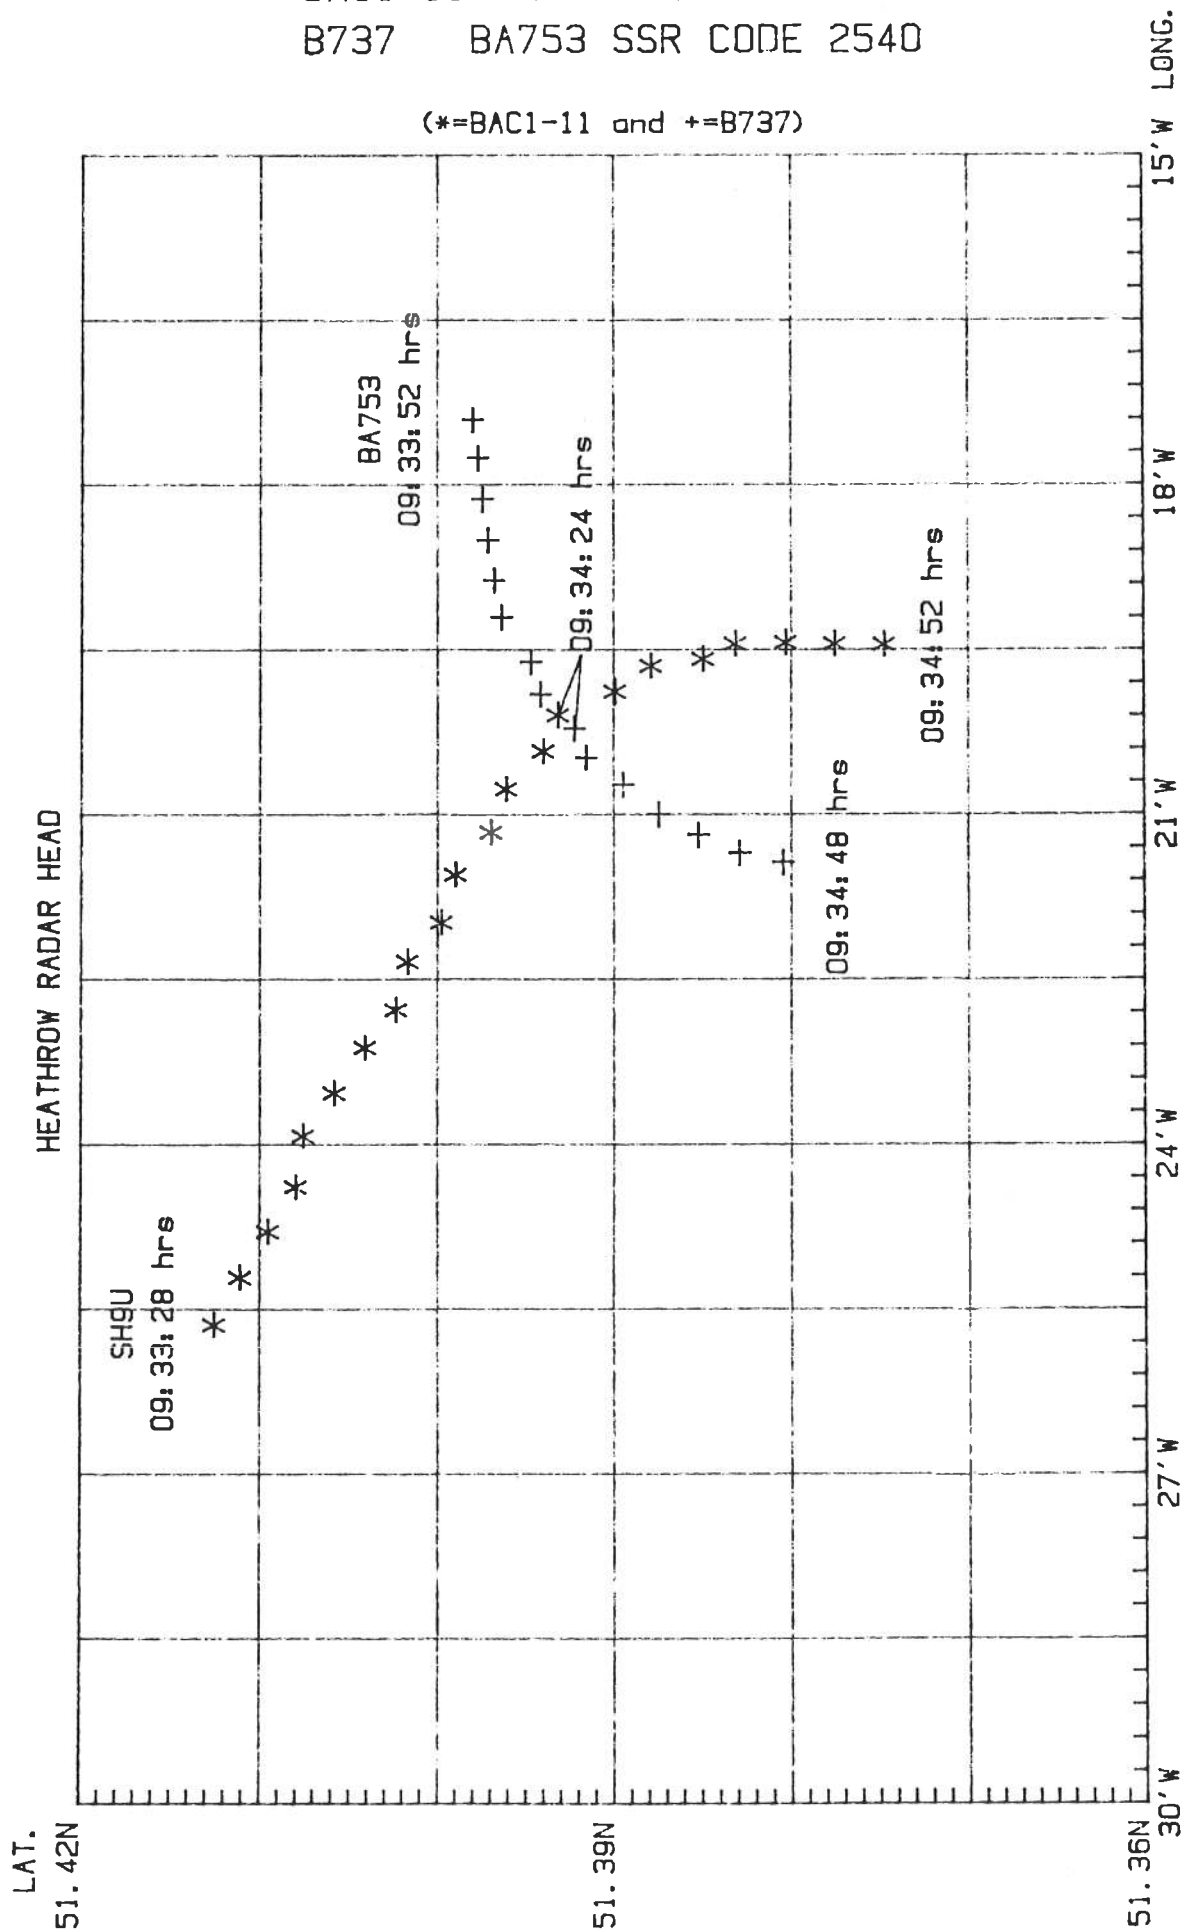
On the occasion of this incident, the concentration of Director 1 was diverted from the position of BA 753 for a period of nearly two minutes, during which he spoke to only Shuttle 9U. The reason for this period of distraction could not be positively identified but it is possible that the presence of two visitors, who were listening to the radiotelephony (RTF) and watching his screen, may have contributed.

Releasing the aircraft from the VOR's in this manner allows Director 1 to turn the westbound aircraft left onto an easterly heading so as to position it at the correct distance ahead of, or behind, the eastbound traffic. However, it was not until two minutes later, 0934 hrs, when the two aircraft were less than 2 miles apart, that Director 1 instructed BA 753 to turn left onto 130° and descend to 3000 feet. As soon as BA 753 had acknowledged this, he told Shuttle 9U to turn right onto a heading of 190°. Neither of these instructions held any implication by word or tone, of collision avoidance.

A few seconds later, the commander of BA 753 was obliged to push the control column sharply forward in order to avoid Shuttle 9U. The crew of the Shuttle, having just began to turn did not see the other aircraft, however, an Airmiss Report was filed by both crews.
