SERIOUS INCIDENT

Aircraft Type and Registration:	Boeing 767-332ER, N1608	
No & Type of Engines:	2 General Electric CF6-80C2B6F turbofan engines	
Year of Manufacture:	2000 (Serial no: 30573)	
Date & Time (UTC):	13 August 2017 at 1225 hrs	
Location:	London Heathrow Airport	
Type of Flight:	Commercial Air Transport (Passenger)	
Persons on Board:	Crew - 11	Passengers - 208
Injuries:	Crew - None	Passengers - None
Nature of Damage:	None	
Commander's Licence:	Airline Transport Pilot's Licence	
Commander's Age:	61 years	
Commander's Flying Experience:	16,239 hours (of which 5,619 were on type) ¹ Last 90 days - 177 hours Last 28 days - 72 hours	
Information Source:	Aircraft Accident Report Form submitted by the operator and further AAIB investigation

Synopsis

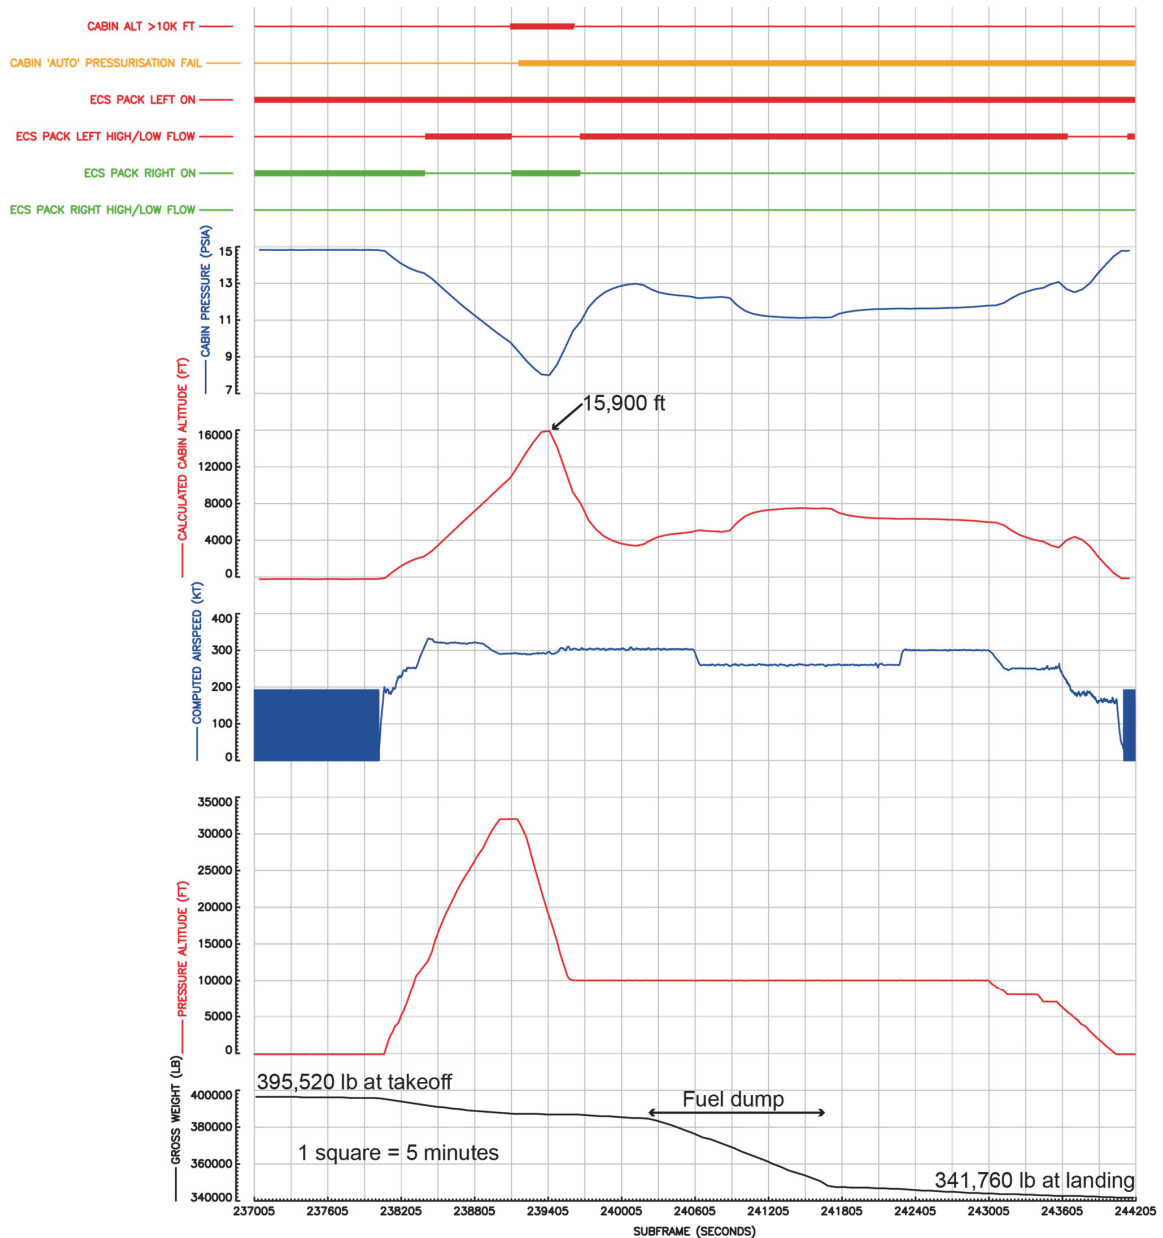
Figure 1

DFDR data at the time of the event – N1608, 13 August 2017

The DFDR data shows that the profile of the calculated cabin altitude followed the aircraft altitude and reached a height of 15,900 ft before reducing as the aircraft descended. There was no evidence of the cabin altitude stabilising between 7,000 to 7,500 ft before this point. The profile of the cabin altitude during the remainder of the flight was consistent with the cabin altitude being manually controlled by the crew. The position of the outflow valve is not recorded on the DFDR.

Approximately five minutes after the aircraft took off, the right Environmental Control System (ECS) pack was switched OFF and the left ECS pack changed to high-flow mode. Eleven minutes later the right ECS pack was switched ON and the left ECS pack returned to low-flow mode. At the same time, the CABIN ALT > 10K FT illuminated followed shortly afterwards by the CABIN AUTO PRESSURISATION WARNING FAIL. After a further nine minutes, when the aircraft had descended to an altitude of approximately 10,000 ft, the right ECS pack was switched OFF, the left ECS pack changed to high-flow mode and the warning CABIN ALT > 10K FT cleared. The right pack remained OFF and the left pack remained in the high-flow mode for the remainder of the flight.

The fault on the right engine PRVC would have generated the EICAS message R ENG PRV, which would have required the crew to turn off the right ECS pack. This action would have caused the left ECS pack to automatically switch to the high-flow mode. It can be seen from the DFDR data, presented at Figure 1, that the left pack automatically switched between low and high-flow mode on two occasions, which is consistent with the crew actioning the QRH. The cabin pressure was also maintained at a satisfactory level during the inbound flight when only the left pack was operating. This indicates that the air conditioning system worked correctly and the flow from the left pack should have been sufficient to pressurise the cabin.

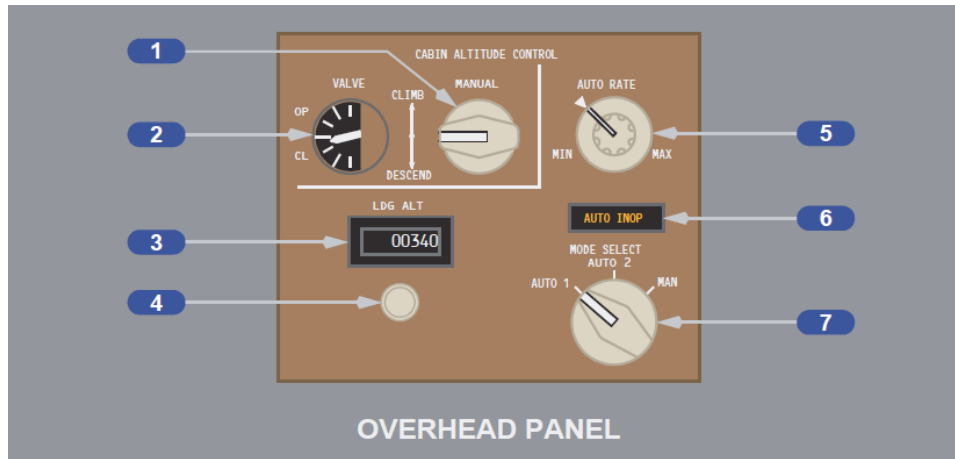
Figure 2
Cabin Altitude Control Panel

In automatic mode, the 'MODE SELECT' (7) on the CACP can be set to either the AUTO 1 or AUTO 2 position. Manual mode is selected by moving the 'MODE SELECT' to the MAN position and the cabin pressure is then controlled by moving the spring loaded 'MANUAL' control (1) to either the CLIMB or DESCEND position. This action moves the outflow valve towards either the open (OP) or closed position (CL).

For the cabin pressure to decrease as the aircraft climbed there would have had to have been either insufficient airflow into the cabin or excessive leakage from the cabin. The commander reported that the indicator on the CACP showed that the outflow valve was near to the CLOSED position when they commenced their descent to 10,000 ft. Examination of the aircraft at Heathrow and Atlanta, and inspection and testing of the components removed from the aircraft, could not identify a fault that would have restricted the airflow into the cabin or resulted in an excessive leakage. However, since the components were replaced the aircraft has flown more than 2,000 hours and 240 cycles with no further reported faults with the cabin pressurisation.
