**ACCIDENT**

| <b>Aircraft Type and Registration:</b> | 1) Cessna 152, G-WACG<br>2) Guimbal Cabri G2, G-JAMM |
| <b>Date &amp; Time (UTC):</b> | 17 November 2017 at 1201 hrs |
| <b>Location:</b> | Near Waddesdon, Buckinghamshire |

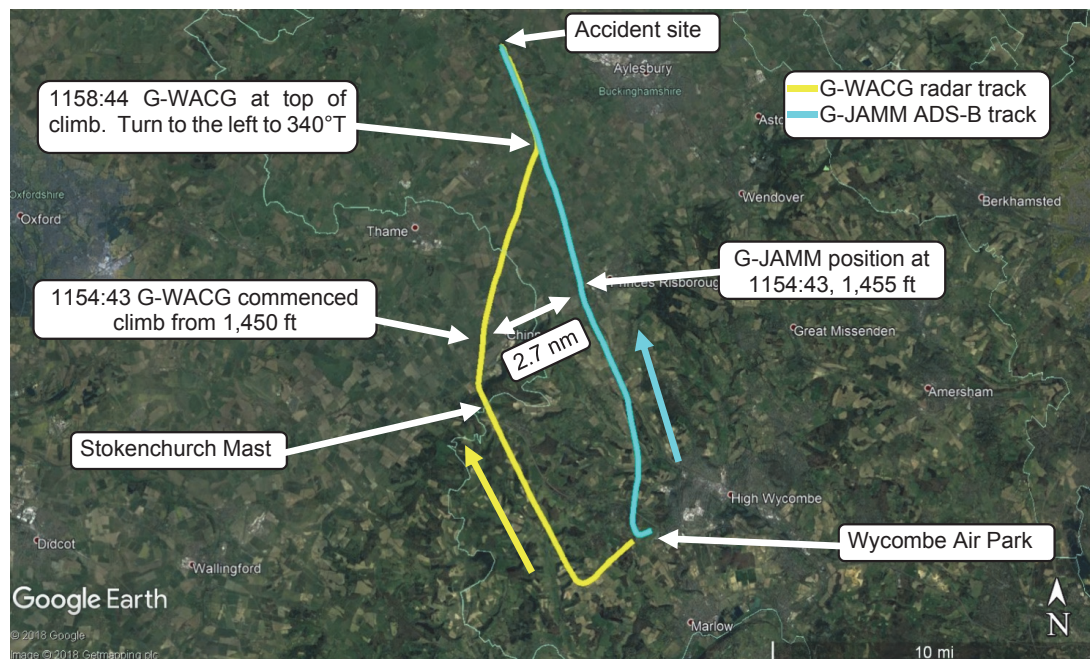
**Figure 3**

G-WACG and G-JAMM position information

During the first six minutes of flight, the distance between the aircraft increased up until the point where G-WACG turned to the right at the Stokenchurch Mast. Just prior to G-WACG commencing its climb, the aircraft were at a similar level, approximately 2.7 nm apart with G-WACG slightly behind and to the left of G-JAMM (Figure 3).

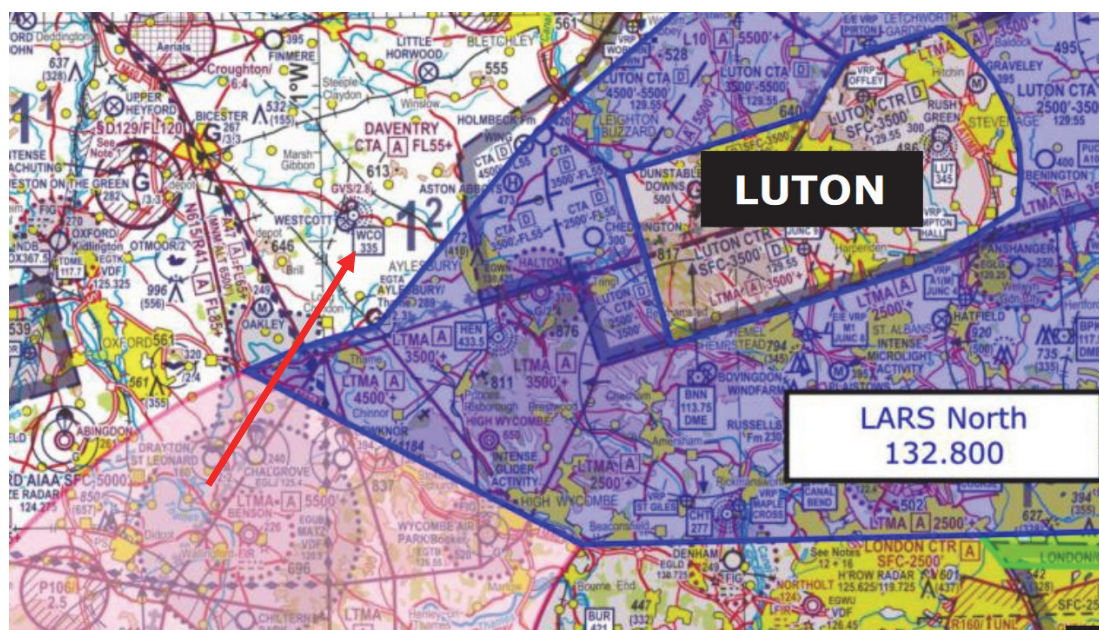
**Figure 6**

The area to the north-west of WAP, where many training flights operate, is partly covered by Farnborough North Lower Airspace Radar Service (LARS), Figure 6. Farnborough LARS provides Air Traffic Services outside controlled airspace to pilots flying under or around the London Terminal Manoeuvring Area. The type of service available depends upon the request made by the pilot and the capacity of the unit. The 'Farnborough LARS Guide' published online by NATS includes the following note:

Accident location (indicated by arrow) relative to Farnborough LARS North

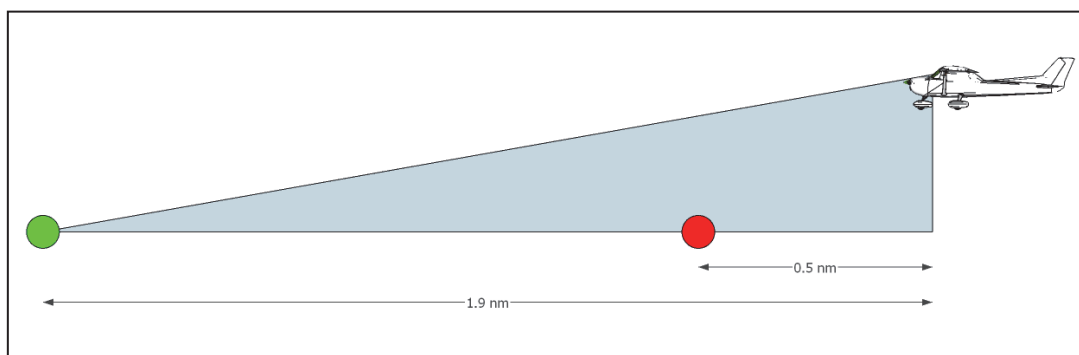
**Figure 10**

Radar data indicated that, when G-WACG was 1,950 ft above G-JAMM, it was only 0.5 nm behind it. A simple assessment indicates that, if G-WACG was straight and level with zero pitch angle at 2,000 ft above G-JAMM, it would have to have been at least 1.9 nm behind for the pilot to have had any opportunity of detecting a possible conflict without additional manoeuvring (Figure 10). In the absence of a turn, the pilot would need to have pitched the aircraft at least 24° nose-down to have had any chance of observing the helicopter. The situation, whereby additional manoeuvring would have been required by G-WACG to bring the helicopter into view, would have persisted up to the point of collision.

Forward visibility from G-WACG  
(grey area is obscured from vision,  
red circle indicates the radar position of G-JAMM,  
green circle indicates the minimum distance at which  
G-JAMM would have been visible)
