No: 11/91

Ref: EW/C91/8/3

**Aircraft Type and Registration:** Christen Eagle II, G-BREI

**Date & Time (UTC):** 17 August 1991 at 1036 hrs

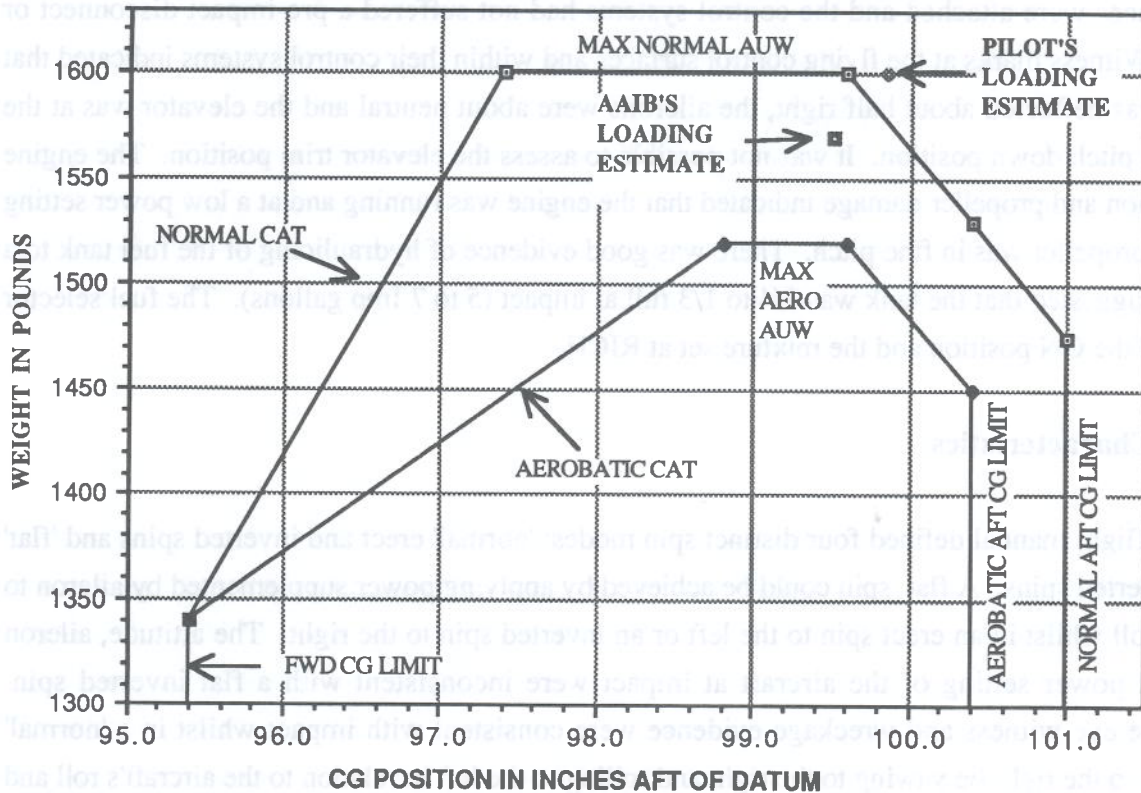
### CHRISTEN EAGLE II LOADING LIMITS

just 7 US gal of fuel the aircraft could be flown at maximum A UW but not within either CG envelope. The loading limits together with the AAIB's estimate of the loading at the time of impact are summarised in the diagram below:

The diagram shows that the aircraft was probably within the limits for normal manoeuvres but certainly outside the limits for aerobatics. In this respect, the flight manual contained the following relevant text:

*WARNING Any particular Christen Eagle II aircraft will recover from any spin type using standard recovery techniques ONLY IF THE AIRCRAFT IS PROPERLY BALANCED. The CG of the aircraft must be within design limits to ensure safe spin recovery. Any aircraft can be dangerously loaded (CG beyond design limits) making spin recovery extremely difficult or impossible.*
