ACCIDENT

Aircraft Type and Registration:	DH82A Tiger Moth, G-ANRM	
No & Type of Engines:	1 De Havilland Gipsy Major 1H piston engine	
Year of Manufacture:	1943 (Serial no: 85861)	
Date & Time (UTC):	30 June 2018 at 1725 hrs	
Location:	Sywell Aerodrome, Northamptonshire	
Type of Flight:	Training	
Persons on Board:	Crew - 1	Passengers - 1
Injuries:	Crew - 1 (Minor)	Passengers - 1 (Minor)
Nature of Damage:	Wings, propeller, forward fuselage and rudder damaged	
Commander's Licence:	Commercial Pilot's Licence	
Commander's Age:	58 years	
Commander's Flying Experience:	5,230 hours (of which 856 were on type) Last 90 days - 119 hours Last 28 days - 63 hours	
Information Source:	Aircraft Accident Report Form submitted by the pilot and enquiries made by the AAIB

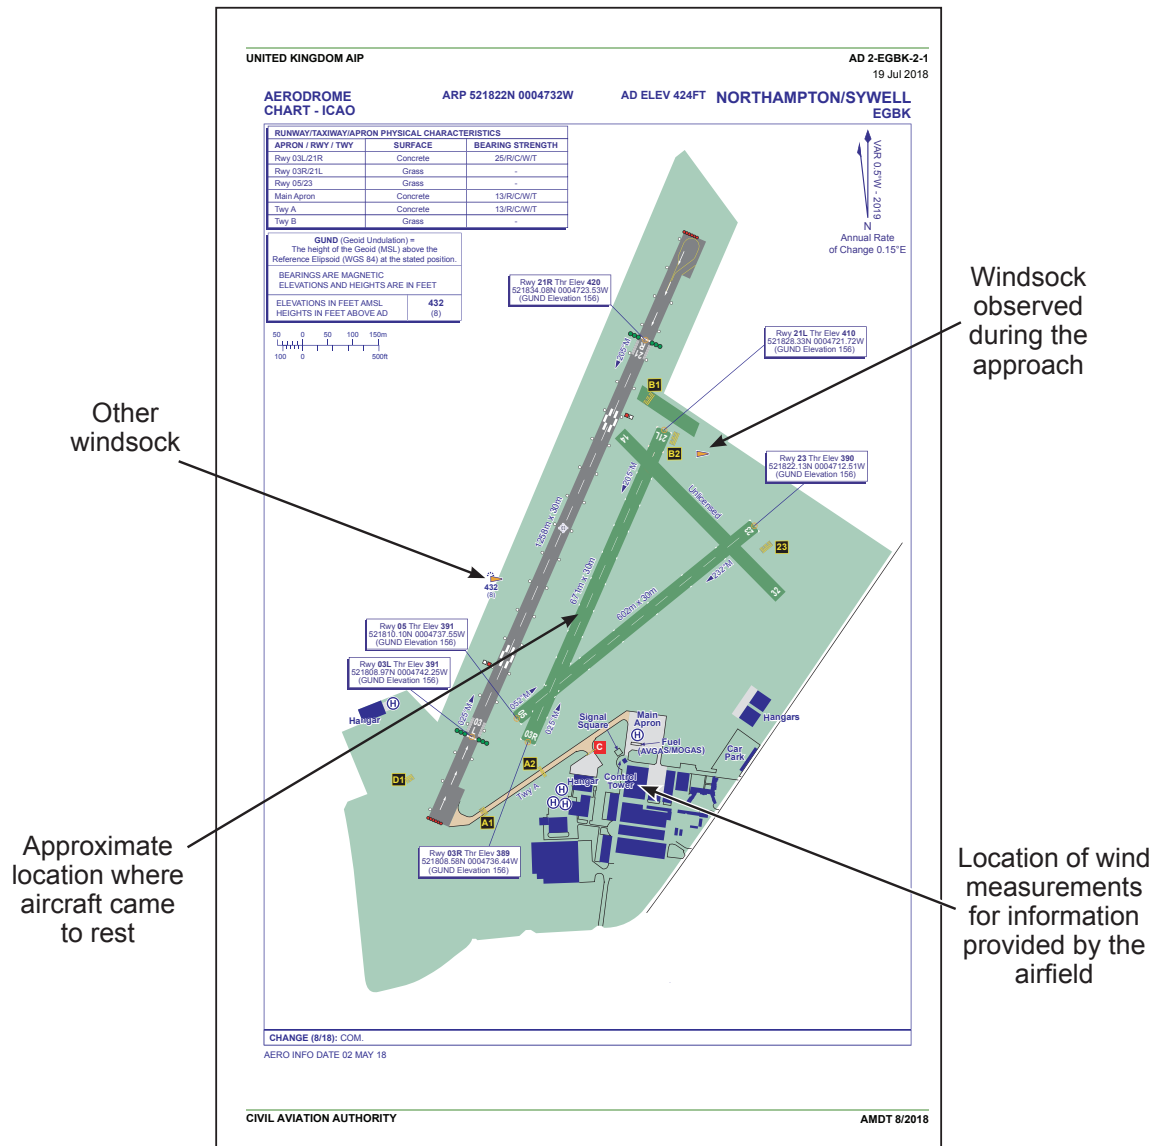
Figure 2

Over the course of the evening, the wind had varied between 030° to 050° at 12 to 18 kt. The maximum gust recorded was 20 kt. Around the time of the incident, Sywell Information briefly observed an anemometer reading of 070° at 18 kt. They reported that this reading differed from the direction indicated by the windsock nearest to the incident. The chief pilot for the aircraft operator investigated the accident and visited Sywell. During the visit, he found that the indications provided by the two windsocks differed from each other and from the wind information provided by Sywell (Figure 2).

Aerodrome chart (amended and used with permission from NATS aeronautical information service)

The chief pilot stated that the wind had been within the operator’s recommended limits for Runway 03R. However, pilots had received a brief to use Runway 03R or Runway 05 depending on approach conditions. The chief pilot commented that using Runway 05 may have been preferable because of the tendency for gusts to veer and strengthen, especially in the evening.
