AAIB Bulletin 12/90

Aircraft Type and Registration: McDonnell Douglas DC-9-32, G-PKBM

Nature of Damage: Left outer landing gear door detached; minor damage to left main flap

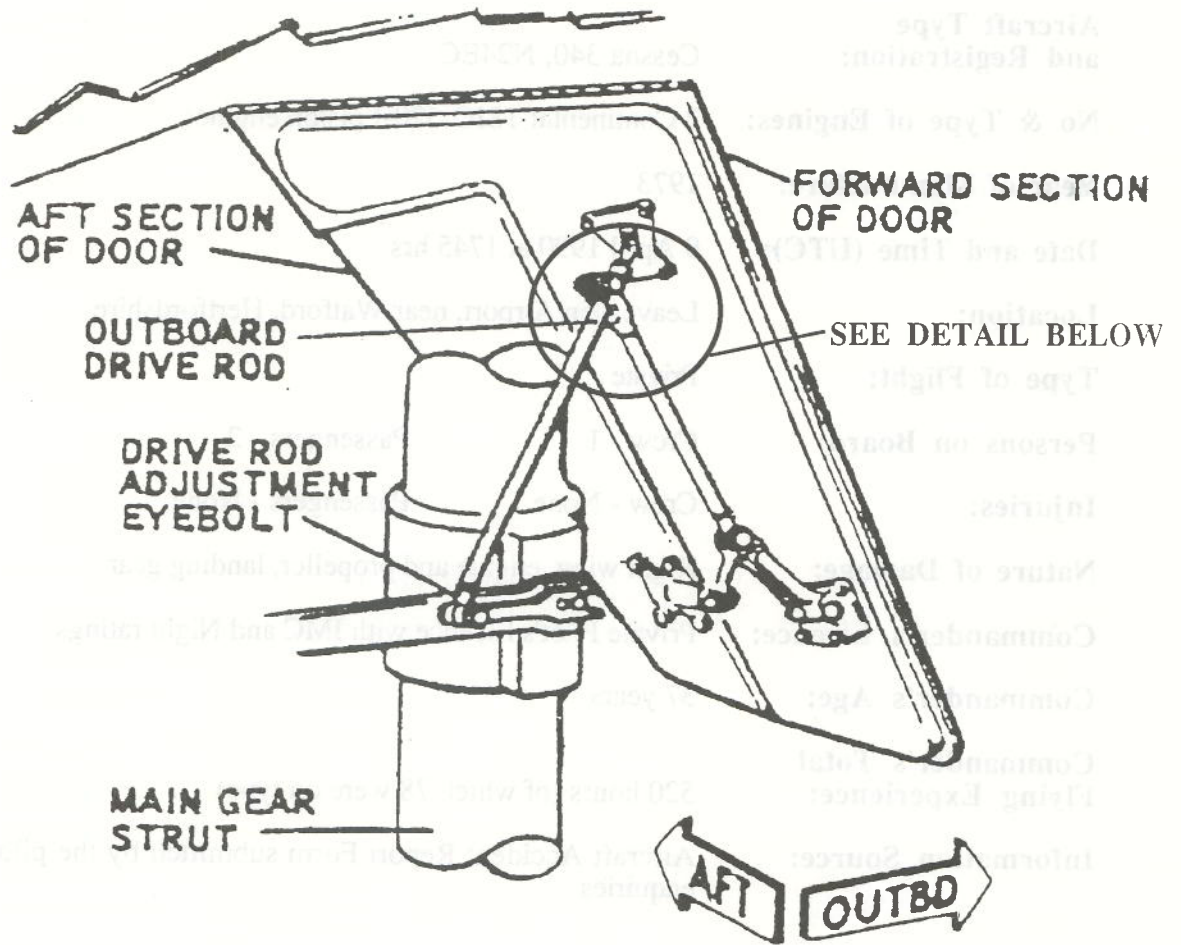
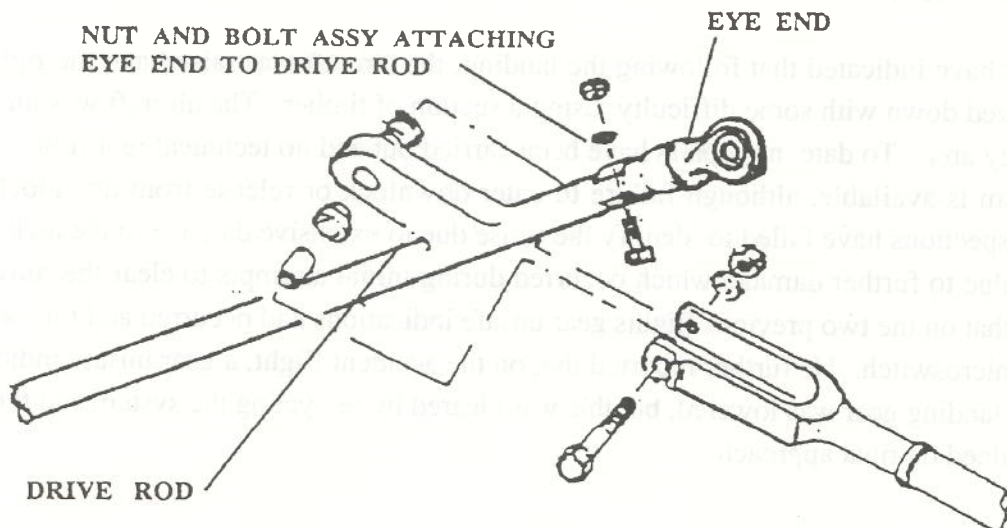
DC9 MAIN LANDING GEAR DOOR ASSY DETAIL

Inspection revealed that the main landing gear outboard door drive rod had become detached from the eye end fitting, but the latter had remained attached to the door assembly (see Figure). The securing nut and bolt that attached the end fitting to the rod was not found. Thus either the bolt had failed or the nut had come undone, allowing the bolt to fall out. The door had then failed its hinge attachment and separated from the aircraft striking the left main flap as it fell away, causing a dent and puncturing the skin.

A more detailed examination revealed little evidence of lubrication on either the left or right landing gear linkages. However, there was no indication that lack of lubrication or linkage seizure had caused the problem. Furthermore, it was observed that there was no elongation of the mating holes on the drive rod or eye-end fitting, suggesting that no excessive load had been applied to the drive rod.

A fleet inspection of main landing gear door linkages revealed that differing types of bolt secured the eye-end fitting to the drive rod and that the orientation of the bolt also varied between aircraft. The correct orientation was 'head-down' in order to reduce the possibility of interference with the door fitting. It was then found that the Illustrated Parts Catalogue and the Overhaul Manual called up different bolt types. The advice of the aircraft manufacturer was therefore sought. Their response was that the correct configuration was an NAS 1404-12 pan-headed bolt installed head-down, although different bolts, albeit of the same strength, had been used on earlier installations. However, the same retaining nut, an NAS 679A4 locknut, was used regardless of the type of bolt. This was also the only joint on the door assembly which did not employ a castellated nut and split pin.

The aircraft manufacturer further stated that there had been 18 cases of the subject door becoming detached in flight, with the horizontal stabilizer having suffered severe damage in one instance. However only one, or possibly two, cases were ascribed to loose or mis-rigged linkages. The manufacturer plans to issue an Alert Service Bulletin (No. A32-244) calling for an inspection for cracks, corrosion and general security of these linkages. The FAA is considering mandatory action on this subject in the near future.

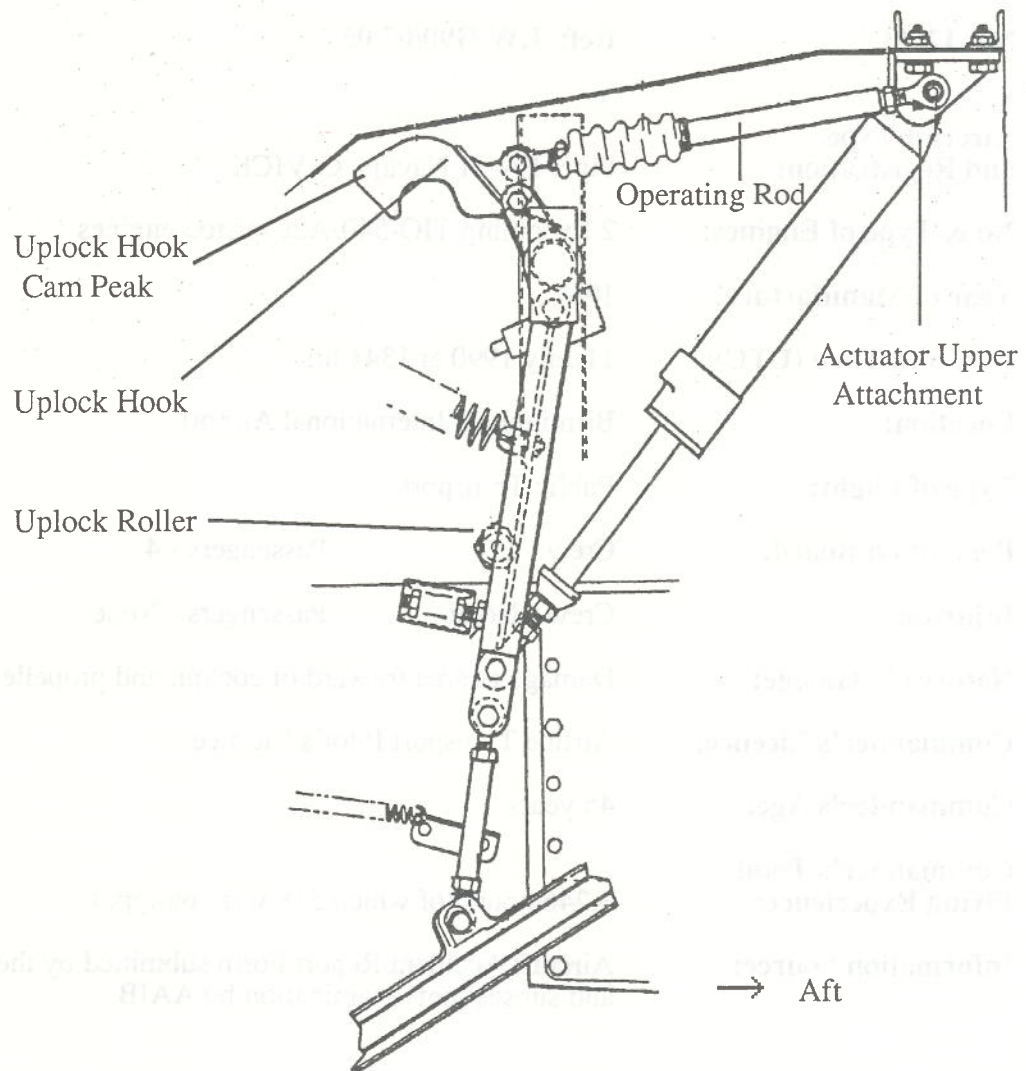
Nose Landing Gear Operation

Examination showed that the welded lugs forming the support for the uplock hook pivot bolt were both distorted in a manner consistent with overload forces applied by uplock rod tension with rotation of the uplock hook restricted.

The uplock operating rod was bent in two places, probably by overload forces applied during nose up rotation of the uplock hook beyond the point at which the uplock operating rod telescopic action bottomed out (under compression). There was also considerable play in the uplock hook pivot, with some elements found to be oval - again consistent with overload. Marking was found on the upper face of the uplock hook consistent with contact from the uplock roller nut.

The bending of the operating rod and the ovality of the hook pivot could have been caused by forces produced when the spring portion of the operating rod bottomed out because of its excessive length. Slop developing in the uplock hook pivot could eventually cause the roller to contact the uplock cam hook above the peak during retraction, allowing the roller nut to ride on the top face of the uplock hook, thereby preventing a subsequent nose gear extension.

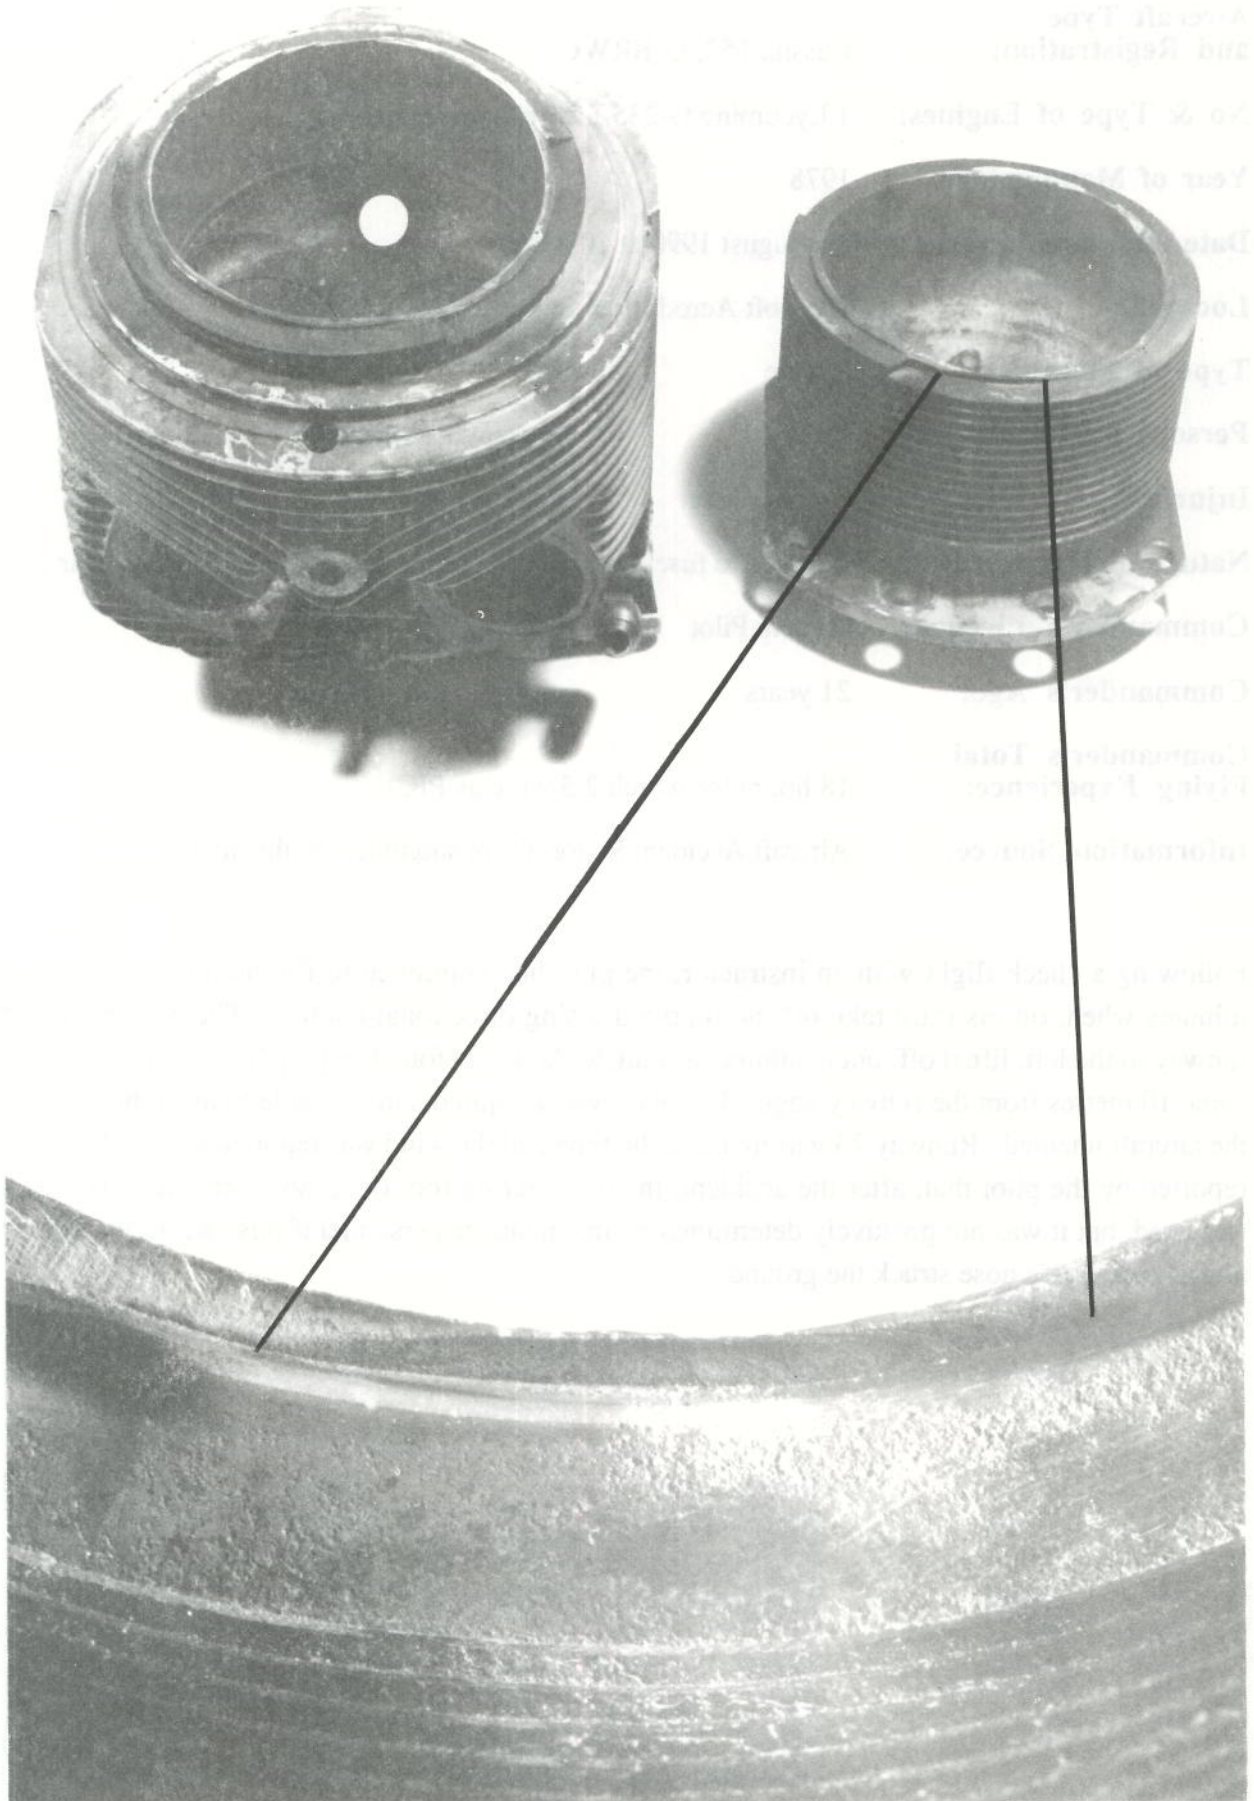
G-BOHB FAILED ENGINE CYLINDER

It was found that the engine's left hand rear cylinder had detached through a circumferential fracture in its skirt which had developed between two of the cooling fins. The failure was initially examined by a CAA Surveyor who consulted a metallurgist about the nature of the failure but it was subsequently despatched to AAIB for metallurgical examination at RAE Farnborough. Co-incidentally the CAA

The two cylinders had failed in fatigue and the failures were almost identical in location, initiation and development (cylinder from G-BOHB is shown in the photographs). The cylinder external surfaces had been protected by paint but this had largely disappeared from the barrel surface between the fins and the unprotected surfaces were corroded. Initiation had been from a single origin in an area of the external surface which was corroded and pitted. Staining from hot combustion gases was evident over about one third of the circumference of the fracture (this effect was less marked but slightly more extensive in the case of the other cylinder). This showed how far the crack had progressed before the final rapid rupture. There was no suggestion from the metallurgical examination of any material defect or deficiency.

AREA OF FATIGUE ORIGIN

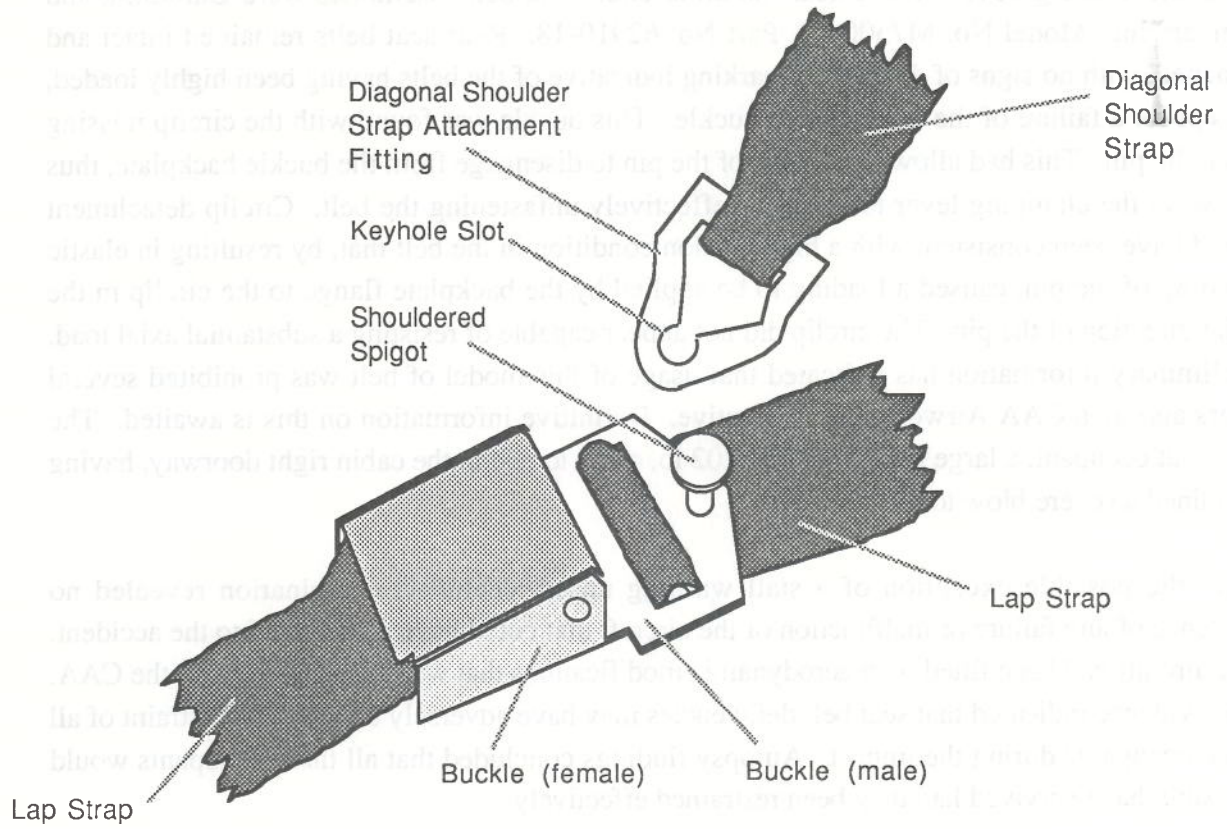
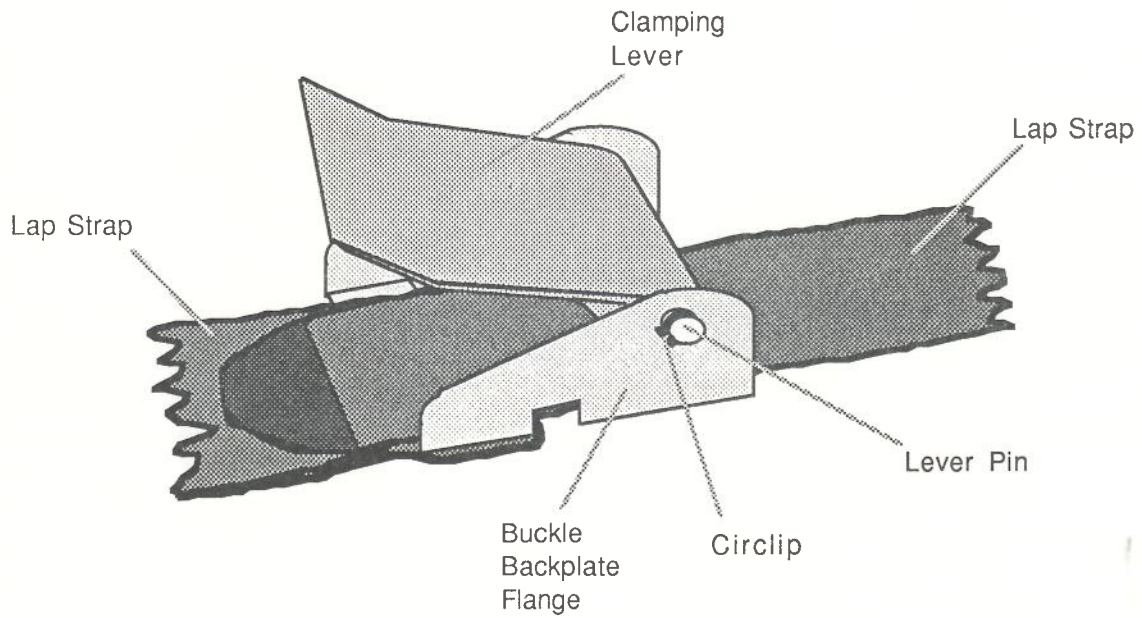
FIG 1

circumferential groove formed near the other end. The belt assemblies were Cumming and Sanders Inc. Model No. M7500-S2, Part No. 62910-18. Rear seat belts remained intact and attached, with no signs of distress or marking indicative of the belts having been highly loaded, except for a failure of the left seat belt buckle. This buckle was found with the circlip missing from the pin. This had allowed one end of the pin to disengage from the buckle backplate, thus allowing the clamping lever to displace, effectively unfastening the belt. Circlip detachment could have been consistent with a high tension condition in the belt that, by resulting in elastic bending of the pin, caused a loading to be applied by the backplate flange to the circlip in the axial direction of the pin. The circlip did not appear capable of resisting a substantial axial load. Preliminary information has indicated that usage of this model of belt was prohibited several years ago by a CAA Airworthiness Directive. Definitive information on this is awaited. The rear seat occupant, a large man weighing 202 lb, came to rest in the cabin right doorway, having sustained a severe blow to the chin.

With the possible exception of a stall warning unserviceability, examination revealed no evidence of any failure or malfunction of the aircraft that could have contributed to the accident. The aircraft had been fitted with aerodynamic modifications that were not approved by the CAA. The evidence indicated that seat belt deficiencies may have adversely effected the restraint of all three occupants during the impact. Autopsy findings concluded that all three occupants would probably have survived had they been restrained effectively.

CAA General Aviation Safety Information Leaflet (GASIL) 10/90 (Engineers' Supplement, page f) describes a method of renewing such buckle bushes, proposed by a member of the USA Cessna Pilots' Association, using soft clear plastic automotive fuel hose. No information has been found to suggest that there is a CAA approved repair scheme but further details are awaited from the CAA.
