**AIRCRAFT ACCIDENT REPORT 1/2005**

**Report on the accident to  
Sikorsky S-76A+, G-BJVX  
near the Leman 49/26 Foxtrot platform  
in the North Sea  
16 July 2002**

**Air Accidents Investigation Branch**

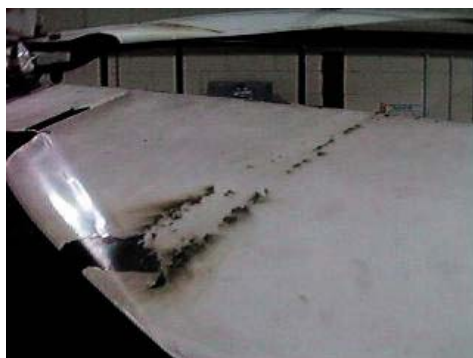
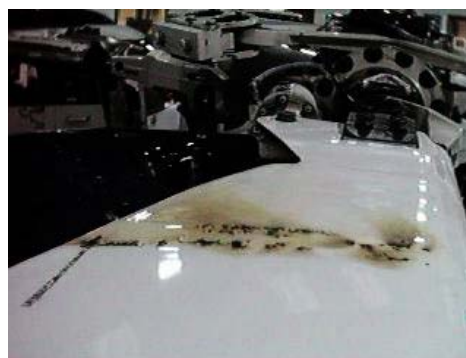
The damaged blades were initially inspected by the manufacturer's UK-based representative and a rotor blade repair organisation in the UK. The blades were then sent to a blade repair station in the USA for further assessment. The EI which detailed the 'Recommended Post Lightning Strike Inspection For Main & Tail Rotor Blades' had been issued to the USA blade repair station. Its staff inspected the blades in accordance with the EI but did not carry out any repairs. Instead, the repair station forwarded the damaged blades to their original manufacturer. The manufacturer assessed two blades as beyond repair and they were scrapped but the other two were repaired. Component records for the blades that were scrapped were destroyed but photographs of two of the damaged blades were retained and these are shown at Figure 3 below. They are photographs of the two blades colour-coded red and black. The red blade was repaired but the black blade was scrapped. Coincidentally, the blade that subsequently failed on G-BJVX was allocated the 'yellow' colour code on both helicopters. No photographs of this blade or the blue blade were available. Nevertheless, the photographs below illustrate the nature of visible damage inflicted on the red and black blades by a lightning strike.

**Figure 3 - Lightning damaged blades fitted to G-BHBF**

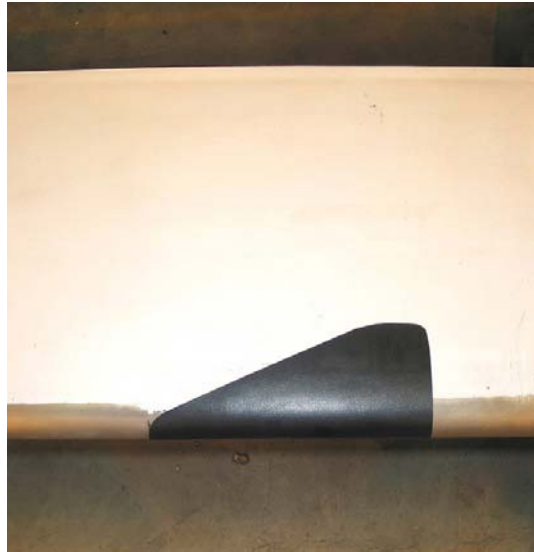
Before returning the blade to the operator as a serviceable component, the USA Repair Station applied five opaque polyurethane protective patches to the titanium leading edge erosion cover. Four were placed over cracks in the leading edge erosion cover and one was placed over the scarf joint between the two sections of the erosion cover. A similar patch to that placed over the scarf joint is shown in Figure 4.

**Figure 4 - Example of an opaque protective patch covering the scarf joint in the titanium leading edge erosion cover**

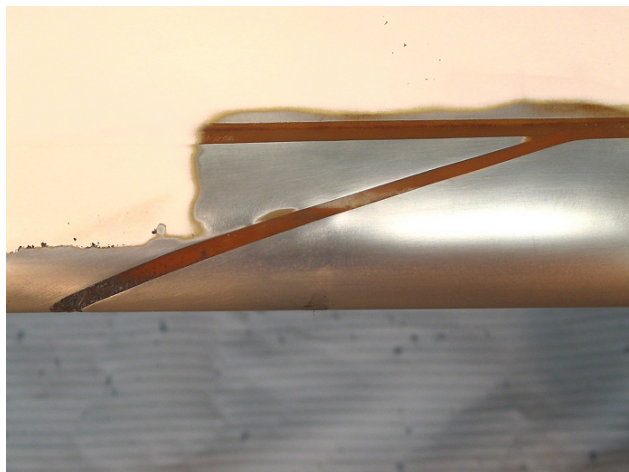
The purpose of this polyurethane patch was to prevent erosion of and moisture ingress into the exposed hardened adhesive filler in the scarf joint. On the upper surface of the blade the similar patch extended approximately 35 mm rearwards from the trailing edge of the titanium leading edge erosion cover. On the underside of the blade the similar patch extended approximately 42 mm rearwards from the trailing edge of the erosion cover. A scarf joint that has been exposed by removing the patch, paint and hardened structural adhesive is shown at Figure 5.

**Figure 5 - Scarf joint in a titanium leading edge erosion cover with the protective patch, paint and hardened structural adhesive removed**

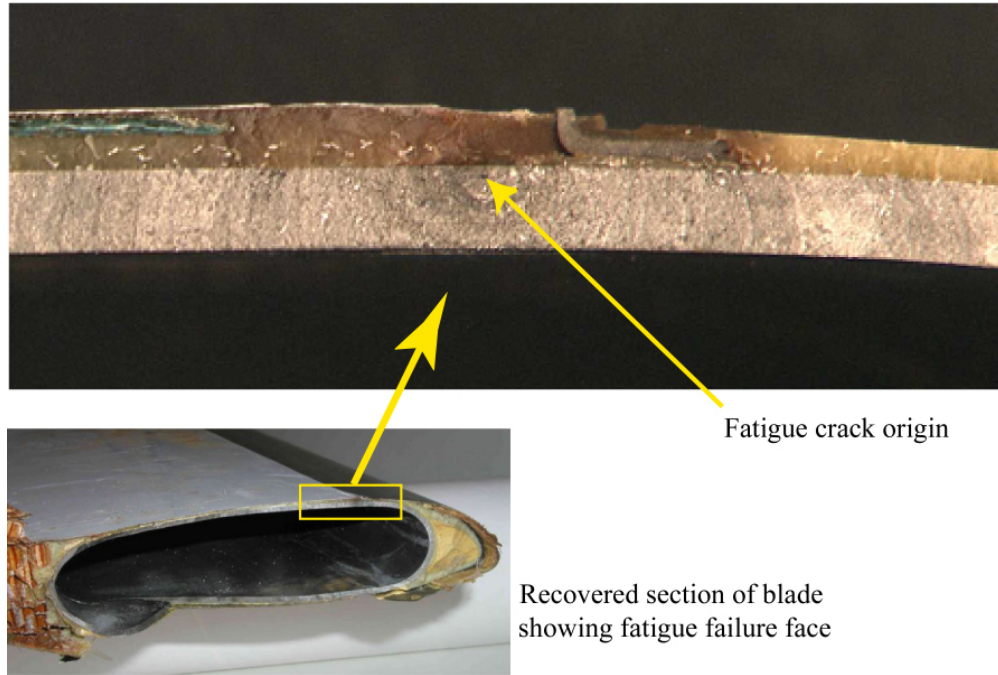
**Figure 6 - Fatigue crack origin**

Expanded view of spar upper surface showing fatigue failure origin

The temperature required to produce the microstructural change was in excess of 995°C. This martensitic transformation would have altered the beneficial compressive residual stress from shot-peening, and probably resulted in an unfavourable, localised, residual tensile stress. The untempered martensitic material is also somewhat softer than the normal alpha-beta material. (Note that this is opposite to the effect seen in martensitic steels.) These localised changes resulted in greater susceptibility to fatigue initiation. The area where the change in the microstructure had occurred was where the tip of the tang of the inboard end of the outboard titanium leading edge cover had come into contact with or extremely close to the spar. There was no evidence to indicate whether the tip had or had not contacted the spar. The defect had arisen because of a manufacturing anomaly which had caused the tang to become folded under the outboard end of the inboard leading edge cover (see Figure 7).

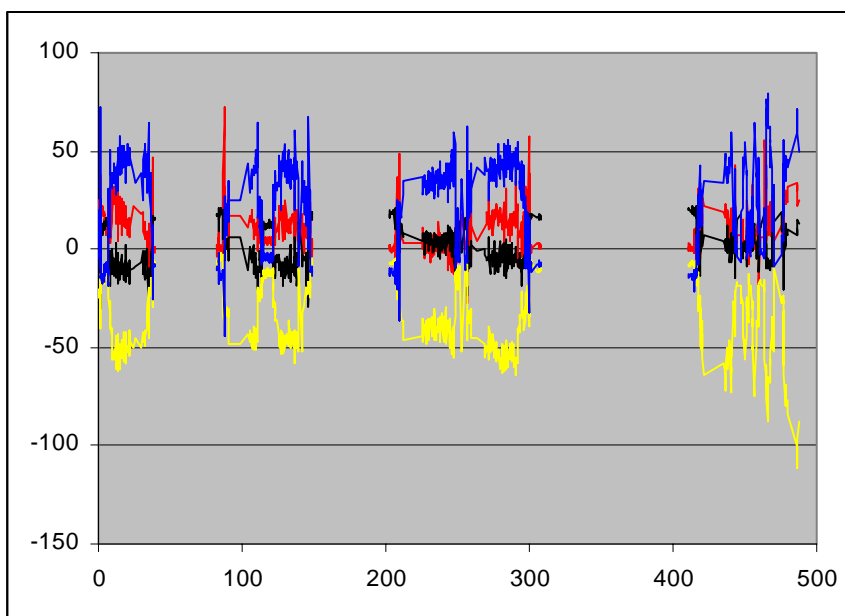
**Annex K Figure 4 - Track Data (mm) from FDR vs Pseudo Time (min)**

Figure 4 of Annex K (reproduced below) shows little difference in the track of the yellow colour-coded blade during the first three flights on the graph (the second, third and fourth flights of the day) but a change is unmistakable during the fifth and final multi-sector flight. These changes must be related to spar crack size and so the crack was growing rapidly during this flight.

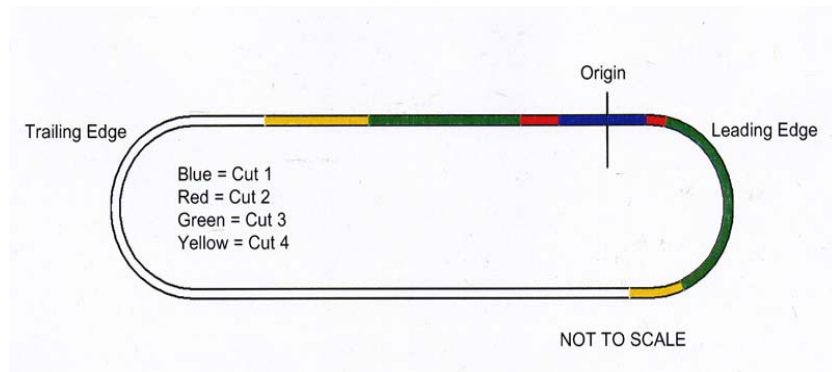
**Figure 8 – Crack growth simulation**

The major part of the crack was in the upper surface and leading edge of the spar. The trial report at Annex R contains a colour-coded diagram of saw cuts used to simulate the crack size at various stages; this diagram is repeated in Figure 8.

Coloured band(s)	Crack length (mm)	Flight time before failure
Blue	30	9 hrs 30 mins
Blue and red	41	7 hours 35 mins
Blue red and green	102	2 hours
Blue, red, green and yellow	142	0 mins

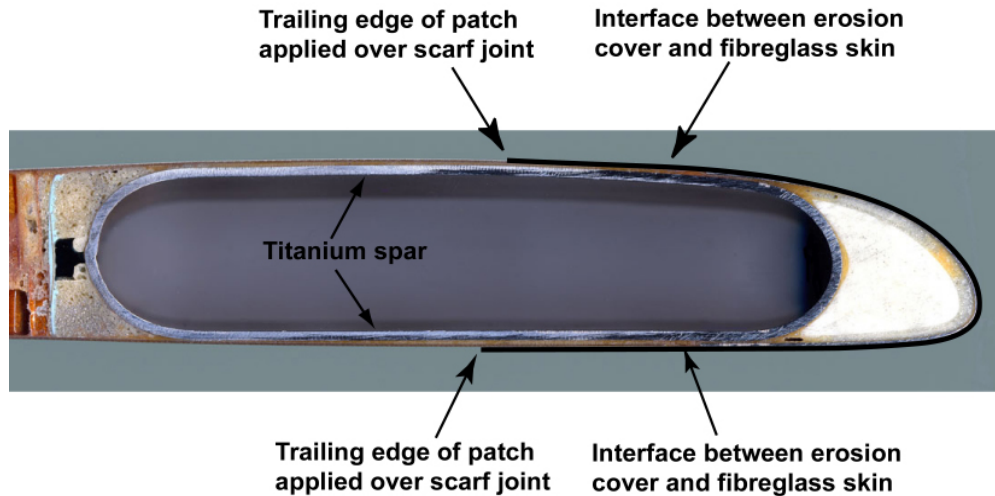
**Figure 9 – Approximate extent of polyurethane patch over scarf joint**

The spar fatigue origin was 6.7 mm forward of the rear edge of the erosion cover so, on the upper surface of the blade, the patch extended at least 41 mm rearwards from the spar crack origin. The graph on page 6 of Annex P shows that at the time of the Daily Inspection, 6.25 flight hours prior to the final failure, the spar crack had progressed approximately 30 mm rearwards from its origin. The crack relationship test showed that any associated skin crack was unlikely to be longer than the spar crack. Consequently, if a skin crack existed at that time, it was invisible.

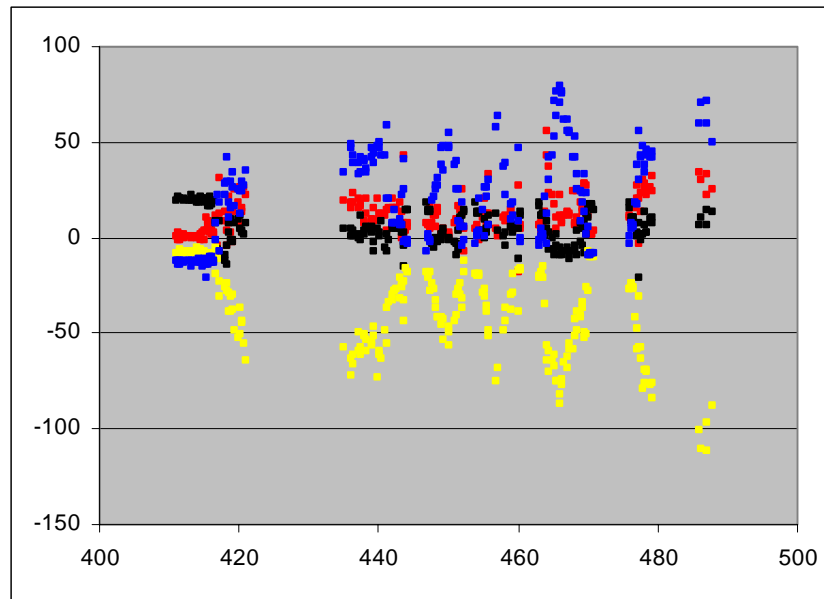
**Figure 6 Track Data (mm) vs Pseudo Time (min) for Final Operation**

To illustrate the progression of the defect during the last operation, the data from Figure 4 Track Data (mm) from FDR vs Pseudo Time (min) has been expanded to cover just the last operation and drawn with track measurements shown individually.

As can be seen from this plot, each time the aircraft accelerated the yellow blade track went down, but the track split became progressively worse each time. Plotting the yellow blade track against airspeed for the five accelerations illustrates this:

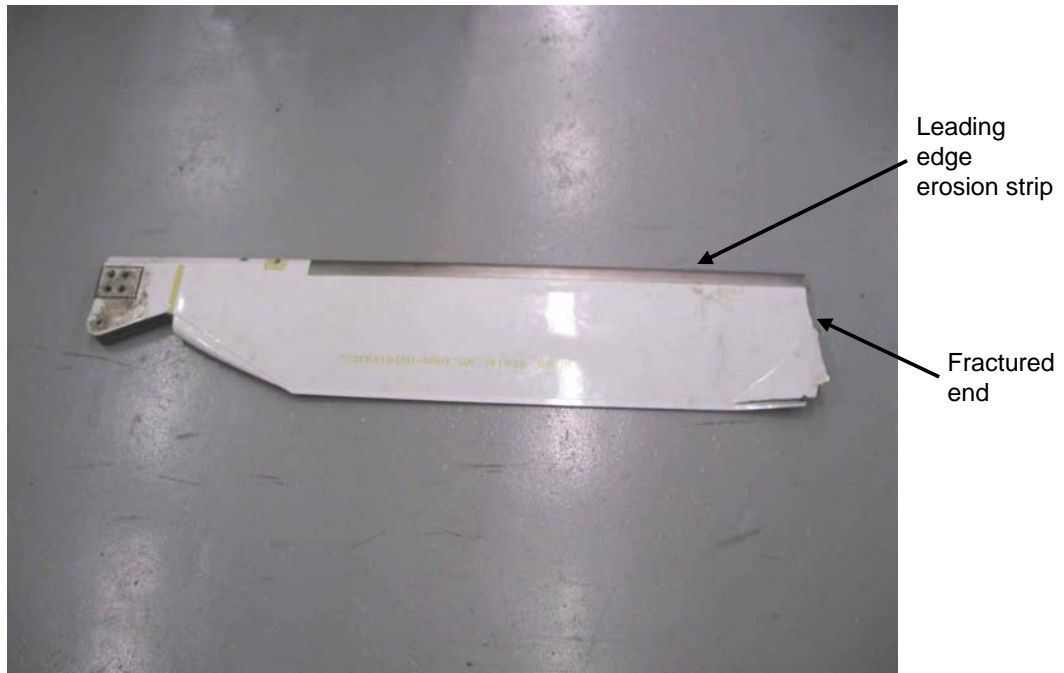
Leading edge erosion strip

Fractured end

Figure 1. Inboard section of main rotor blade as-received.

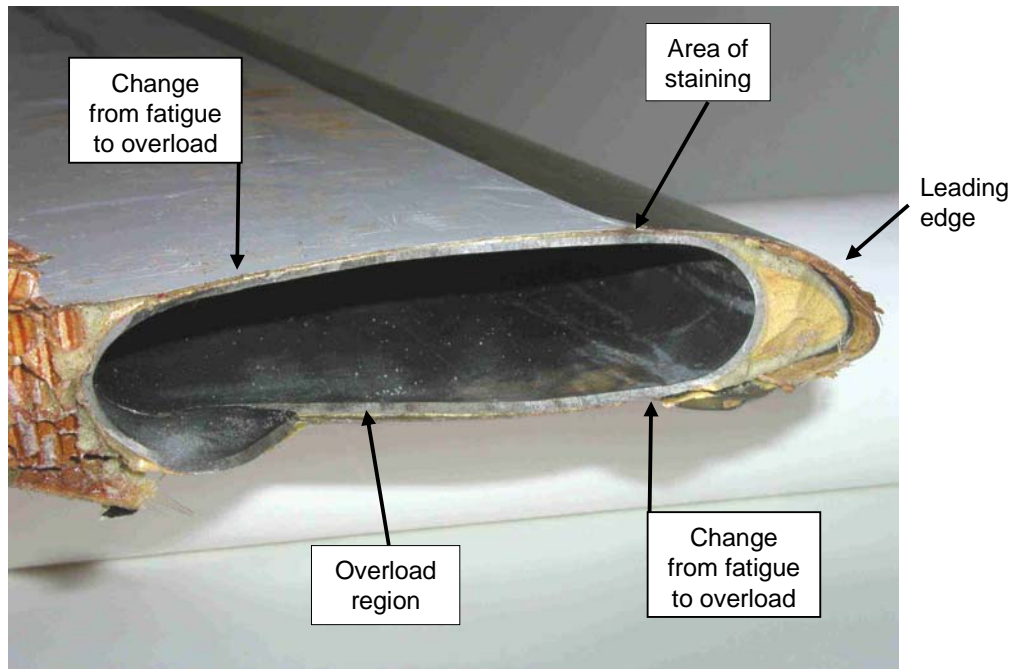
Change from fatigue to overload

Figure 2. Fracture surface of main rotor blade spar as-received. Arrows indicate position of change in fracture surface

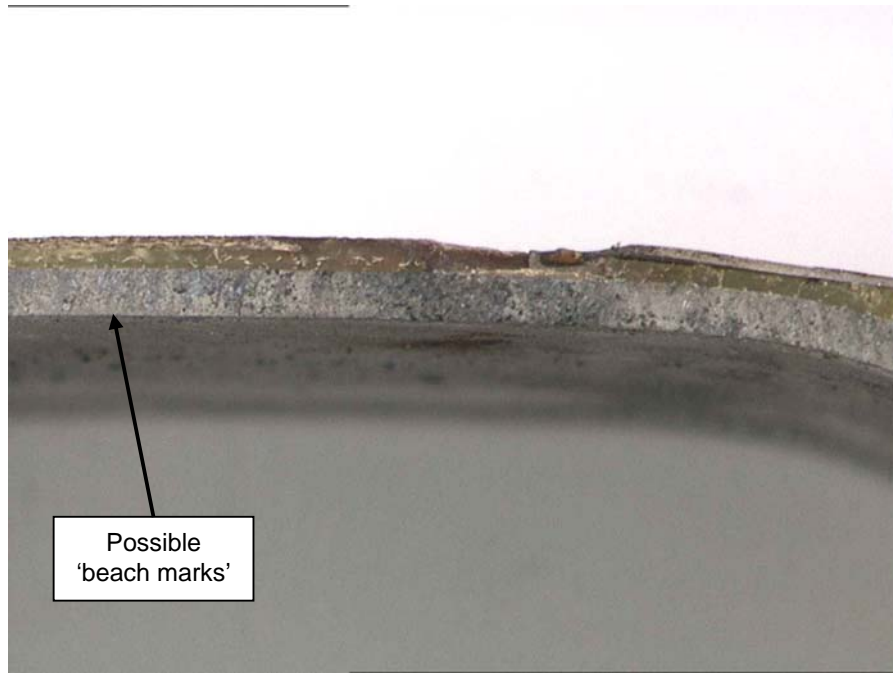
Figure 3. Stain on fracture surface at top of spar (identified in figure 2).

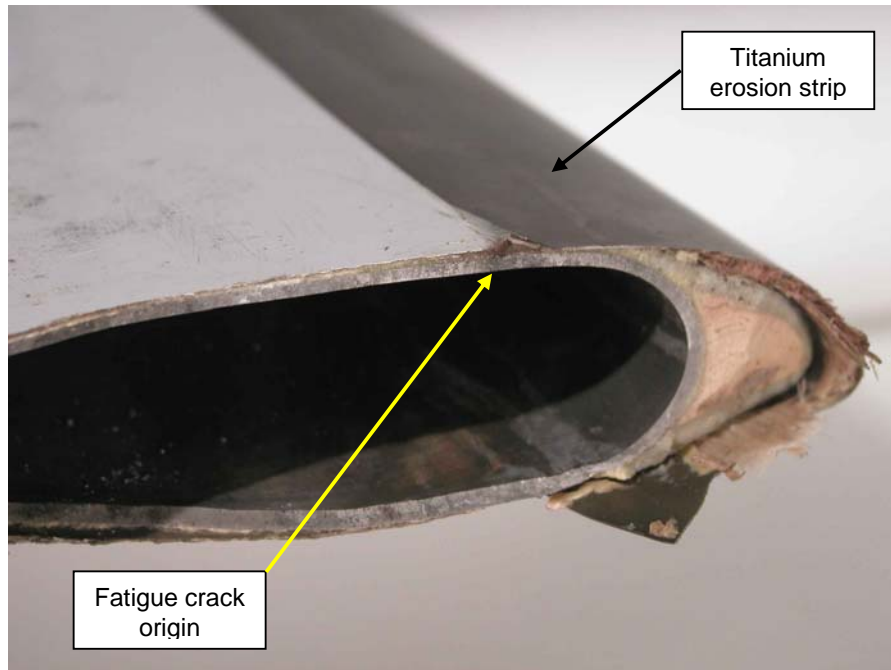
Figure 5. Position of fatigue crack origin with respect to erosion strip.

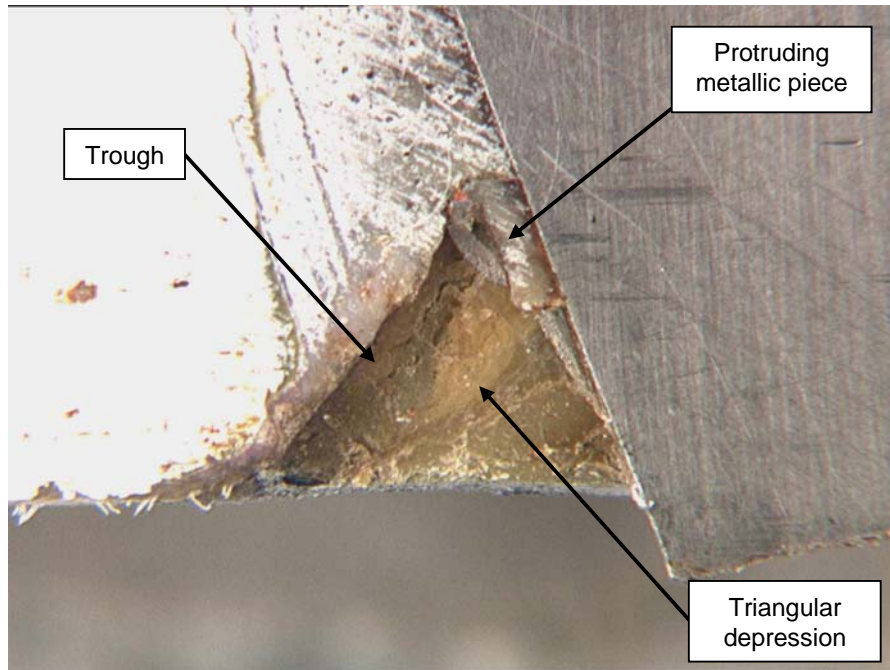
Figure 7. Detail of triangular depression.

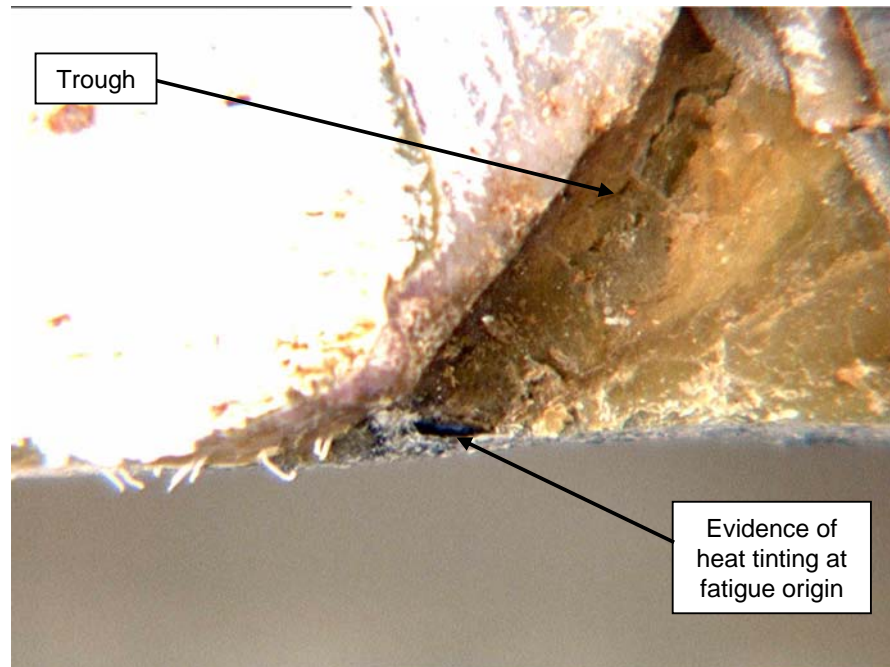
Figure 8. Detail of trough within triangular depression.

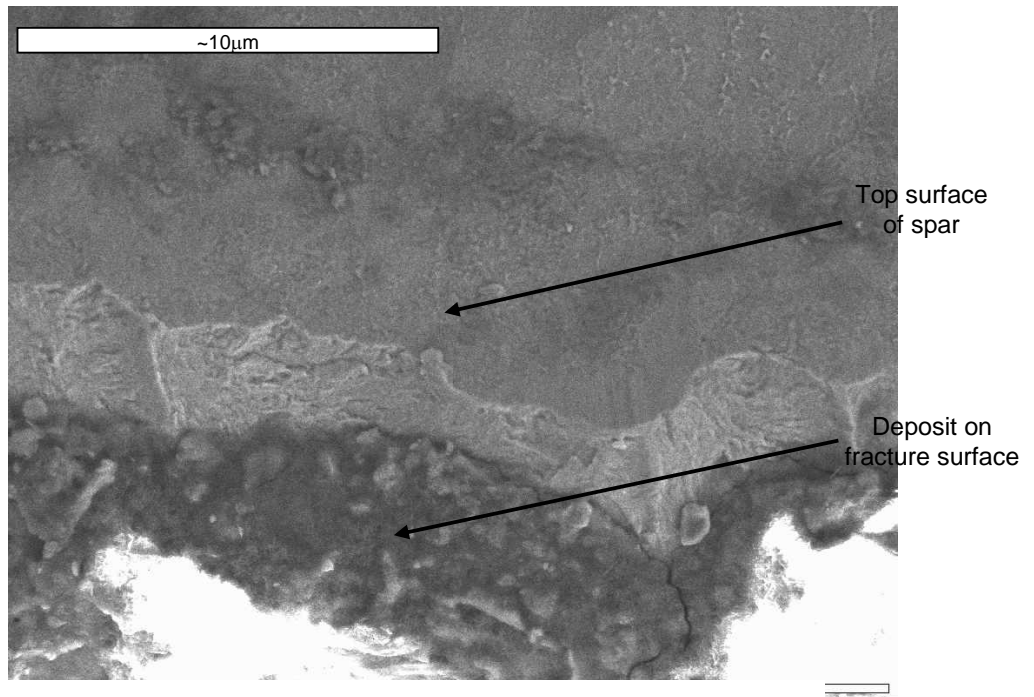
Figure 14. Deposit at origin of fatigue crack.

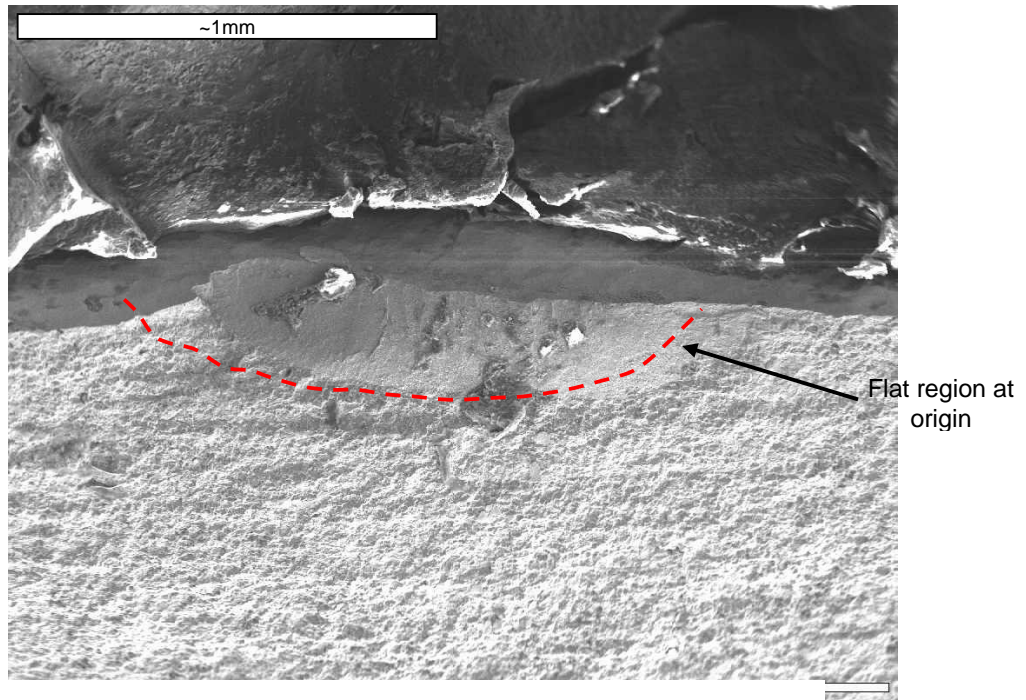
Figure 17. Fracture surface at fatigue crack origin after cleaning.

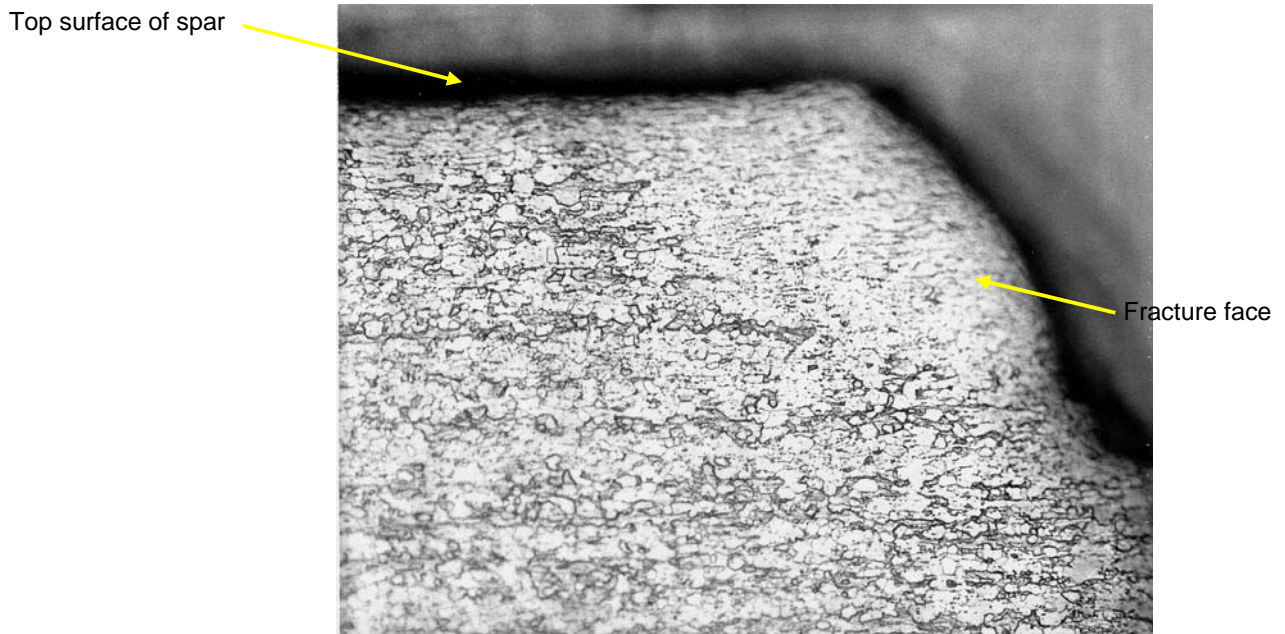
Figure 22. Microstructure at cross-section through fatigue crack origin. Mag x 200

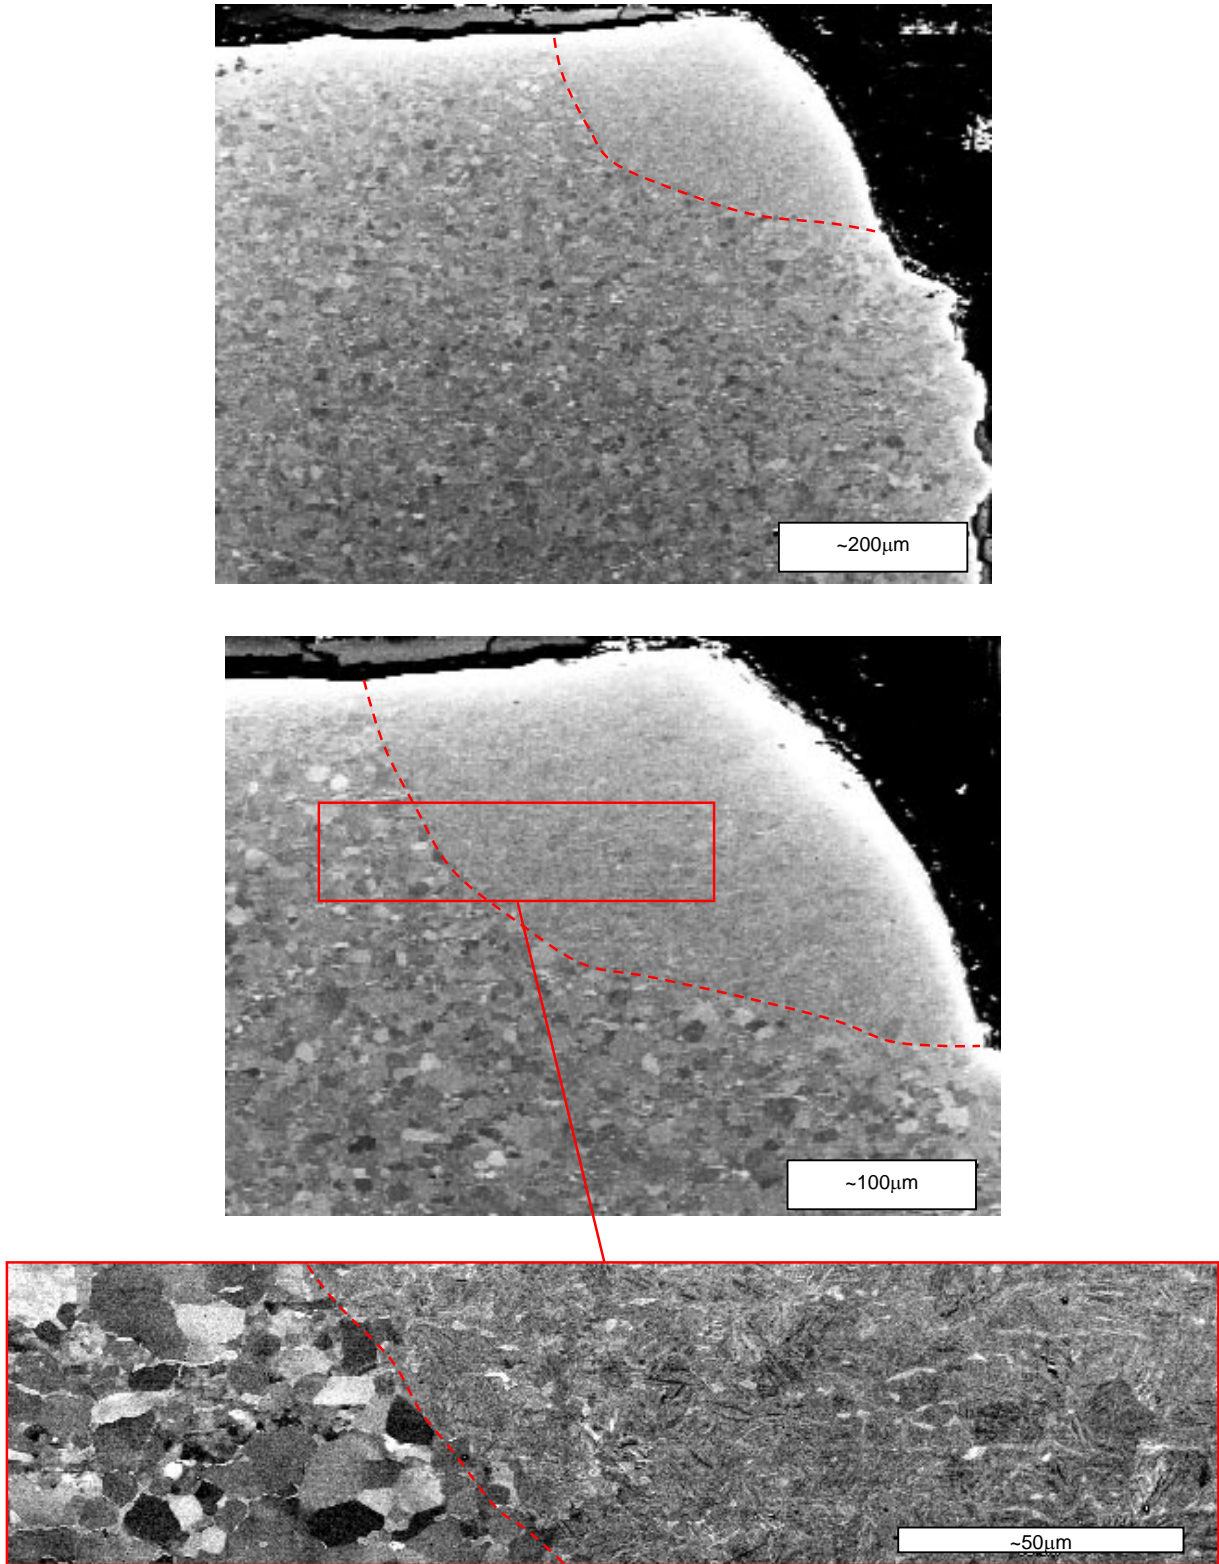
Figure 23. SEM images of microstructure at cross-section through fatigue crack origin.

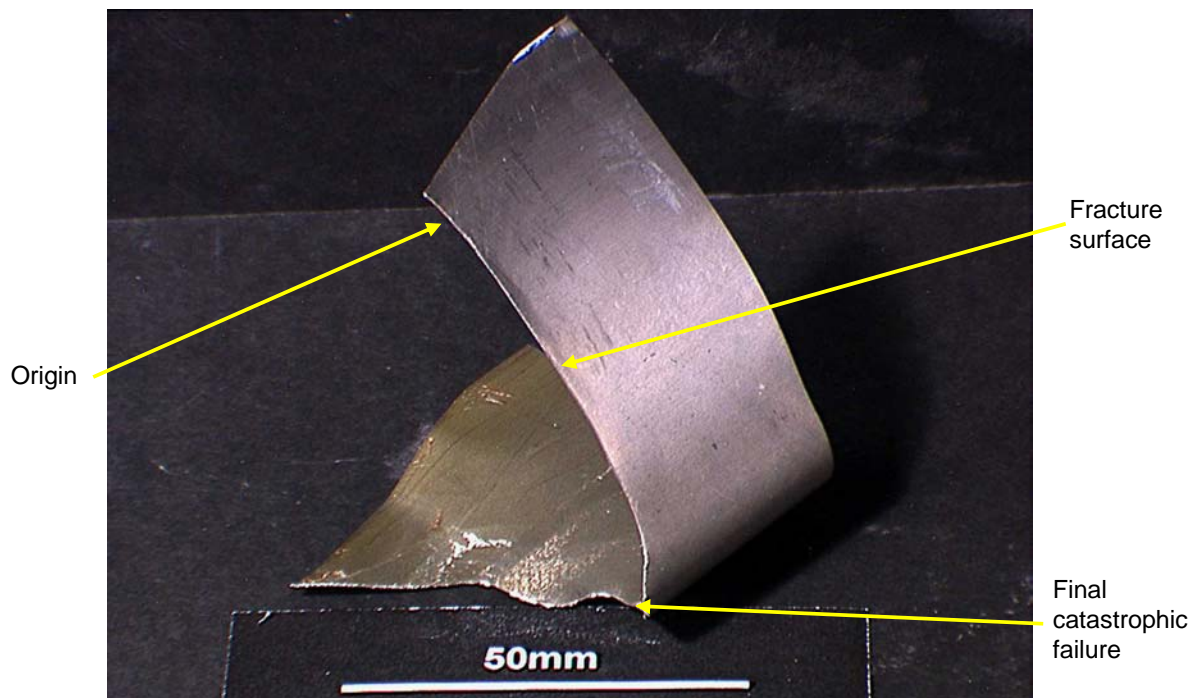
Figure 1. Section of Erosion strip with fractured edge.

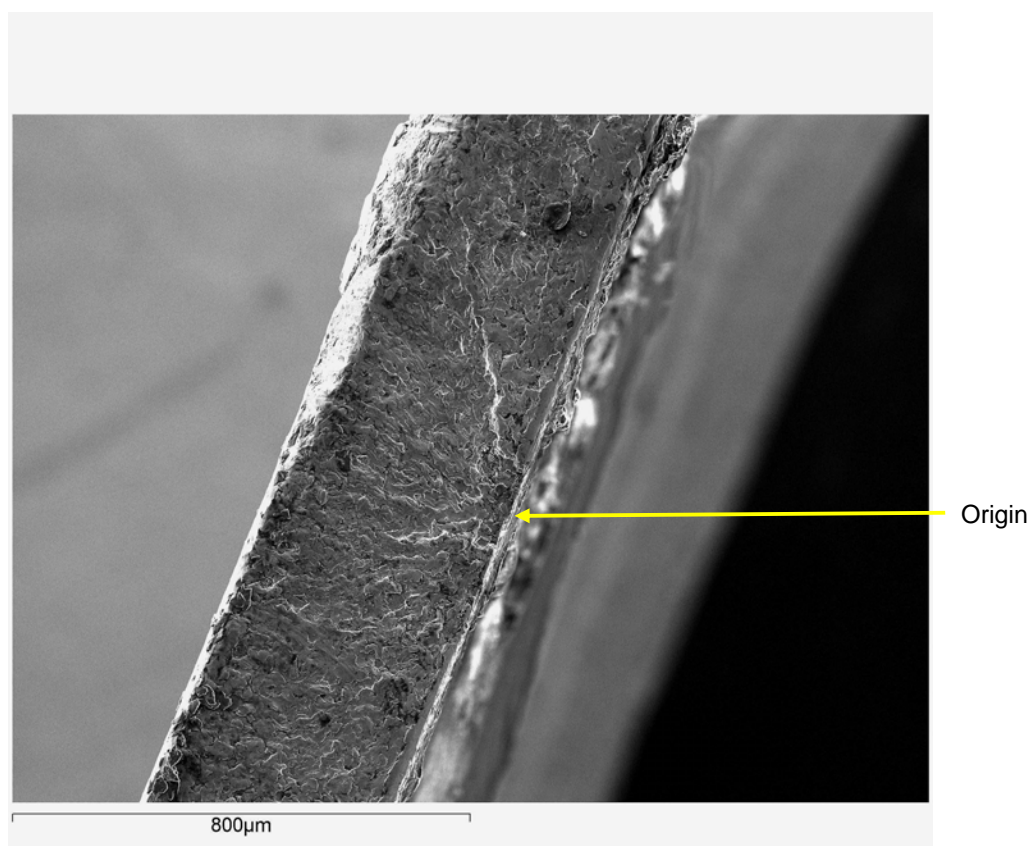
Figure 2. Origin for fatigue crack.
