ACCIDENT

Aircraft Type and Registration:	Ikarus C42 FB80, G-CDYO	
No & Type of Engines:	1 Rotax 912-UL piston engine	
Year of Manufacture:	2006 (Serial no: 0604-6810)	
Date & Time (UTC):	10 June 2018 at 1830 hrs	
Location:	Membury Airfield, Berkshire	
Type of Flight:	Private	
Persons on Board:	Crew - 1	Passengers - None
Injuries:	Crew - None	Passengers - N/A
Nature of Damage:	Damage to the nose landing gear and propeller	
Commander's Licence:	National Private Pilot's Licence	
Commander's Age:	65 years	
Commander's Flying Experience:	156 hours (of which 107 were on type) Last 90 days - 4 hours Last 28 days - 1 hour	
Information Source:	Aircraft Accident Report Form submitted by the pilot

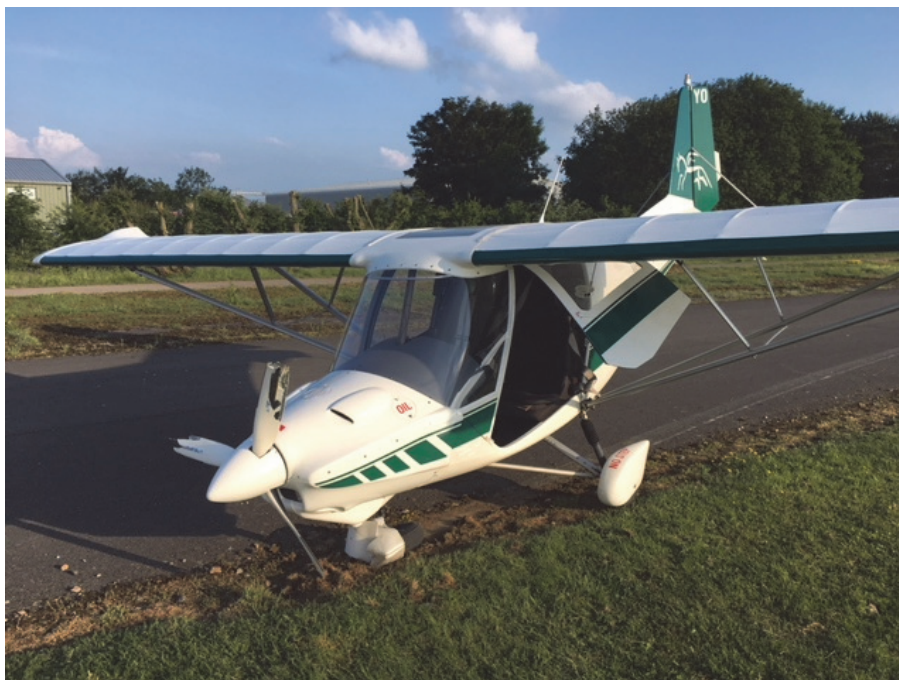
Figure 1

The pilot was returning from a local flight to land on Runway 05 at Membury Airfield. The weather was CAVOK, wind northerly at 5 kt and temperature 25°C. The pilot reported that he was slightly higher and faster than normal on approach. Another aircraft was waiting to depart at the holding point so the pilot of G-CDYO planned to land half way down the runway to allow plenty of space between the two aircraft. On landing, G-CDYO bounced twice and on the third touchdown the nosewheel collapsed and the propeller struck the runway. The aircraft came to a halt on the left-hand edge of the runway (Figure 1).

G-CDYO with collapsed nosewheel and propeller damage

After the accident the pilot reflected that he should have gone around when he realised he was high and fast on the approach and was not going to land at the start of the runway or after the first or second touchdown.
