**ACCIDENT**

<b>Aircraft Type and Registration:</b>	Ikarus C42, G-FLYM	
<b>No &amp; Type of Engines:</b>	1 Rotax 912ULS piston engine	
<b>Year of Manufacture:</b>	2007 (Serial no: 0707-6903)	
<b>Date &amp; Time (UTC):</b>	29 May 2017 at 1550 hrs	
<b>Location:</b>	Near Castlewellan, Co Down	
<b>Type of Flight:</b>	Private	
<b>Persons on Board:</b>	Crew - 1	Passengers - 1
<b>Injuries:</b>	Crew - None	Passengers - None
<b>Nature of Damage:</b>	Damaged beyond economic repair	
<b>Commander's Licence:</b>	National Private Pilot's Licence	
<b>Commander's Age:</b>	56 years	
<b>Commander's Flying Experience:</b>	46 hours (all on type) Last 90 days - 30 hours Last 28 days - 3 hours	
<b>Information Source:</b>	Aircraft Accident Report Form submitted by the pilot and further enquiries by the AAIB

**Synopsis**

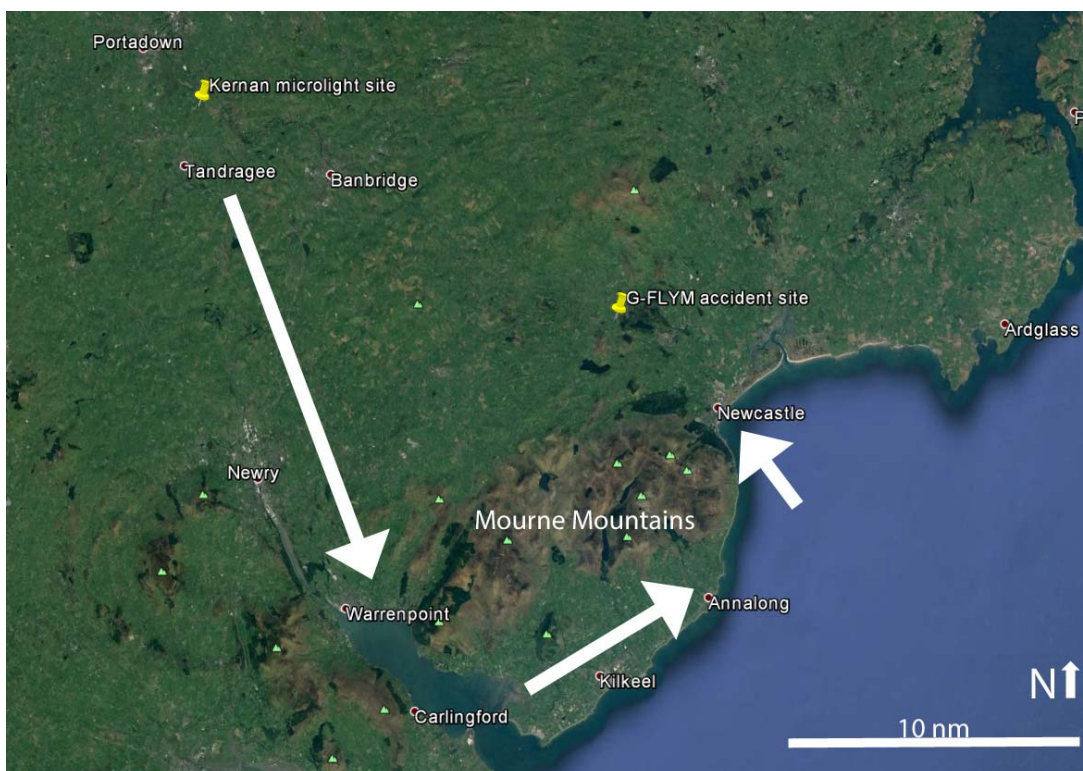
**Figure 1**

The accident site was located about 1.5 nm north-west of Castlewellan where the terrain rises to 750 ft amsl.

Approximate route flown from Kernan microlight site to the accident site  
(underlying image © Google Earth)
