**ACCIDENT**

| <b>Aircraft Type and Registration:</b> | Jabiru UL-450, G-CEOM | |
| <b>Location:</b> | Cromer Airfield, Norfolk | |

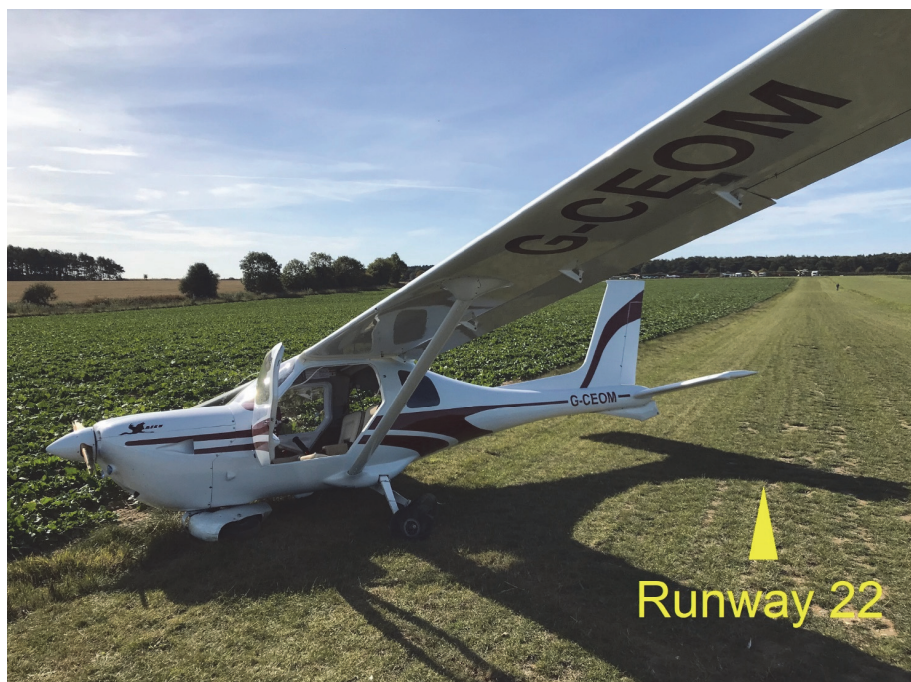
The pilot and a passenger were flying from Darley Moor Airfield to Cromer Airfield. During the pre-flight inspection the pilot noticed that both main tyres appeared slightly underinflated and having checked their pressures, which were 20 psi, increased them to 25 psi. The takeoff and flight to Cromer, located 111 nm east of Darley, were uneventful. The aircraft was established on the approach to grass Runway 22 at 55 kt with full flap. The wind was from 245° at 5 kt. As the aircraft touched down, the aircraft immediately turned to the left and started to skid sideways, which subsequently caused the nose and right landing gear legs to collapse. The aircraft came to a stop at the side of the runway (Figure 1). The pilot and passenger were not injured.

The pilot reported that the left tyre was found to be deflated and there were grooves in the runway caused by the left wheel and brake assembly. He considered that, following inflation of the tyres at Darley Moor, the left wheel tyre valve had not fully sealed, allowing air to slowly leak from the tyre.

**Figure 1**  
G-CEOM gear collapse
