**SERIOUS INCIDENT**

| <b>Aircraft Type and Registration:</b> | Jetstream 4100, G-MAJW | |

**Synopsis**

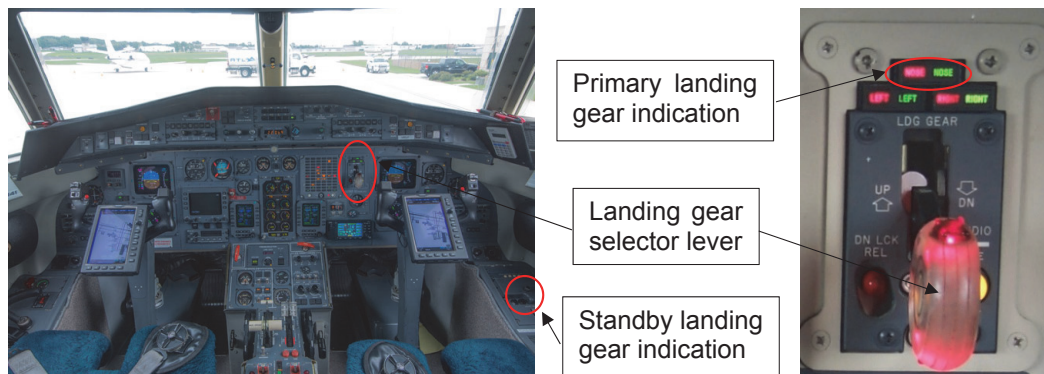
**Figure 1**

Landing gear position is primarily indicated by illuminated captions on the landing gear selector-panel by RED or GREEN captions (Figure 1). A GREEN caption denotes the associated landing gear is 'down and locked' whereas a RED caption denotes either the gear is unlocked or in transit. When the landing gear is retracted and locked, no caption is lit. Microswitches on the downlocks and uplocks are used to control the cockpit display indicators and there are two on each downlock and one on each uplock. On the right-hand

Location of the landing gear indicators

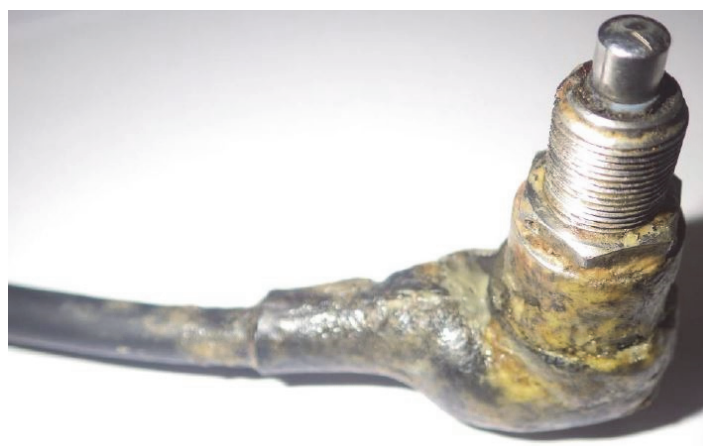
**Figure 2**

The NLG primary downlock microswitch and its associated wiring harness were removed from the aircraft for further examination (Figure 2). No visual defects were identified but movement could be felt between the wiring harness and the microswitch which was due to damaged and broken wires in the harness.

The harness had been fitted to the aircraft during scheduled maintenance of the downlock assembly on 6 May 2016 and the aircraft had since completed 2,291 flight cycles. The harness was to the latest modification standard, the protective boots and sheathing were in good condition and with adequate moisture-inhibiting compound present. In response to this incident, the operator has introduced a 600 flight hours repetitive inspection of both indication systems and during the initial fleet-wide inspection, no further harness failures were found.

It is probable that the failure of the primary downlock harness was due to vibration as the environmental protection was in good condition. To verify the condition of the fleet, the operator has inspected all the other harnesses fitted to their aircraft and no other failures were found, so they are considering it an isolated event.

On approach to Sumburgh Airport the primary indication system for the NLG did not indicate 'down and locked' due to a failure between the microswitch and the wiring harness. The failure of the standby indication system to illuminate was because the microswitch was out of position relative to the downlock pin.

- 'One-off' inspection - Nose landing gear standby micro switch check.
- 'One-off' inspection - NLG down lock and primary and standby microswitch inspection.
- Repeat inspection every 600 flight hours - Landing gear indication system check.
- Update all Emergency and Abnormal Checklists in accordance with manufacturers latest revision.
