No: 8/89

**Aircraft Type
and Registration:**

BAe. 146-100, G-BKHT

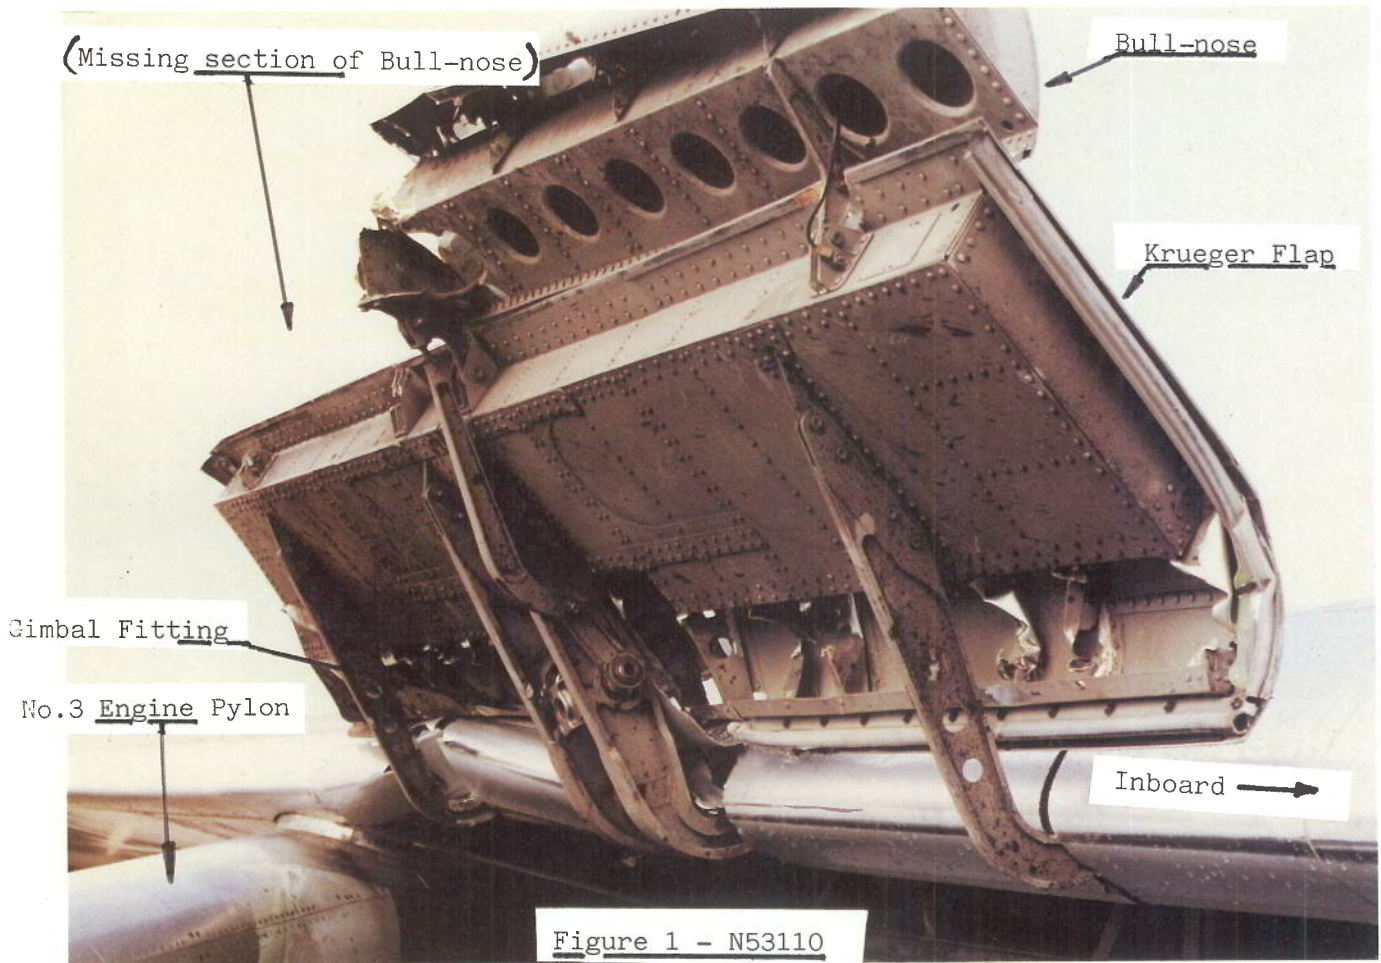
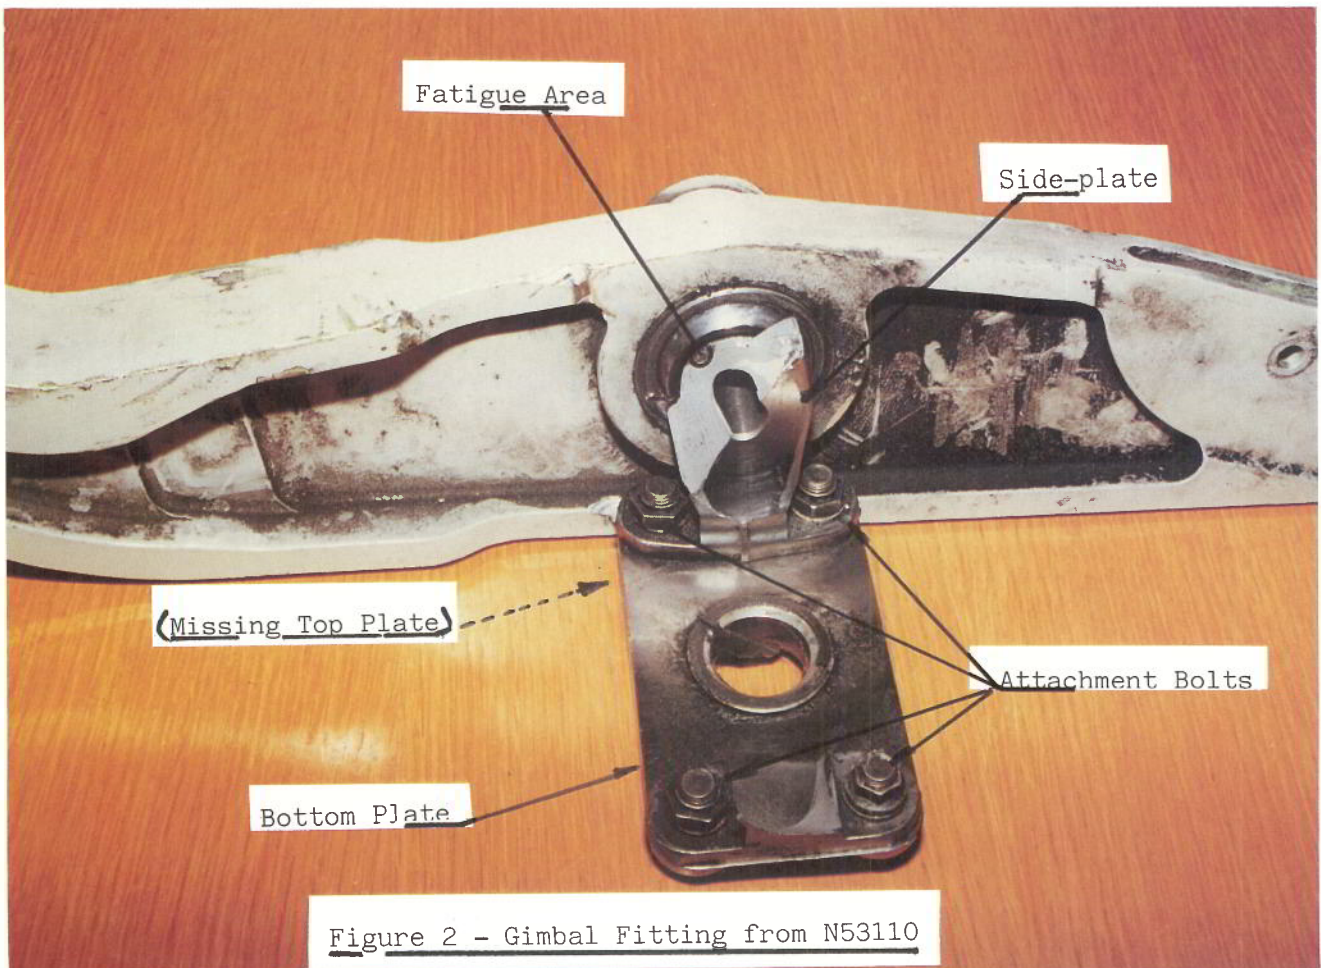
The first indications to the flight crew of the nature of the damage was when the ground crew advised them of damage to the No.16 leading-edge Krueger flap (figure 1), adjacent to the No.3 engine. It was evident that this section of Krueger flap had been able to rise above its normal position and that the 'bull-nose' portion had scraped against the engine pylon; this caused a piece of the 'bull-nose' to break off and strike the fuselage about 10 feet forward of the R4 door, slightly penetrating the skin.

Subsequent examination showed that the extra movement of the Krueger flap had been initiated by the failure of the gimbal fitting (figures 1 and 2) which links the ballscrew transmission system, mounted in the wing, with the support arms of the Krueger flap. Following the failure of the fitting, the section of Krueger flap was free to move upwards and to allow the outboard section of 'bull-nose' to scrape against the engine pylon.

Detailed metallurgical examination showed a small area of fatigue cracking around an area of undercut on one of the side-plates : fatigue fracture in this Titanium material is characterized by an extremely small critical crack length and the side-plate then failed in rapid overload. The missing sections of the fitting and of the Krueger flap were not recovered.

The manufacturer has attributed past failures of this fitting to looseness or fracture of one or more of the 8 gimbal attachment bolts on each fitting (6 fittings per aircraft). The original attachment bolts were manufactured from H11 steel, which, according to the manufacturer and CAA Airworthiness Notice No.12, Appendix 35, is susceptible to stress corrosion.

- 1) replacement of the original (H11 steel) gimbal attachment bolts with their Inconel equivalent,
- 2) changing of all gimbal assemblies which the Special Check identified as having attachment bolt torque below 95 in-lbs and
- 3) amendment of the maintenance schedule to include a periodic torque check at Inter check frequency.

At the time of the accident to G-AWNA (11.2.88) the appropriate Service Bulletin was SB 747-27-2148, which simply required a one-time torque check on the attachment bolts. On 6.10.88, therefore, AAIB made two formal recommendations to the CAA:

On 23.11.88 the manufacturer issued Revision 3 to this Service Bulletin, specifying the use of

Inconel bolts as replacements for the existing (H11) bolts and recommending the replacement of all the existing bolts. The Revision does not, however, call for any repetition of the check. Following the accident to N53110 (20.4.89), therefore, AAIB repeated the two recommendations. These have been accepted by the CAA, who have asked the manufacturer and the FAA to improve the Service Bulletin and are processing a CAA Additional Airworthiness Directive to ensure compliance for all aircraft of this type on the British register.

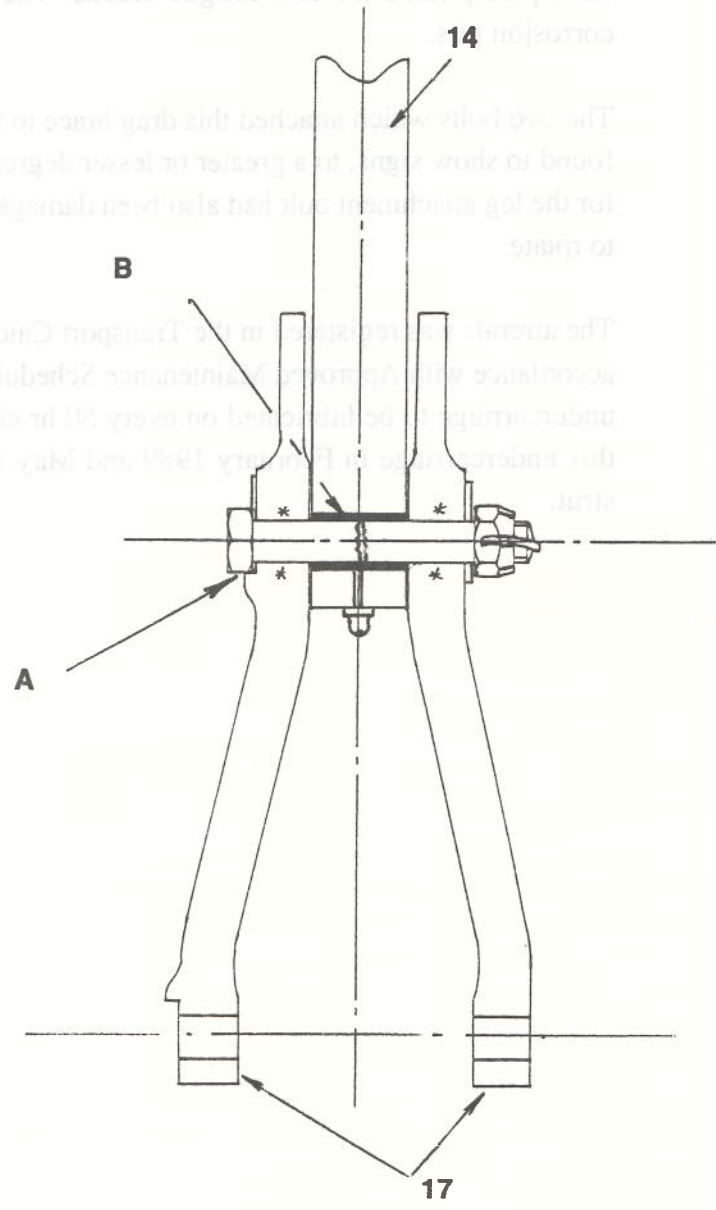
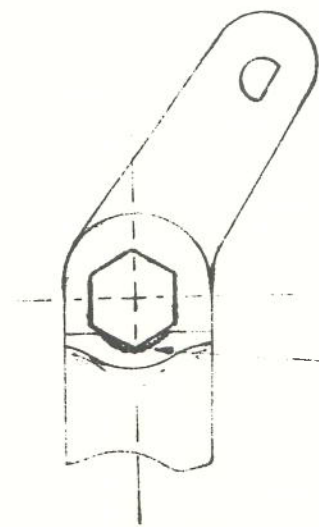
Detailed examination of this bolt revealed that it had failed in reverse bending fatigue and also that it was in poor condition generally. It was apparent that most of the shank showed signs of pitting corrosion

and there was surface damage consistent with the effects of the bolt rotating under load in the two cranked links. The bolt holes in these links (*) were oval. It was also apparent that the machined anti-rotation flat on the inboard link (A) had been damaged by the bolt head, such that bolt rotation was possible. Ovality was also present towards the outer ends of the bronze bush (B) in the centre link.

It was thus apparent that, after the flat had been damaged by bolt rotation, wear had taken place due to continued rotation in the unbushed and unlubricated holes in the cranked links. Once this had occurred, the bolt was no longer working purely in shear but could also experience bending stresses which, in turn, precipitated the two fatigue cracks. The origins of these cracks were centered on individual corrosion pits.

DAMAGE TO ANTI-ROTATION 'FLAT'

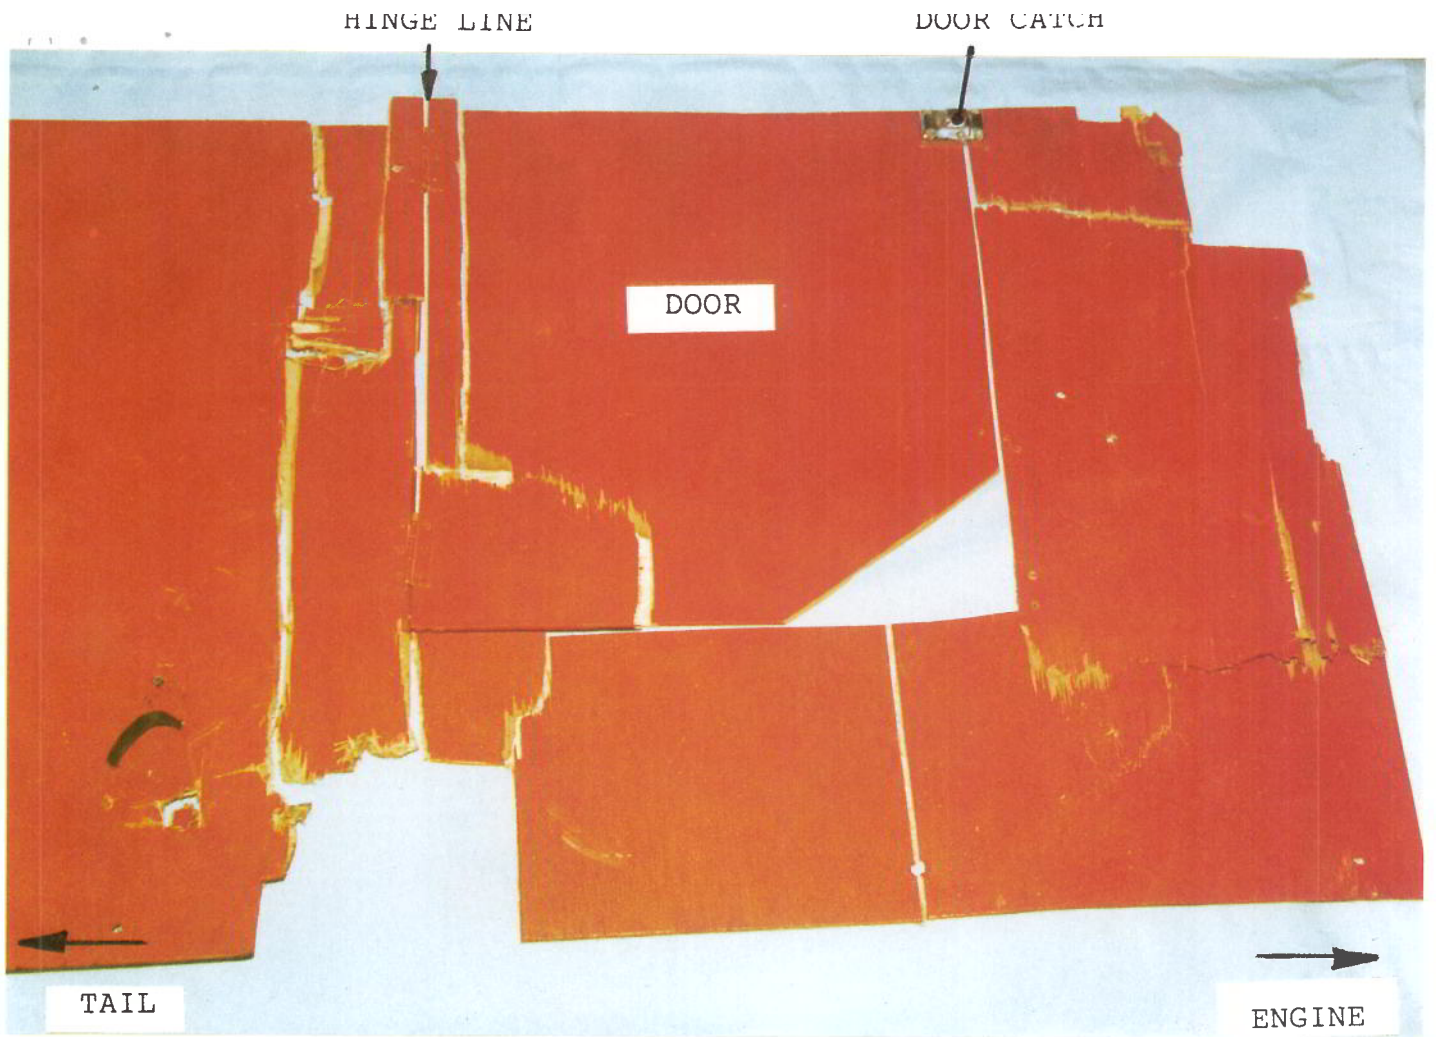
PHOTOGRAPH No 1

The wreckage was taken to the AAIB at Farnborough where a more detailed examination was carried out. The area surrounding the cockpit door was assembled (Photograph No 1) and there was very good evidence that the door had been open at impact. This door was mounted with its hinge line to the rear which, if the retaining catch (Photograph No 2) failed, would allow the door to open outwards into the slipstream, possibly fouling the wing rigging wires and producing a very strong airbrake effect on the right side. The design of the door and catch was such that if the door was subsequently slammed closed, there appeared to be nothing to prevent the door passing through the closed position and swinging inwards and rearwards onto the pilot's right leg. Evidence from the wood failures suggested that at impact the door was open inwards. Examination of the throttle system indicated that at impact the throttle was set at a position that would give 89% of the engines full power rpm..

A recommendation was made that the CAA should re-consider the Certification or Approval of rear-hinged doors and the standard of the door catches on microlight aircraft.
