**SERIOUS INCIDENT**

| <b>Aircraft Type and Registration:</b> | Morane Saulnier MS.315E D2, G-BZNK | |

**Synopsis**

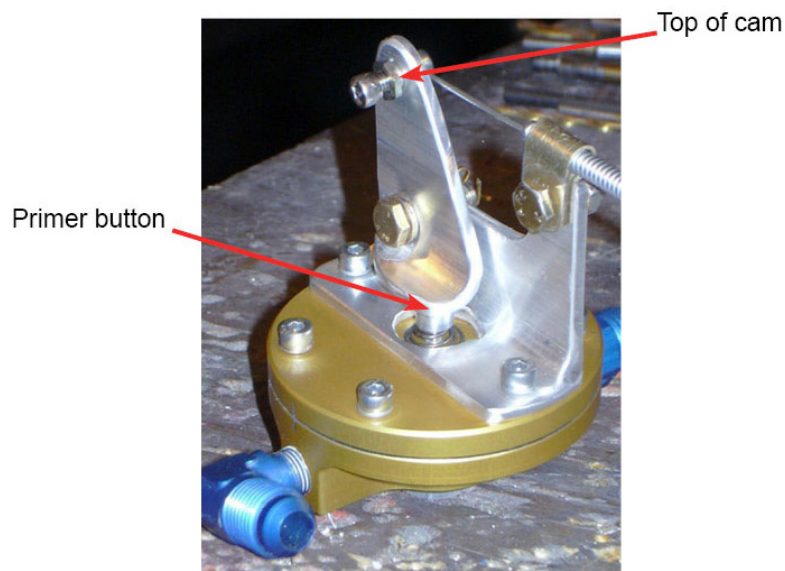
**Figure 2**

In this installation, fuel is supplied to the throttle body via a fuel pressure regulator that incorporates a primer button (Figure 2). When depressed, the primer button overrides the regulator and allows fuel to flow freely into the throttle body for engine starting.

Example fuel pressure regulator and primer button.  
(Image produced by Rotec Aerosport Pty Ltd and used with permission)
