## ACCIDENT

| <b>Aircraft Type and Registration:</b> | Piper PA-28-161 Cherokee Warrior III, G-WAVS | |
| <b>Location:</b> | Bredon Hill, Overbury, Worcestershire | |

## Synopsis

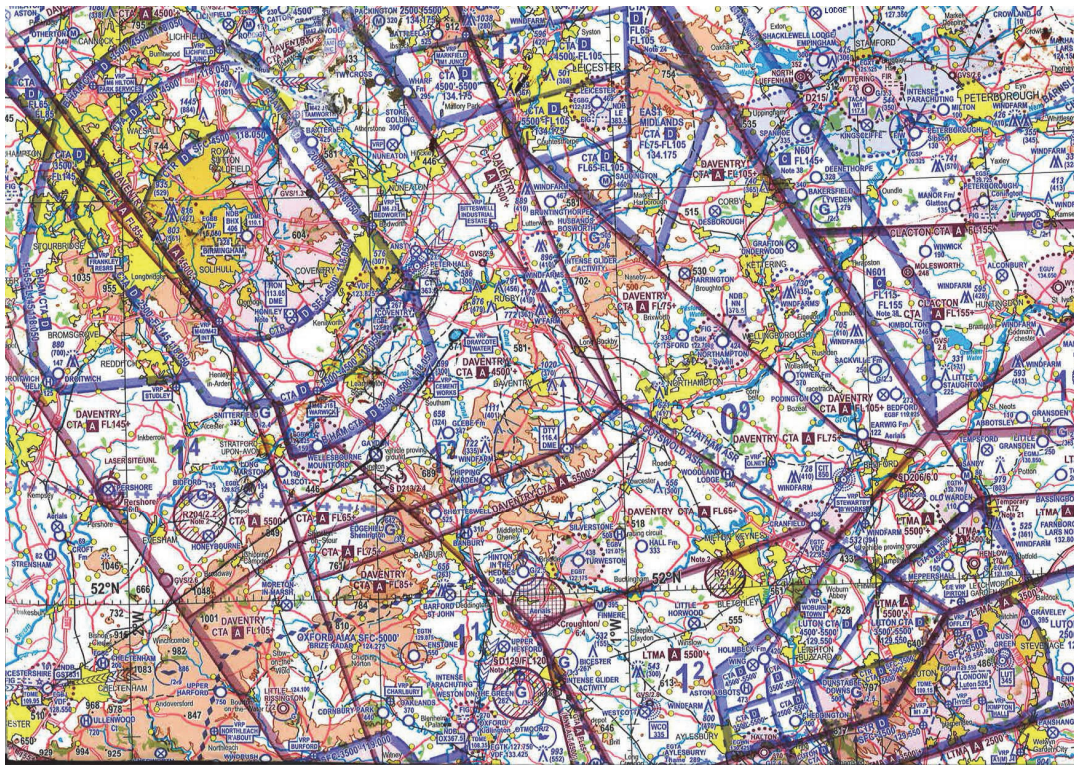
**Figure 1**

Part of aeronautical chart with track line

The school's operations manual defined minimum safe altitude as being 1,000 ft above the highest obstacle within 5 nm of the intended track. For the planned route at Figure 1 this would have given a safe altitude of 2,400 ft. However, on the day of the accident an altitude of 2,400 ft would have required penetrating icing conditions for which the aircraft was not equipped.

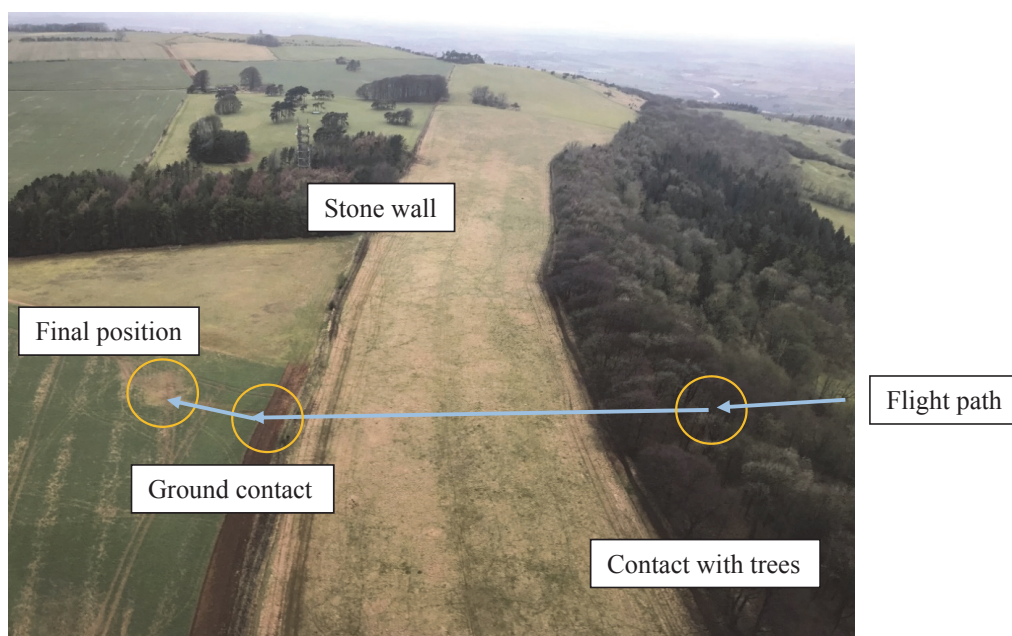
The accident site was near the summit of Bredon Hill at an elevation of approximately 940 ft. There is a mast on the summit with an elevation of 1,046 ft, which is marked on the aeronautical chart. An aerial view of the site is at Figure 2.

**Figure 2**  
Accident site and Bredon Hill mast

Inspection of the accident site and wreckage indicated that the aircraft struck the top of trees near the summit of Bredon Hill on a heading of approximately 230°. This initial impact detached a portion of the outer left wing approximately 1.8 m in length, and part of the left aileron. The remainder of the aircraft then rolled to the left and descended to the ground approximately 170 m past the trees landing on its left side in a nose-down attitude causing further substantial damage. The aircraft contacted the surface close to and past a stone wall, which had not been contacted, and then quickly came to rest. This indicated that the final descent had been steep and at a slow forward speed.

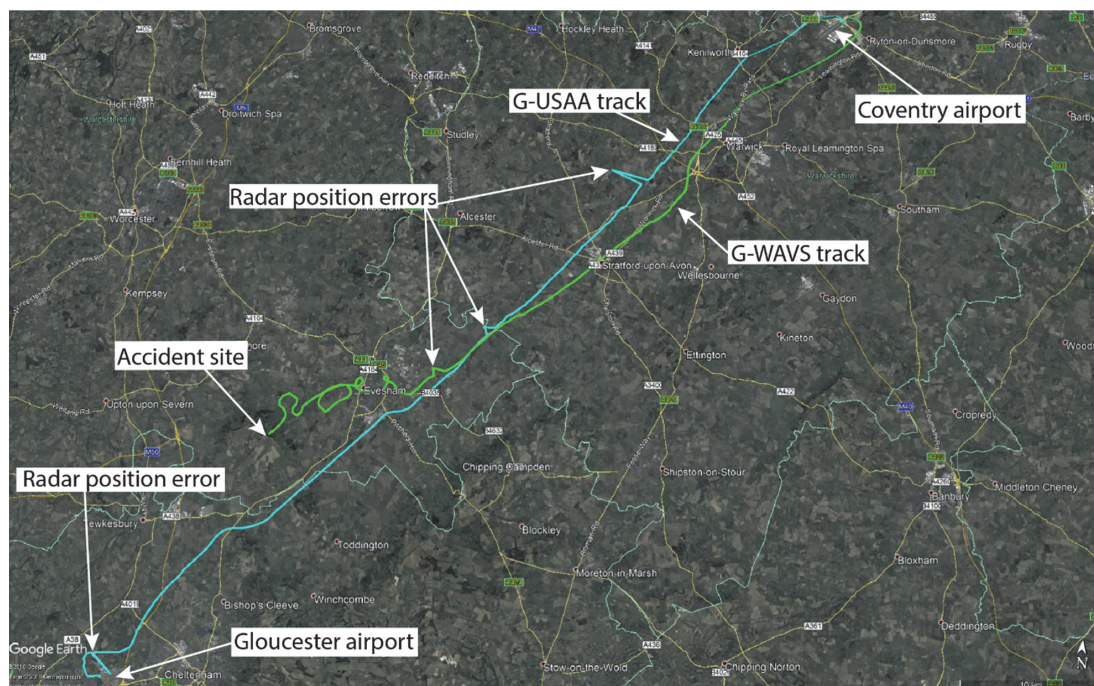
**Figure 3**  
Radar tracks of G-WAVS & G-USAA

The radar data shows G-WAVS flew from Coventry towards Warwick and Stratford-upon-Avon, flying between approximately 800 ft and 900 ft amsl. G-USAA initially tracked to the north of G-WAVS, maintaining a separation of between 1 and 2 nm, but at a higher altitude of approximately 1,100 to 1,200 ft amsl. Both aircraft descended

approximately 300 ft when south of Stratford-upon-Avon, and their tracks converged. G-WAVS then turned towards the north-west, away from the track of G-USAA, and several low-level orbits were flown near Evesham before the aircraft flew towards Bredon Hill. Figure 4 shows the final track of G-WAVS and the altitude returns received from the aircraft's transponder, corrected to show altitude in feet amsl.

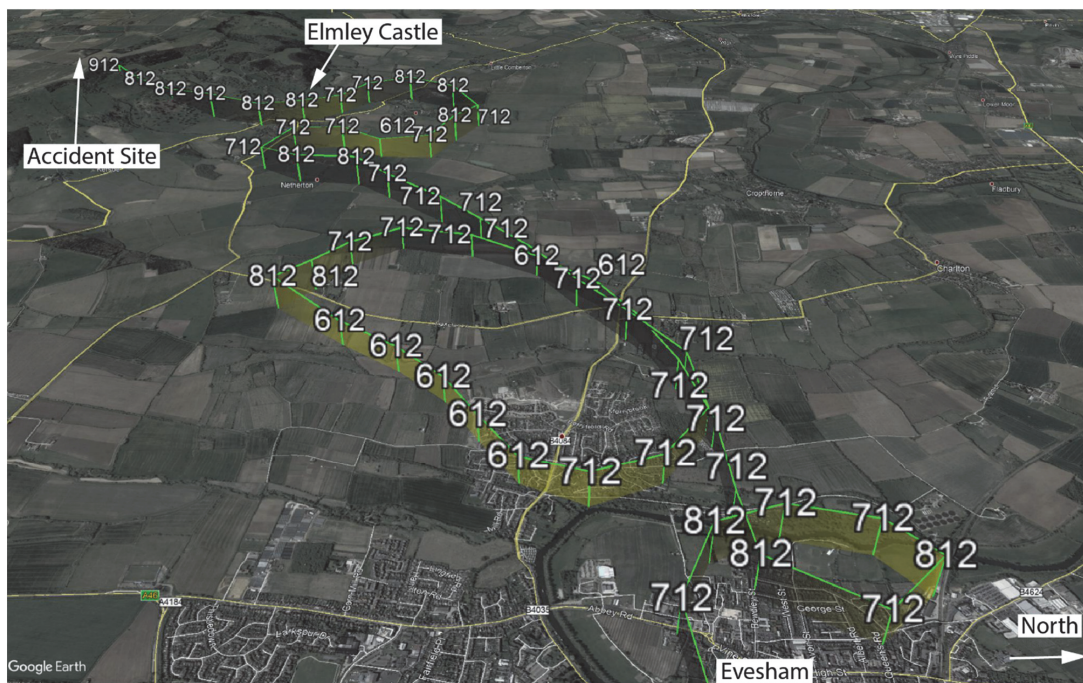
**Figure 4**

The final track and altitude returns from G-WAVS

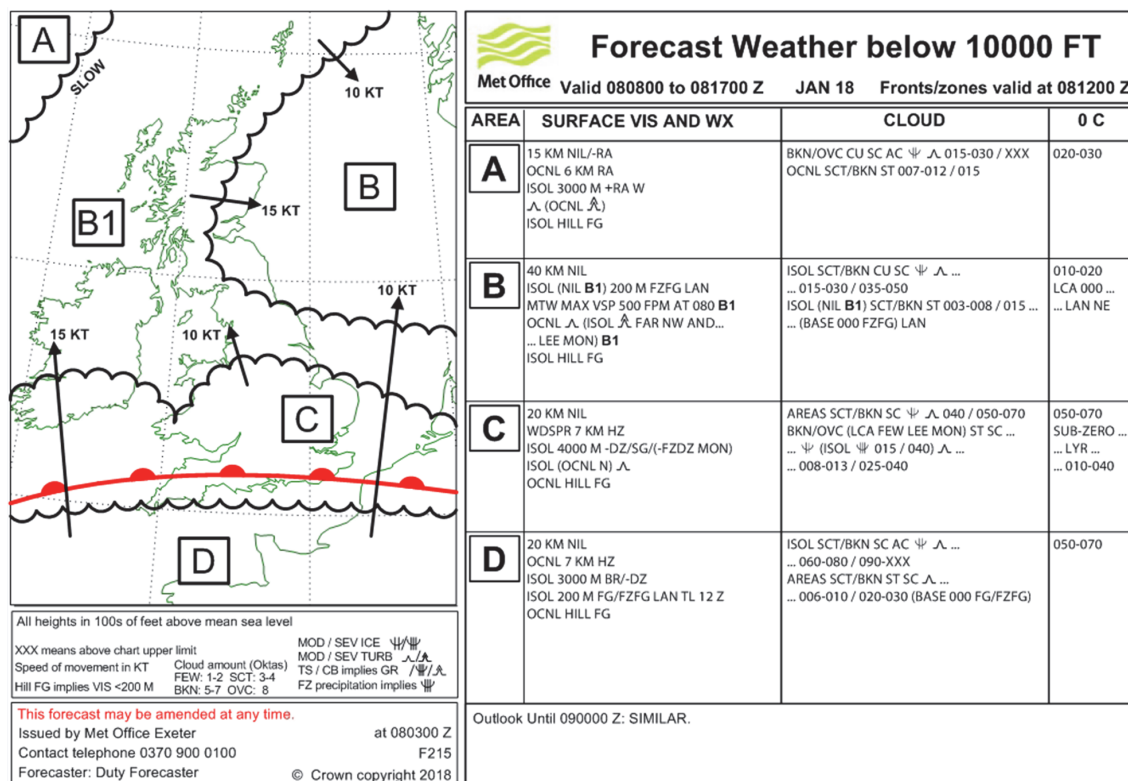
Figure 5

*'The chart shows that at 1200 UTC, the area of interest was covered by area C. The weather conditions in this area was [sic] associated with the warm front with general visibility around 20KM, but also widespread haze giving 7KM visibility. Isolated patches of light drizzle, or even snow grains were also possible which would reduce the visibility to 4000 M. It was a cloudy area with Broken or Overcast skies, bases of the cloud between 800-1300FT and tops 2500-4000FT. Any hills over 800FT would see foggy conditions.'*

Forecast weather below 10,000 ft

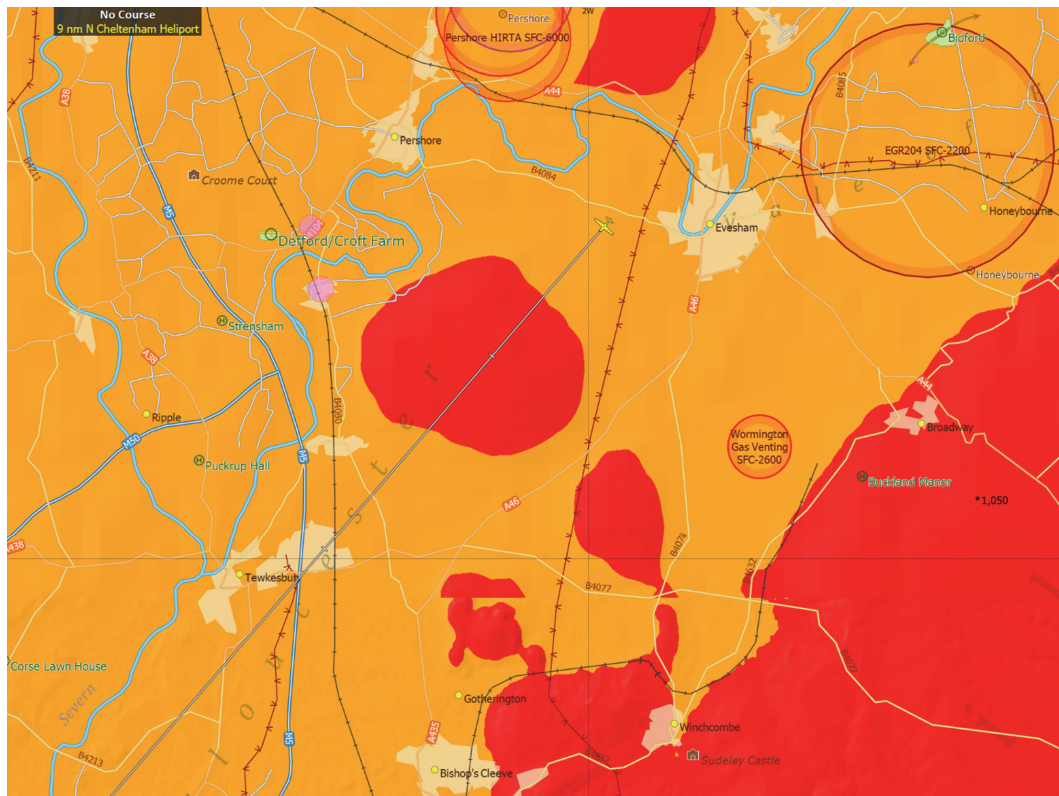
**Figure 6**

An example application showing the simulated track of G-WAVS towards Bredon Hill

The image shows the rising ground of Bredon Hill relative to the simulated aircraft flying at 900 ft amsl, and high ground to the right side of the Figure.

The occupants of G-WAVS were not using a flight planning or mapping application. Although such applications may not meet the requirements for certification as a terrain awareness warning system, they can offer valuable situational awareness to a pilot of surrounding higher ground when used appropriately.
