No: 6/92

Ref: EW/C92/2/2

Aircraft Type and Registration: Piper PA-28R-200 Cherokee Arrow II, G-IPJC

Location: Skiddaw, Near Keswick, Cumbria

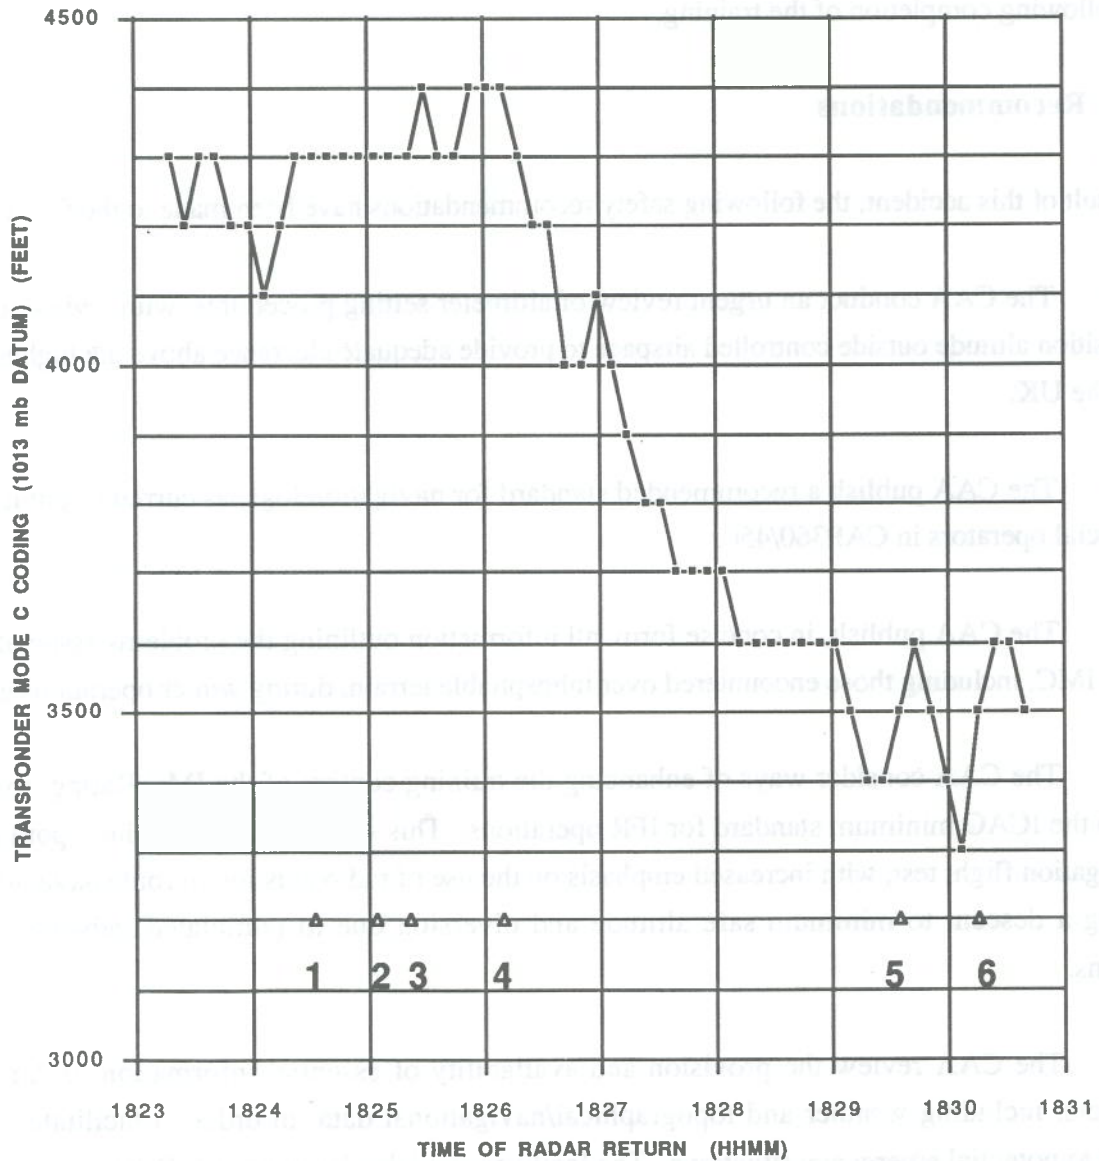
FIGURE 1. G-IPJC MODE C DATA AND RADIO TRANSMISSION CORRELATION

Handover to Pennine Radar occurred at 1759 hrs, and at 1805 hrs the pilot requested descent to FL45, reporting at that level seven minutes later. The aircraft was passed to Scottish Control (East) at 1821 hrs, when approximately 27 nm south east of the Dean Cross VOR. Although a radar squawk (code 5074) was allocated and set by 'JC, formal identification did not occur immediately. At 1824 hrs, the pilot requested descent to FL35, "to get out of some rough weather", and enquired as to whether that level would be clear of any obstacle/safety altitude. The controller requested the aircraft's present position, to which the pilot replied that he was tracking on the Dean Cross VOR but that his DME was not giving any indication of distance, so he was unsure of position at that moment. 'JC was requested to squawk ident, and was positively identified on the 133° Radial from Dean Cross, at a range of 16 nm. The pilot repeated his request for descent "to get below this weather", and "descent below Flight Level 40". At 1826 hrs, the controller replied that he was not able to give terrain information in that area, as he was not equipped to do that. The pilot replied that he understood. Subsequent replay of the radar recording showed that the aircraft commenced a descent shortly after this exchange. A diagram showing the SSR Transponder Mode C altitude encoding data received at the Great Dun Fell Radar from 'JC, and the correlation with radio transmissions, is included at Fig.1.

The local QNH at the time of the accident was 1004 mb. Therefore, when set to 1013 mb, the aircraft's altimeter would have been over-reading its true altitude by 243 feet (1 mb is equivalent to approximately 27 feet altitude). Radar data indicated that the aircraft descended to FL35 (1013 mb), which is equivalent to 3257 feet AMSL (QNH). The summit of Skiddaw is 3055 feet AMSL. However, the final north-westerly track of the aircraft brought it close to the summit of Skiddaw on the downwind side. Given the strong winds, moderate to severe downdraughts and turbulence would be expected in the lee of such terrain.

The final contact with 'JC, from the Great Dun Fell Radar recording, occurred at 1830 hrs and 40 seconds, the final radar position being approximately 250 metres from the accident site. Radar returns received at SSR sites such as this are from transponder equipped aircraft only, therefore no returns from high ground or weather are recorded.

- 1 G-IPJC REQUESTS DESCENT TO GET OUT OF ROUGH WEATHER
- 2 NO DME INDICATIONS FROM DEAN CROSS - UNSURE OF POSITION
- 3 RADAR IDENTIFIED DCS 133°/16 nm
JC REQUESTS DESCENT BELOW FL40 TO GET BELOW WEATHER
- 4 ATC REPLY - NO IDEA OF TERRAIN IN THAT AREA - NOT EQUIPPED TO DO THAT
- 5 ATC - POSITION DCS 130/9.5 - HIGH GROUND IN THE VICINITY UP TO 3054 FEET
"TO KEEP YOU WITHIN RADAR COVERAGE AND ALSO ABOVE THE HIGH GROUND,
SUGGEST YOU START A CLIMB AGAIN"
- 6 OTHER AIRCRAFT RELAYS SUGGESTED CLIMB CALL
