AAIB Bulletin No: 12/93

Ref: EW/G93/07/09

Aircraft Type and Registration: Piper PA-31-350 Navajo Chieftan, G-OLLY

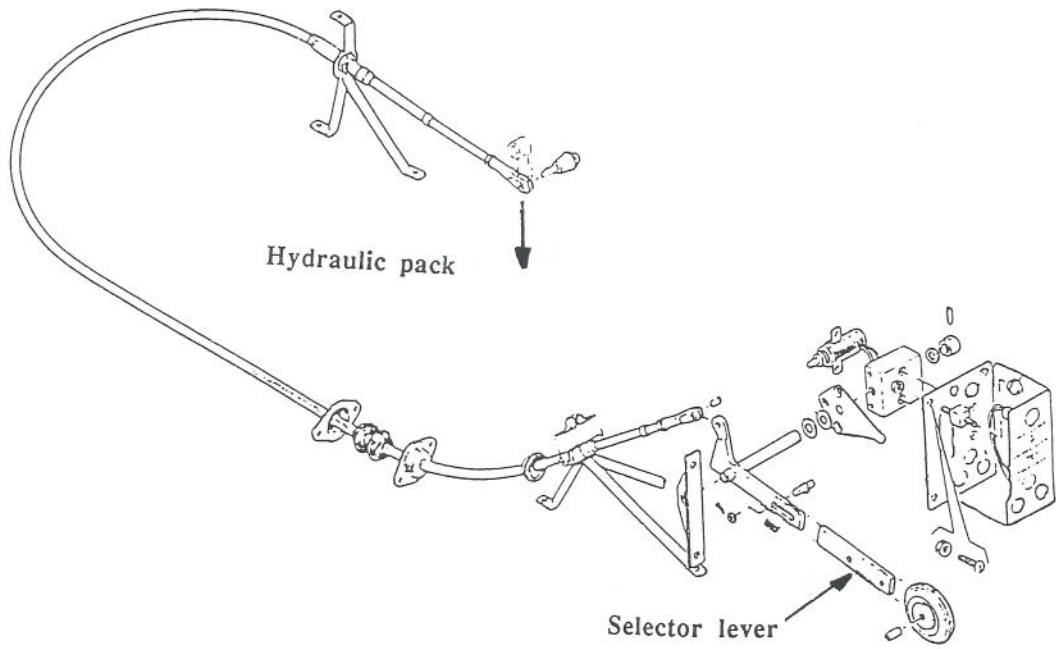
Fig 1 Landing gear selector cable installation

During the recovery of the aircraft, it was noted that the actuator lever on the hydraulic selector pack in the nose of the aircraft did not move in response to operation of the selector lever in the cockpit. This indicated that the selector cable had broken. After placing the aircraft upon jacks, the down selection was made directly on the selector pack actuator lever and, after operating the emergency hand-pump, the gear extended normally. Operation of both the normal and emergency gear extension systems is dependent on movement of this lever to the 'DOWN' position. Upon inspection, it was found that the operating cable had failed 15 mm from the end of a steel rod into which it had been crimped, the other end being connected to the cockpit selector lever. The part number of the failed component was 55416-02, and it was a non-lifed item. It had been on the aircraft since new, and had achieved 6,061 hrs. A sketch of the cable is shown at Fig 1.

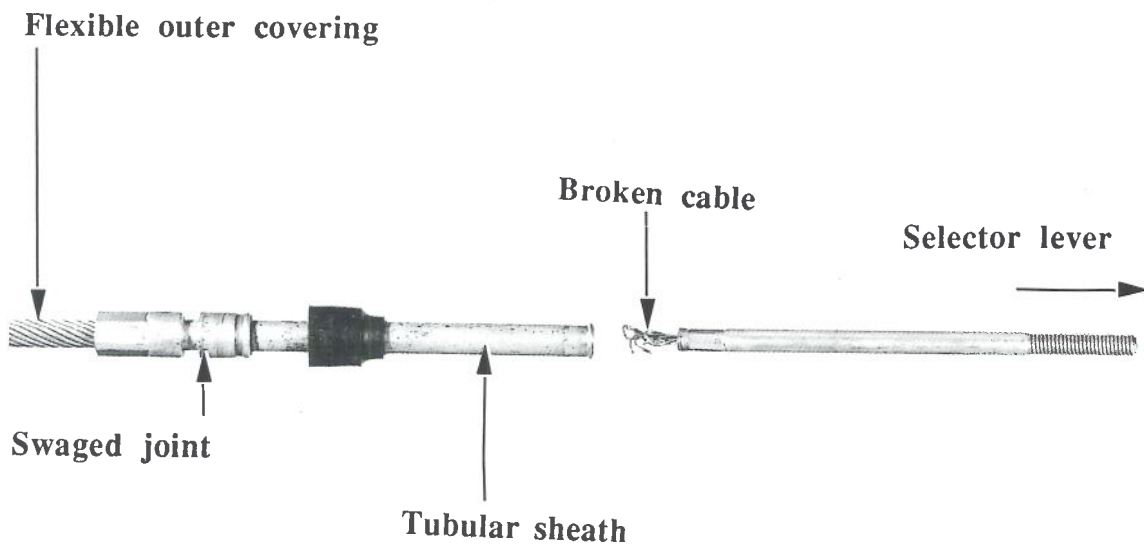
Fig 2 Failed cable assembly

The cable was subjected to metallurgical examination. A photograph of the component is shown at Fig 2. One half of the failed cable can be seen, the mating half being located within the tubular sheath close to the swaged joint that attaches the flexible outer covering. Both halves of the cable failure are shown at Fig 3. All the individual wires had been bent, especially those attached to the steel rod. The fractured ends appeared 'burnished' and were worn due to rubbing contact within the tubular sheath and, as a result, none showed any evidence of fatigue damage when examined using an electron microscope. The wire ends were removed and then ground to produce longitudinal sections before being optically examined. This revealed the presence of multiple fatigue cracks growing transversely from the surface. This indicated that the failures were the result of bending fatigue.

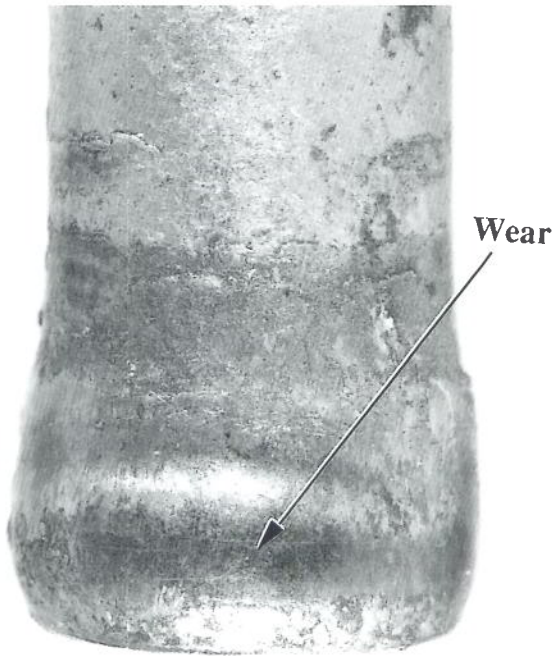
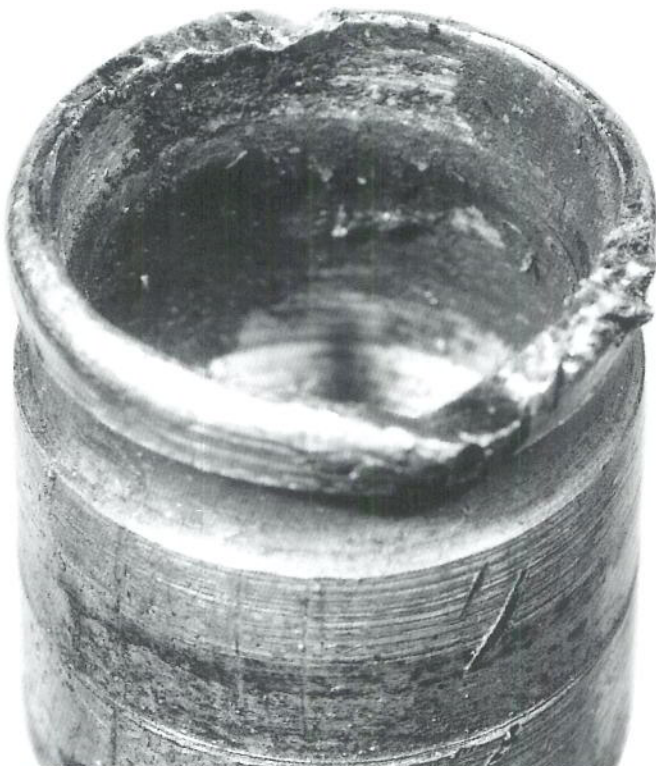
Fig 4 Both halves of swaged joint

The tubular sheath was attached to the flexible outer covering by means of a swaged joint. When this was separated, it was evident from the wear pattern (see Fig 4) that the joint may have been deformed in bending at some stage, thereby causing a 'kink' in the cable. It is possible that this could have been responsible for the fatigue in the individual wires. The inside of the tubular sheath displayed longitudinal scoring from the broken ends of the wires, over a length of some 60 mm extending from the joint.

The organisation that maintained G-OLLY is considering implementing a procedure whereby the operating cables are changed at 5,000 hour intervals on the aircraft in their charge. The cables are relatively easy to fit and such action would not constitute an expensive precaution.
