No: 12/90

Ref: EW/G90/07/05

| <b>Aircraft Type and Registration:</b> | Piper PA-31 Navajo, G-VICK | |
| <b>Location:</b> | Birmingham International Airport | |

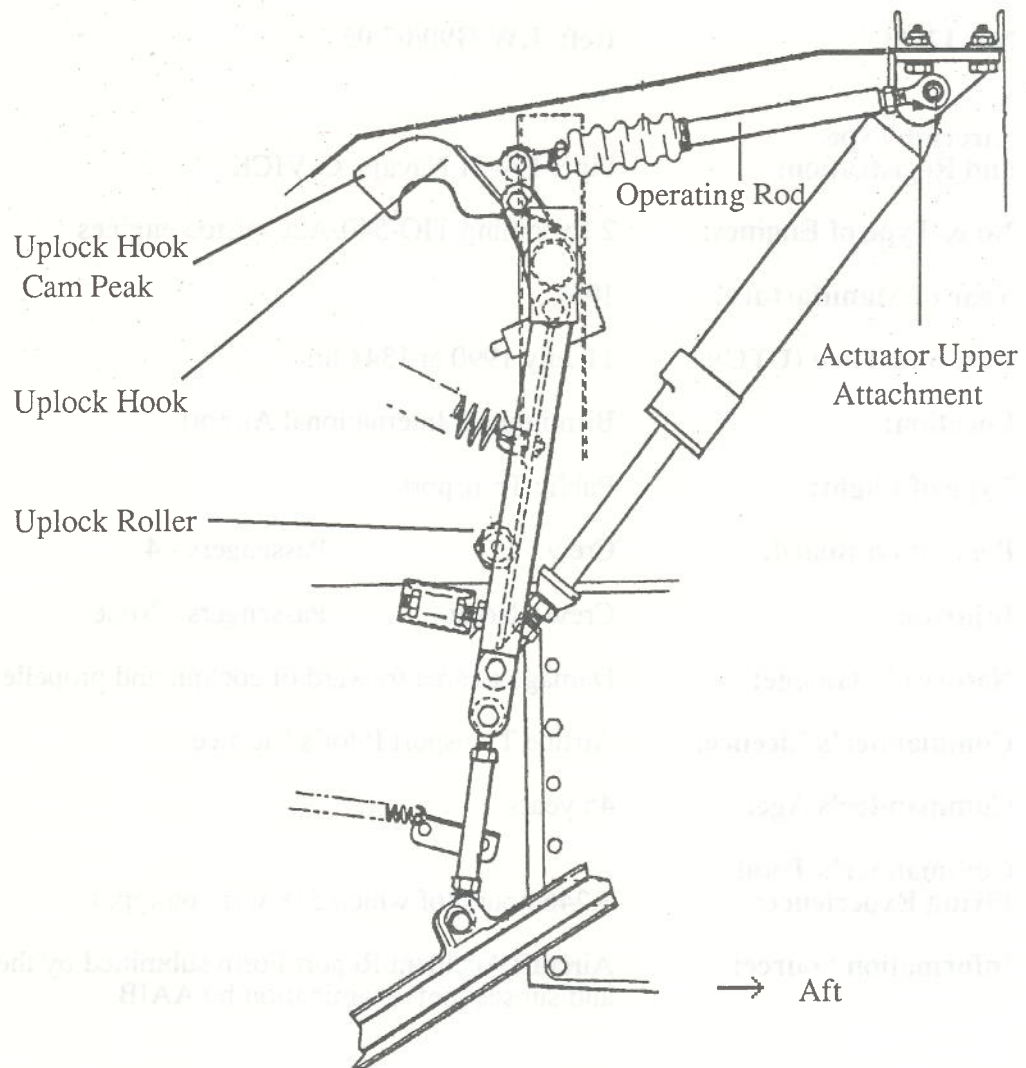
### Nose Landing Gear Operation

The uplock hook is spring-loaded in the locked direction. On extension of the gear, the actuator upper attachment moves aft in a slot, thereby opening the hook by means of an operating rod. On gear retraction the uplock roller contacts a cam portion of the hook and rotates the hook nose up allowing the roller to enter the hook. This rotation of the hook is permitted by a telescopic action of the operating rod.

Examination showed that the welded lugs forming the support for the uplock hook pivot bolt were both distorted in a manner consistent with overload forces applied by uplock rod tension with rotation of the uplock hook restricted.

The uplock operating rod was bent in two places, probably by overload forces applied during nose up rotation of the uplock hook beyond the point at which the uplock operating rod telescopic action bottomed out (under compression). There was also considerable play in the uplock hook pivot, with some elements found to be oval - again consistent with overload. Marking was found on the upper face of the uplock hook consistent with contact from the uplock roller nut.

The bending of the operating rod and the ovality of the hook pivot could have been caused by forces produced when the spring portion of the operating rod bottomed out because of its excessive length. Slop developing in the uplock hook pivot could eventually cause the roller to contact the uplock cam hook above the peak during retraction, allowing the roller nut to ride on the top face of the uplock hook, thereby preventing a subsequent nose gear extension.

After the damaged components had been replaced and the system rigged, the overall length of the operating rod was approximately 4 mm less than that of the original rod: this was equivalent to approximately 10° of uplock hook rotation in the closed direction, and 20 mm movement of the peak of the uplock hook cam.
