## ACCIDENT

<b>Aircraft Type and Registration:</b>	Piper PA-32R-301T Saratoga, N517FD	
<b>No &amp; Type of Engines:</b>	1 Lycoming T10-540 SER Piston Engine	
<b>Year of Manufacture:</b>	2001 (Serial no: 3257263)	
<b>Date &amp; Time (UTC):</b>	16 May 2018 at 1026 hrs	
<b>Location:</b>	Fair Isle Airfield, Shetland Islands	
<b>Type of Flight:</b>	Private	
<b>Persons on Board:</b>	Crew - 1	Passengers - 5
<b>Injuries:</b>	Crew - None	Passengers - None
<b>Nature of Damage:</b>	Right main landing gear partially collapsed, right stabilator bent and damage to lower rear fuselage	
<b>Commander's Licence:</b>	Commercial Pilot's Licence	
<b>Commander's Age:</b>	64 years	
<b>Commander's Flying Experience:</b>	3,372 hours (of which 2,270 were on type) Last 90 days - 90 hours Last 28 days - 50 hours	
<b>Information Source:</b>	Aircraft Accident Report Form submitted by the pilot

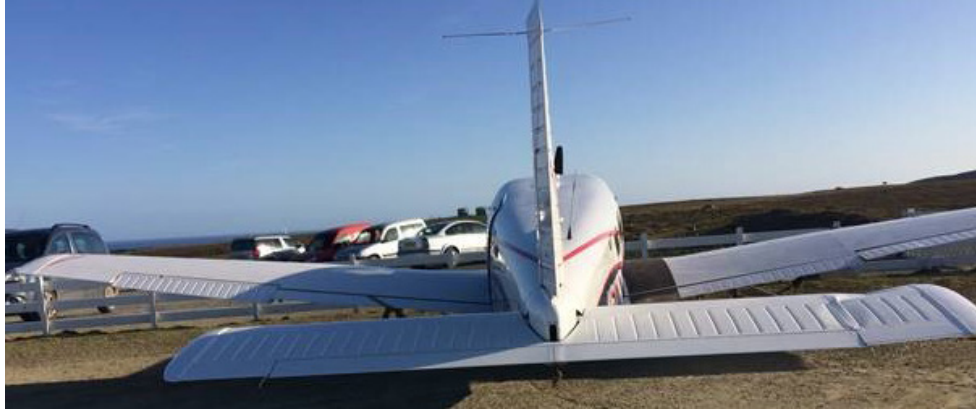
**Figure 1**

The aircraft slowly slid off the prepared surface before coming to rest on the adjacent rough ground, with the right main landing gear partially collapsed and the right rear fuselage resting on the ground. None of the occupants were injured and they were able to disembark normally. There was no evidence that the right wing had touched the surface but the rear horizontal tailplane, the stabilator, had been bent by ground contact (Figure 1).

N517FD after being moved to a parking area and with the right stabilator bent upwards  
(Picture used with permission)
