**ACCIDENT**

| <b>Aircraft Type and Registration:</b> | Piper PA-38-112 Tomahawk, G-BMVL | |
| <b>Location:</b> | Caernarfon Airport, Gwynedd, Wales | |

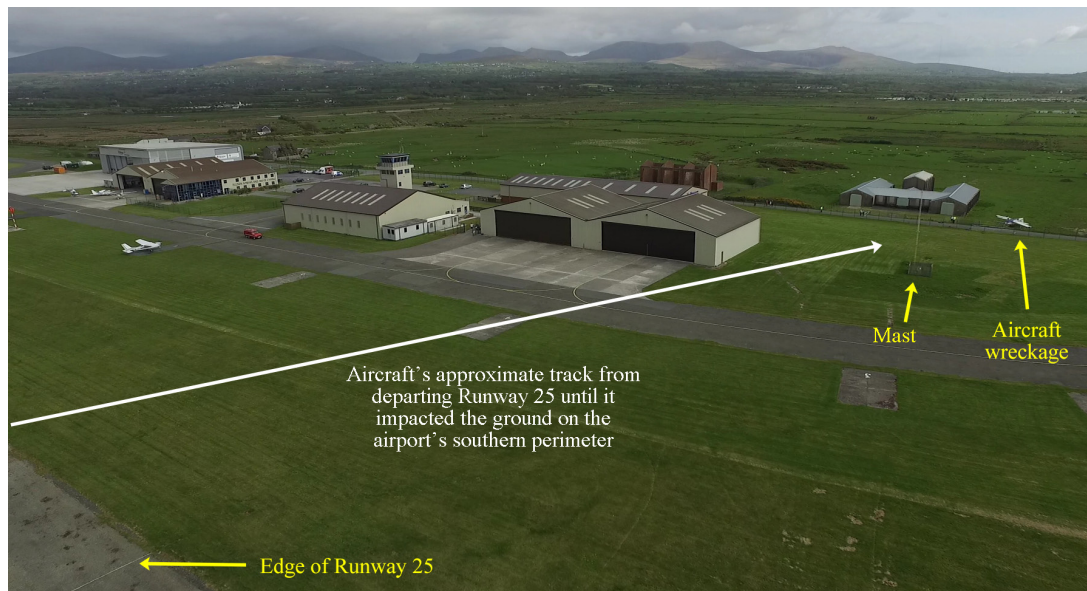
**Figure 1**

The aircraft appears to have flown between the hangars and a mast, bounced on the grass and then struck the ground by the airfield perimeter fence. It then passed through the fence line, travelled across a public road and hit another fence on the southern side of the road (Figure 1). The aircraft then inverted and stopped abruptly, near a farm building, with its nose pointing back towards the airfield (Figure 2).

View of Caernarfon Airport from drone positioned above Runway 25,  
with camera orientated towards the southeast  
(Picture courtesy of North Wales Police)

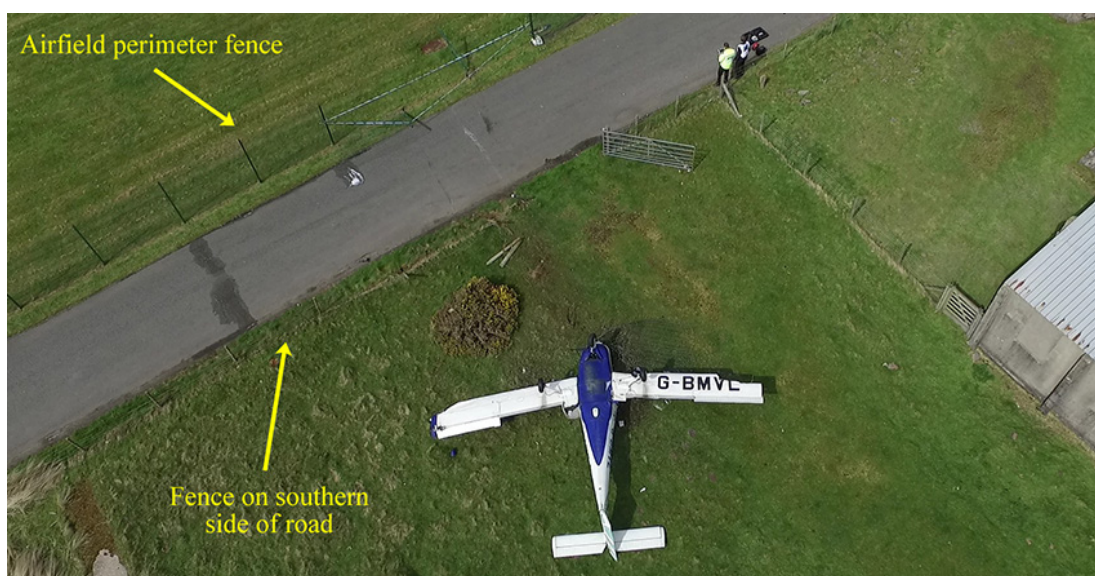
**Figure 2**

View of accident site from police drone  
(Picture courtesy of North Wales Police)
