ACCIDENT

Aircraft Type and Registration:	Piper PA 24, N7456P	
No & Type of Engines:	1 Lycoming 250 piston engine	
Year of Manufacture:	1961	
Date & Time (UTC):	21 July 2017 at 1055 hrs	
Location:	Retford (Gamston) Airport, Nottinghamshire	
Type of Flight:	Private	
Persons on Board:	Crew - 2	Passengers - None
Injuries:	Crew - None	Passengers - N/A
Nature of Damage:	Landing gear collapsed causing damage to underside panels and propeller; engine shock-loaded	
Commander's Licence:	Private Pilot's Licence (Federal Aviation Administration, USA)	
Commander's Age:	59 years	
Commander's Flying Experience:	1,257 hours (of which 388 were on type) Last 90 days - 1 hour Last 28 days - 1 hour	
Information Source:	Aircraft Accident Report Form submitted by the pilot

Synopsis

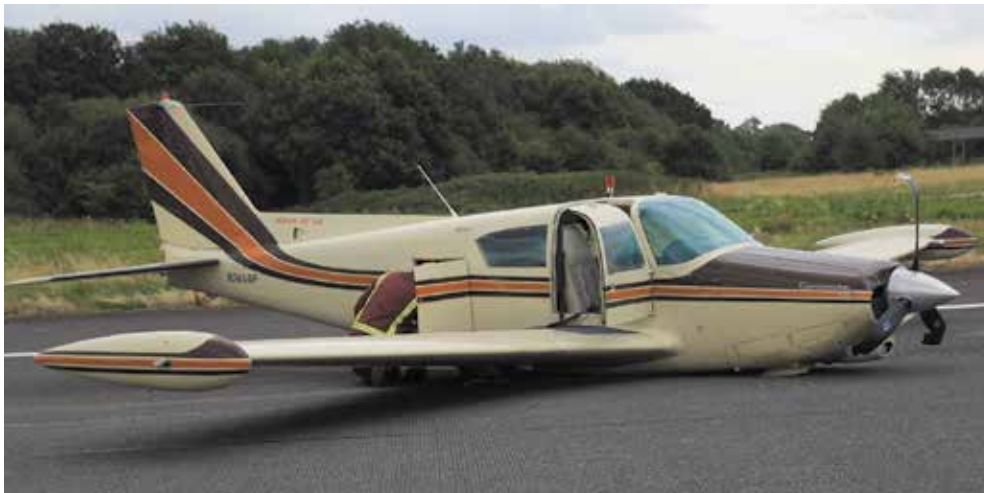
Figure 1

According to the passenger, the nose landing gear collapsed on impact and the aircraft skidded along the runway with the propeller striking the surface and causing the engine to stop. The main landing gear collapsed before the aircraft came to a halt. The pilot then turned off the master switches and the fuel while the passenger opened the door and moved the mixture control to CUT OFF. The two occupants evacuated the aircraft (Figure 1) without injury, prior to the arrival of the airport’s rescue service.

View of N7456P shortly after the crew evacuated
(Photograph courtesy of Dave Grimsdale – Photographer - Retford (Gamston) Airport)
