**ACCIDENT**

| <b>Aircraft Type and Registration:</b> | 1) Robinson R44 Raven, G-CTFL<br>2) Robinson R44 Raven, G-HYND |
| <b>Date &amp; Time (UTC):</b> | 5 May 2018 at 1125 hrs |
| <b>Location:</b> | Cumbernauld Airport, North Lanarkshire |

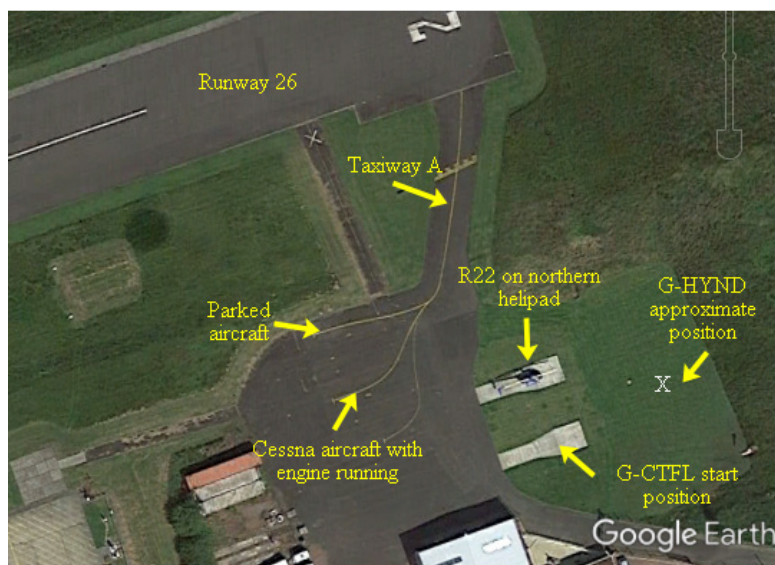
**Figure 1**

The pilot of G-CTFL stated that he was restricted from moving forwards and right onto Taxiway A, because of the position of the parked R22 helicopter and because of a stationary Cessna aircraft, which was in front of him and facing away with its propeller turning (Figure 1). There was a second light aircraft parked to the left of the Cessna and he did not wish to disturb these aircraft with his helicopter’s downwash. The pilot knew that, when he boarded his helicopter, the area to the rear was clear and he had no recollection of hearing any radio transmissions from G-HYND, so he was not aware of its position and was not expecting another helicopter to be parked there. After lifting to the hover, the pilot decided to move rearwards and then taxi behind the R22. He did not turn his helicopter to check that the area to his rear was clear before reversing, because of the proximity of the R22 on his right and because he did not wish to turn his tail left towards the buildings, where some spectators had assembled.

Approximate aircraft disposition in the vicinity of Apron A, at the eastern end of Cumbernauld Airport, before G-CTFL moved

- The northern helipad was extended eastwards by 12 m, so a parked helicopter is further from the apron, leaving space for other helicopters to move between the parked helicopter and the apron.

- The prepared grass area east of the helipads has been extended, to ensure helicopters parked there can remain well clear of the pads.
- A mirror has been placed at the corner of the hangar, to assist pilots using either helipad see any activity to their rear.

- The helicopter operator no longer permits helicopters to reverse from the helipads.
- The helicopter operator's safety team is due to review the procedure for turning off the avionics systems while a Robinson R44 is being shut down.
