ACCIDENT

Aircraft Type and Registration:	EC225 LP Super Puma, G-REDW
No & Type of Engines:	2 Turbomeca Makila 2A1 turboshaft engines
Year of Manufacture:	2009 (Serial no: 2734)
Date & Time (UTC):	10 May 2012 at 1114 hrs
Location:	20 nm east of Aberdeen
Type of Flight:	Commercial Air Transport (Passenger)
Persons on Board:	Crew - 2 Passengers - 12
Injuries:	Crew - None Passengers - 2 (Minor)
Nature of Damage:	Salt water immersion
Commander's Licence:	Airline Transport Pilot's Licence
Commander's Age:	40 years
Commander's Flying Experience:	3,060 hours (of which 2,740 hours were on type)
Information Source:	AAIB Field Investigation

This Special Bulletin contains information about the helicopter's main gearbox (MGB) lubrication system and the results of an investigation into the indication of a failure of the emergency lubrication system, after it was activated by the crew. It follows publication of two earlier Special Bulletins on this accident, AAIB Special Bulletins S2/2012 and S3/2012.

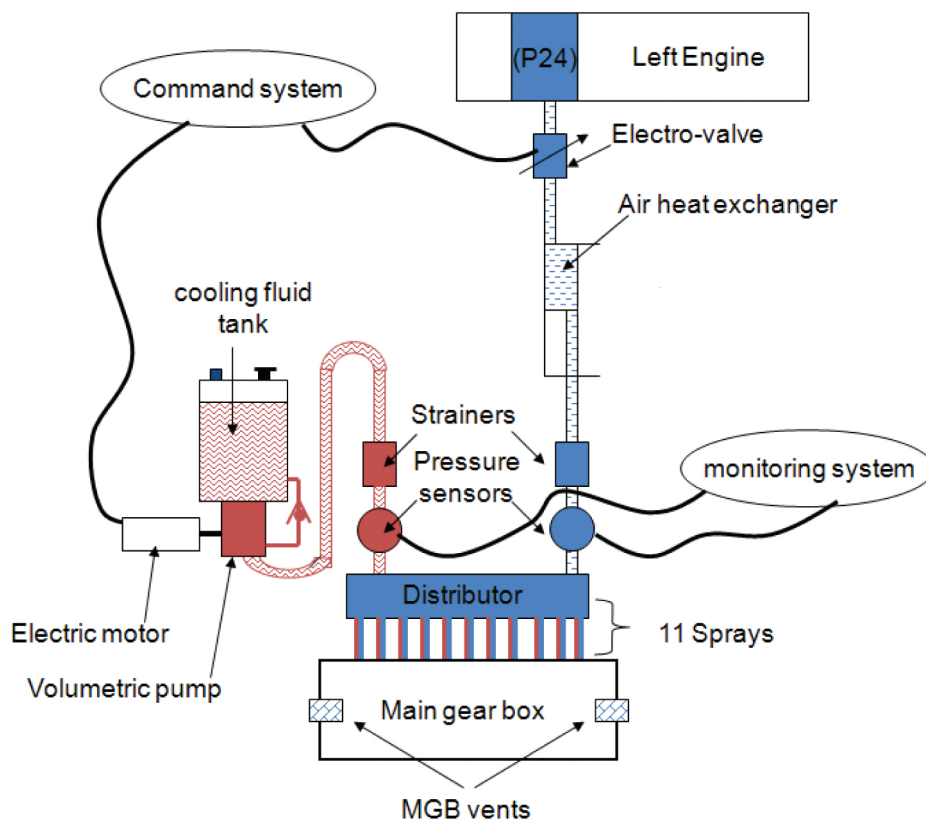
Figure 1

When the emergency lubrication system is activated an electro-valve, called the P2.4 valve, opens and bleed air from the left engine enters the system, after passing through an air heat-exchanger. At the same time, an electric pump supplies Hydrosafe 620 from the reservoir. There are two similar sensors that monitor the pressure in the Hydrosafe 620 pipes and bleed air lines; these sensors are mounted on the MGB. A MGB EMLUB caption will illuminate if low pressure is detected in either the Hydrosafe 620 pipes or the bleed air lines. This warning is inhibited for approximately 30 seconds after the system is activated, to allow the system to reach a steady state.

Schematic of the Emergency Lubrication System

When the bleed air pressure sensor was tested, p_{on} was measured at 0.68 bar. The pressure at the input to the bleed air line would have been about 1.4 bar (relative), with the loss across the air heat-exchanger

around 0.3 bar, but this could have been greater. There would also have been losses in other parts of the system upstream of the pressure sensor. The margins are small and the possible error bands are significant. It is possible, therefore, that the bleed air pressure sensor on G-REDW triggered the MGB EMLUB caption.

More importantly, the upper end of the specification for the bleed air pressure to trigger a low pressure input to the monitoring system is 1.0 bar (relative). Therefore, it was concluded that a bleed air pressure sensor at the top end of the specified tolerance could generate an MGB EMLUB caption, even though all the parts of the emergency lubrication system are operating within their specifications.

It is recommended that the European Aviation Safety Agency requires Eurocopter to review the design of the main gearbox emergency lubrication system on the EC225 LP Super Puma to ensure that the system will provide the crew with an accurate indication of its status when activated.
