AAIB Bulletin S5/2014

SPECIAL

ACCIDENT

Aircraft Type and Registration:	BAE Systems Jetstream 31, G-GAVA
No & Type of Engines:	2 Garrett Airesearch TPE331-10UGR-516H turboprop engines
Year of Manufacture:	1987 (Serial no: 785)
Location:	Doncaster Sheffield Airport, Yorkshire
Date & Time (UTC):	15 August 2014 at 1836 hrs
Type of Flight:	Commercial Air Transport (Passenger)
Persons on Board:	Crew - 2 Passengers - 1
Injuries:	Crew - None Passengers - None
Nature of Damage:	Left main landing gear, left propeller, fuselage and wing
Commander's Licence:	Airline Transport Pilot's Licence
Commander's Age:	54 years
Commander's Flying Experience:	8,740 hours (of which 3,263 were on type) Last 90 days - 147 hours Last 24 hours - 6 hours
Information Source:	AAIB Field Investigation

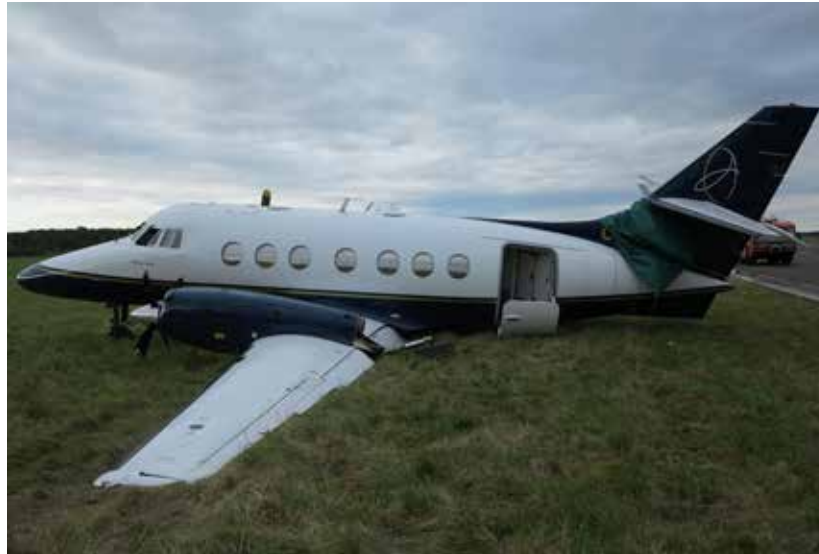
Figure 1

The aircraft touched down at 1836 hrs with an IAS of 102 kt and a peak normal acceleration of 1.3 g, and the commander moved the power levers aft to `GROUND IDLE` followed by `REVERSE`. As the aircraft decelerated, the commander moved the power levers forward to `GROUND IDLE` and asked the co-pilot to move the rpm levers to `TAXI`. At an IAS of 65 kt, eight seconds after touchdown, the left wing dropped suddenly, the aircraft began to yaw to the left and the commander was unable to maintain directional control with either the rudder or the nosewheel steering tiller. The aircraft ran off the left side of the runway and stopped on the grass having turned through approximately 90°. The left landing gear had collapsed and the aircraft had come to a halt resting on its belly, right landing gear and left wing (Figure 1).

The aircraft as it came to rest

The commander pulled both FEATHER levers, to ensure that both engines were shut down, and switched the electrics master switch to EMERGENCY OFF. The co-pilot transmitted "TOWER..... [CALLSIGN]" and the controller replied "[CALLSIGN] COPIED, EMERGENCY SERVICES ON THEIR WAY". The commander instructed the co-pilot to evacuate the aircraft. The co-pilot entered the main cabin where he found that the passenger appeared to be uninjured. The co-pilot considered evacuating the aircraft through the emergency exit on the starboard side of the cabin but judged that the main exit on the port side at the rear of the cabin would be the best option. The cabin door released normally but would not open completely because the sill of the doorway was at ground level (Figure 1). Nevertheless, all occupants were able to evacuate the aircraft through the main exit.

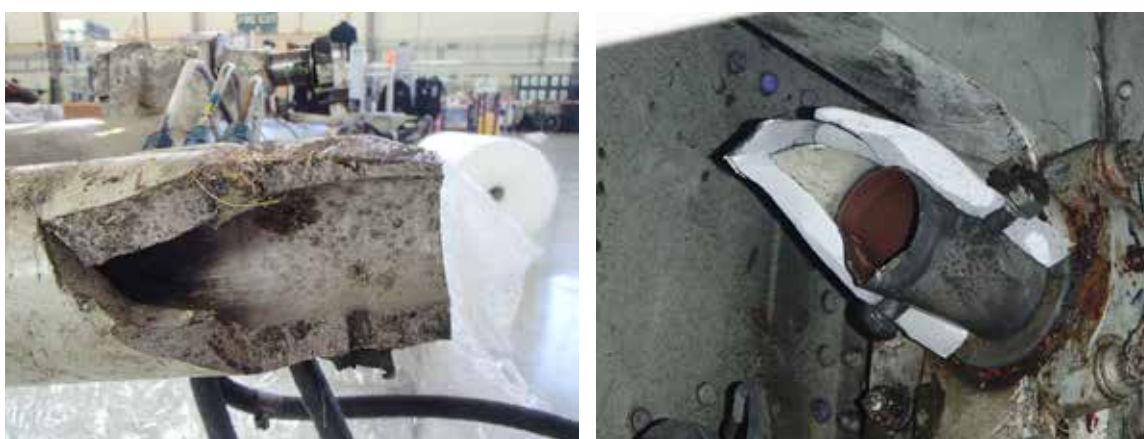
Figure 2

The left landing gear had broken away from its trunnions as a result of the failure of the forward yoke pintle housing; two sections of the pintle housing stayed attached to the pintle spigot (Figure 2). However, the landing gear remained attached to the aircraft by the radius arm (retraction jack) and hydraulic pipelines.

Left main landing gear yoke forward pintle

Preliminary metallurgical examination of the fracture faces on G-GAVA's left landing gear has established that the failure initiated at the top outer edge of the forward yoke pintle and that the crack propagated axially along the top of the pintle, before final overload failure occurred. The presence of corrosion has been identified at the crack initiation site. The forward face of the yoke pintle housing exhibits rotational wear marks and corrosion pitting. There is also evidence of rotational wear marks on both the forward and aft faces of the special washer; further work is required to fully understand the origin of these marks. There was no visual evidence of the presence of gasket material on either of the mating faces of the washer or pintle housing although some gasket material was present on the top machined flat of the housing. Additionally the fracture faces exhibit considerable similarities to those from the G-CCPW accident. This provides strong evidence that the crack initiated due to stress corrosion cracking.

Rotational wear is evident on the mating faces of the forward yoke pintle and the special washer. Further work is being undertaken to determine the origin of this wear and also whether rotational wear on the forward face of the special washer may be related to fouling of the bearing locking pins. There is no visual evidence of gasket material on the mating faces of the yoke pintle and the special washer; however, it is not yet known whether the gasket material was omitted during installation or had been forced out by the rotating washer. Gasket material is evident on the machined flat of the yoke pintle housing, however this area would be expected to be cleaned to facilitate the regular visual inspections in this area.
